Disability Access Audit

Eye
Nr Peterborough
Cambridgeshire

Sandie Burns
DIAL Peterborough
Kingfisher Centre
The Cresset
Bretton
Peterborough
PE3 8DX

15th August 2013

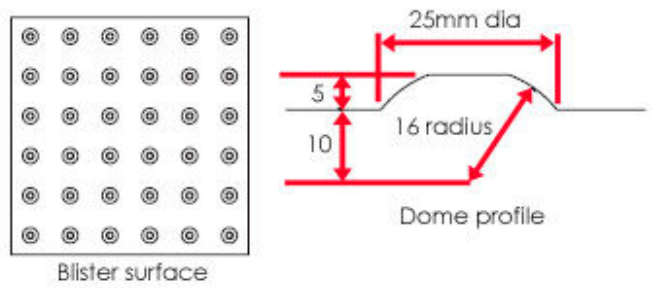
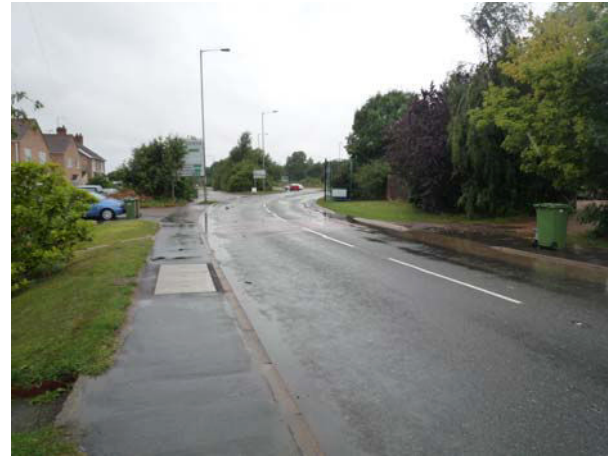
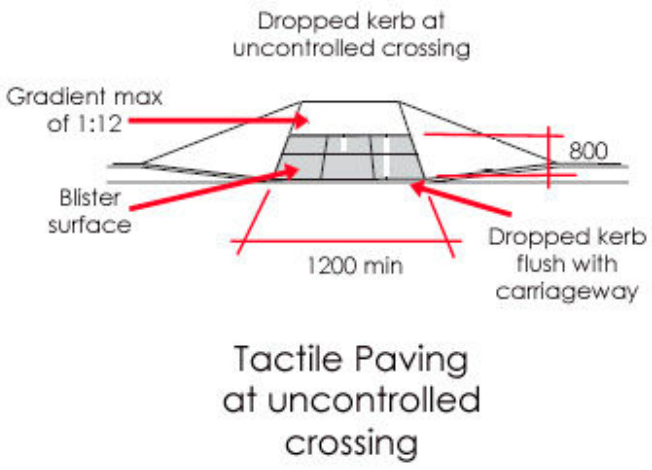
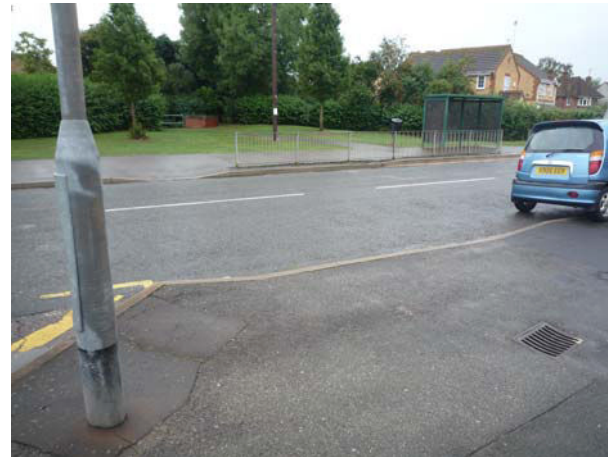
Dropped kerbs adjacent to the bus stop and roundabout with High St

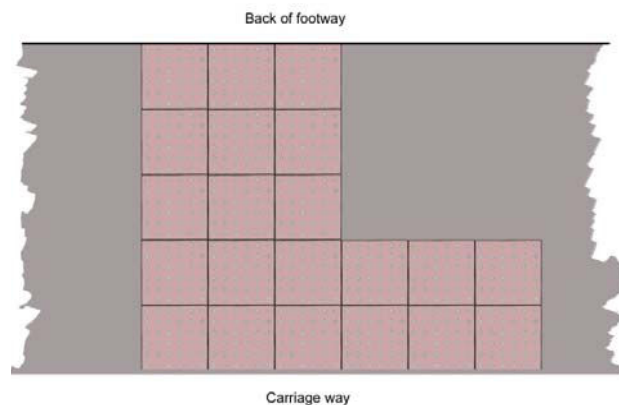
Ref	Observation	Recommendation	Priority
5.5	The zebra crossing outside the post office has not had its blister paving laid in accordance with guidance as this also uses guidance path paving. For controlled crossings, the blister paving should have a section leading to the back of the footway. The blister paving is red and so is the adjoining block paving. At controlled crossings, the blister paving should be red and contrast with the adjoining surfaces.	Provide blister paving to the zebra crossing as per guidance.	2

Layout of blister paving at a controlled crossing

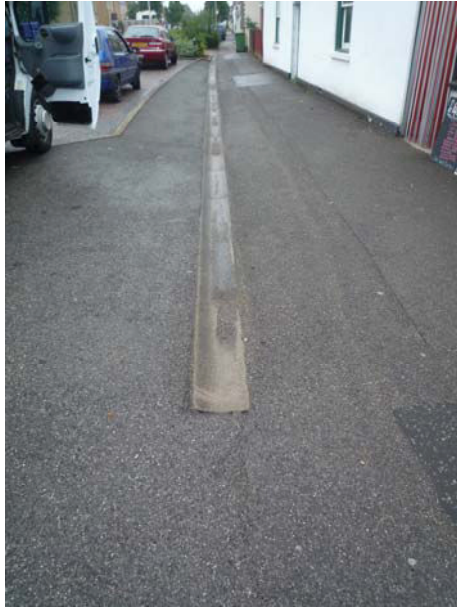
On the High Street, a half dished gully can be found, this will be an issue to wheelchair users, getting their wheels in it will be like being on a railway track, no way off, to others a tripping hazard.

5.6	The surface is generally even and slip-resistant with the surface being made up of tarmac. However, towards the roundabout with Eyebury Rd/Thorney Rd/Crowland Rd, a half dished gully can be found within the pedestrian routes, this is not obvious and to visually impaired people and wheelchair users this could be an issue/hazard.	Look to replace half dished gully with a flush flat top gully	2

Dished gully used in the middle of the footway

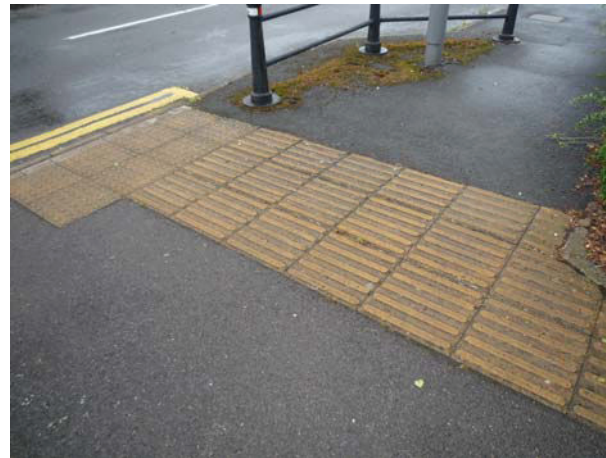
Blister paving and guidance paving used at crossing points along High St

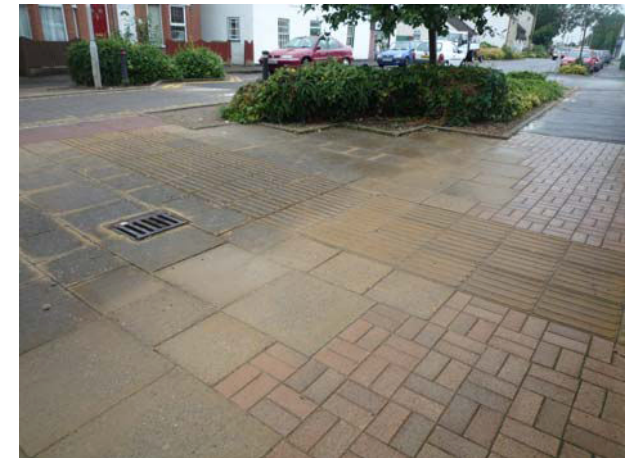
5.4	It was also noted that red tactile has been used at uncontrolled crossings, this should be reserved for controlled crossings only.	Replace red tactile paving with other contrasting colour to uncontrolled crossings when the opportunity arises	3

Red blister paving used at an uncontrolled crossing

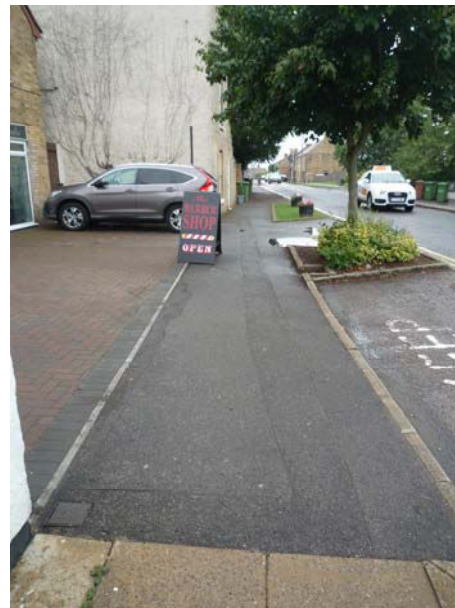
5.7	The route provides adequate width.		
5.8	It is not free of hazards as bollards and "A" boards can be found along the route. To visually impaired people these can be a real issue.	Check on the use of "A" boards by retailers. If used they should be placed outside of the pedestrian routes. Bollards unless absolutely necessary should be removed.	1

"A" boards and bollards are an issue to visually impaired

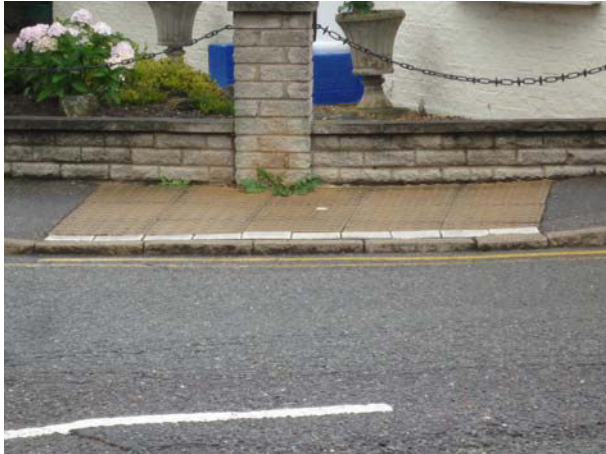
Dropped kerb at the roundabout at the end of Thorney Rd

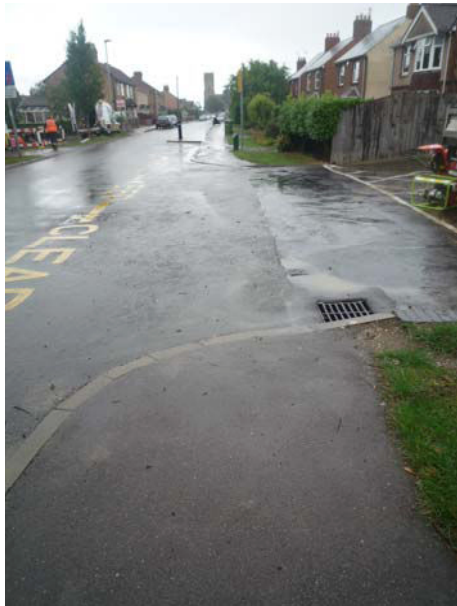
Vehicle crossover to the school, no tactile warning

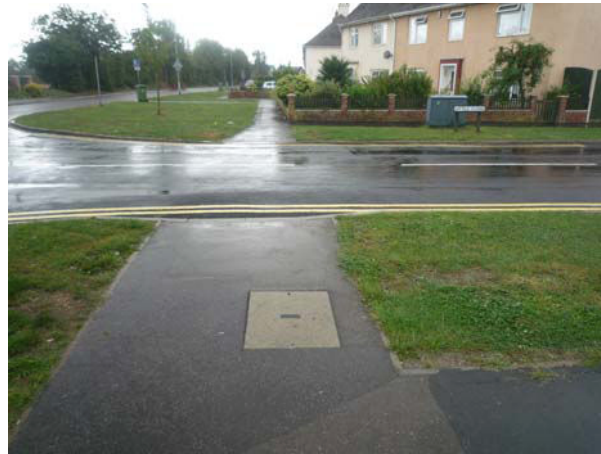
Little Close with a dropped kerb but no blister tactile warning

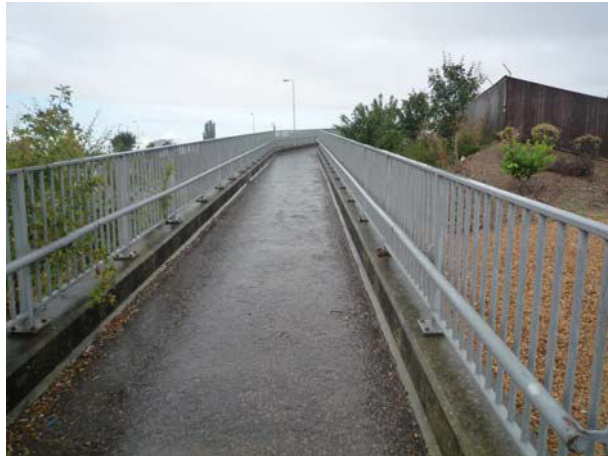
Poor colour contrasting handrails

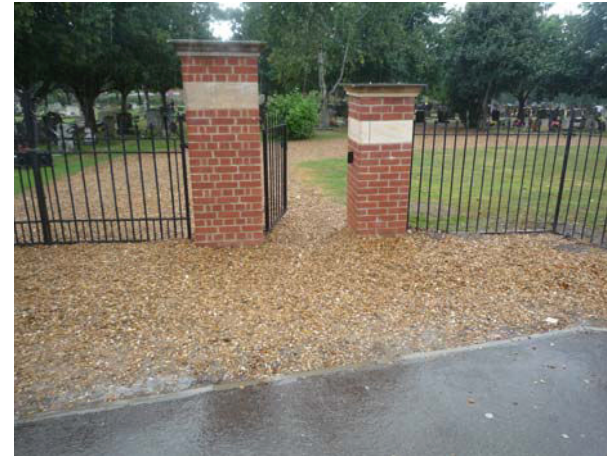
Although the cemetery did not form part of the audit, it was noted that it had walk ways of gravel, this will be disabling to many users, an access audit should be carried out.

Cemetery with large areas of gravel which is disabling to some.

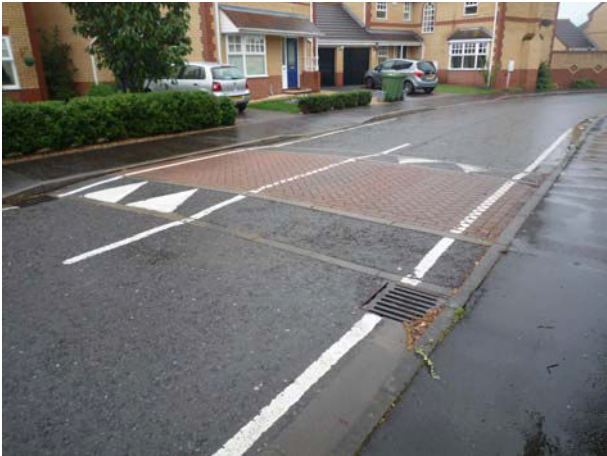
Ref	Observation	Recommendation	Priority
9.1	Generally there is a continuous unobstructed access route along the footway.		
9.2	The route does not have kerbs which have been dropped but the carriageway has been raised, unfortunately the footway kerb and carriageway are not flush, this will be an issue for wheelchair users and visually impaired.	Provide dropped kerbs that are flush with the carriage way	2

Raised carriage way makes a good crossing point but not flush with kerb and no blister warning

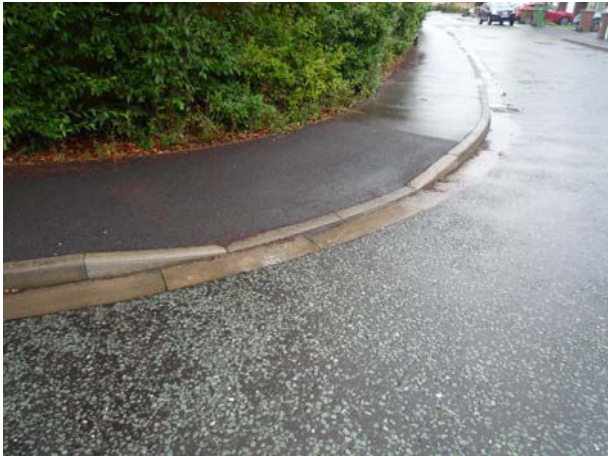
Dropped kerb with no blister warning

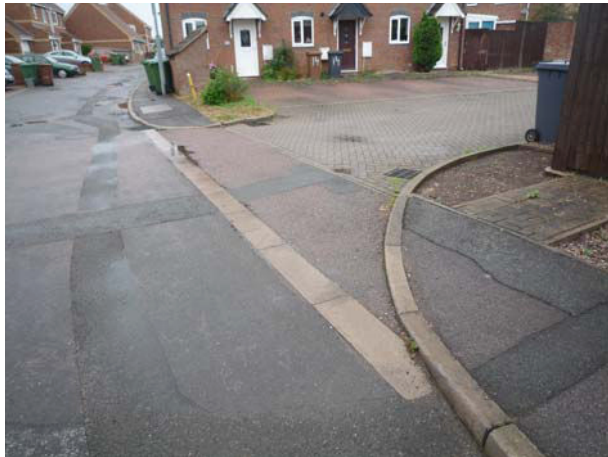
Dropped kerb but lacking in tactile paving

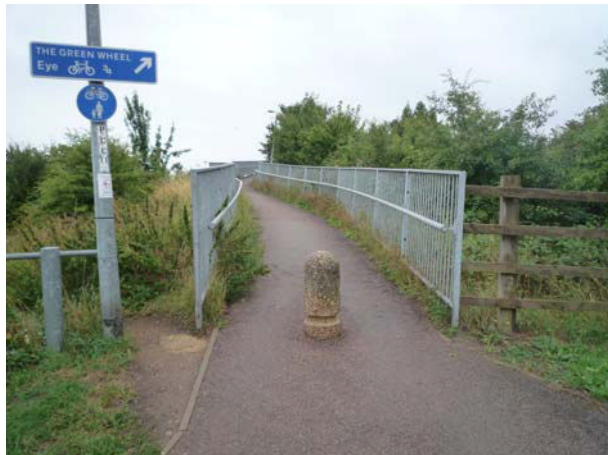
11.6	It is not free of hazards such as bollards, as these can be found to the area in front of the bungalows on Tintern Rise and at the far end of the overhead foot bridge.	Unless absolutely necessary bollards should be removed. If they cannot be removed they should provide good colour contrast against their background and incorporate a colour contrasting band.	1

Bollard on foot bridge. This, if absolutely necessary should be 1000mm high with good colour contrast and incorporate a colour contrasting band.

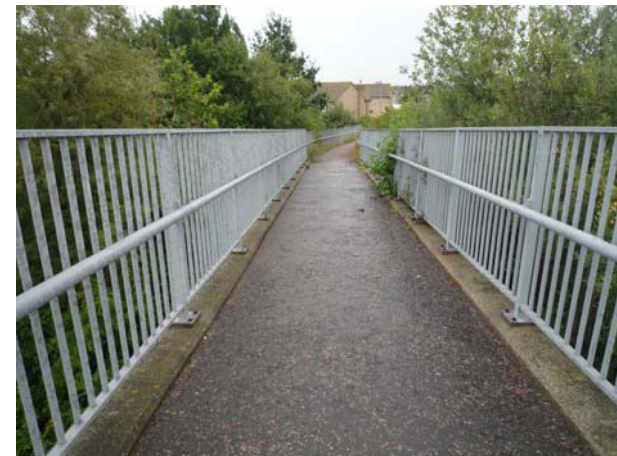
Handrails with poor colour contrast

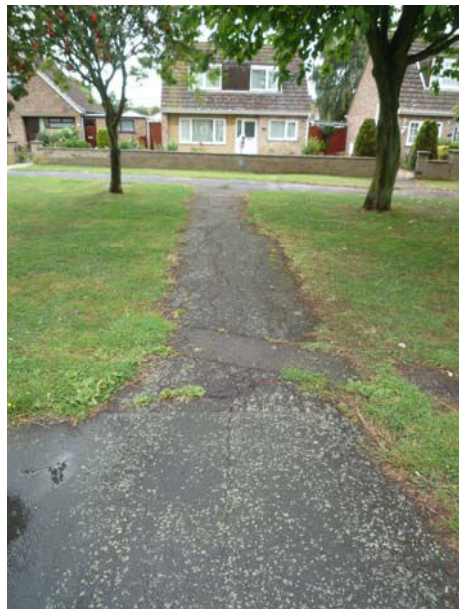
12.3	Tactile paving has not been provided at pedestrian crossings points.	Provide tactile warning to dropped kerb locations	1
12.4	The surface is even and slip-resistant with the surface being made up of tarmac. It was noted that a number of paths are starting to show signs of breaking up, remediation works should be put in a programme of works.	Programme remediation works to footways	3

Path showing the early sign of breaking up

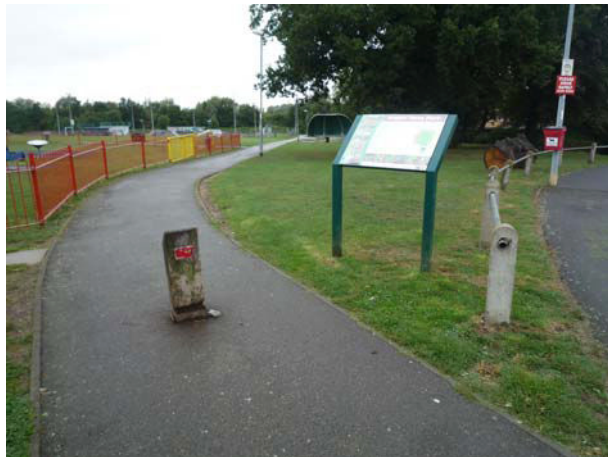
13.5	The route provides adequate width.		
13.6	It is not free of hazards such as bollards, as these can be found at the end of the footpath leading towards the play area and at the start of the paths adjacent to houses.	Unless absolutely necessary bollards should be removed. If they cannot be removed they should provide good colour contrast against their background and incorporate a colour contrasting band.	1

Ref	Observation	Recommendation	Priority
13.9	The route is level (i.e. with no gradient steeper than 1 in 20 and with no steps).		
13.10	Drainage gratings are not within the access route.		
13.11	At the start of the path leading towards the play area there is an information board. This is at a height and position that a person using a wheelchair would find difficult to read.	Provide information that is accessible to all in terms of text and positioning	1

Example of low level bollard in path and information panel which cannot be read by anyone seated or short of stature.

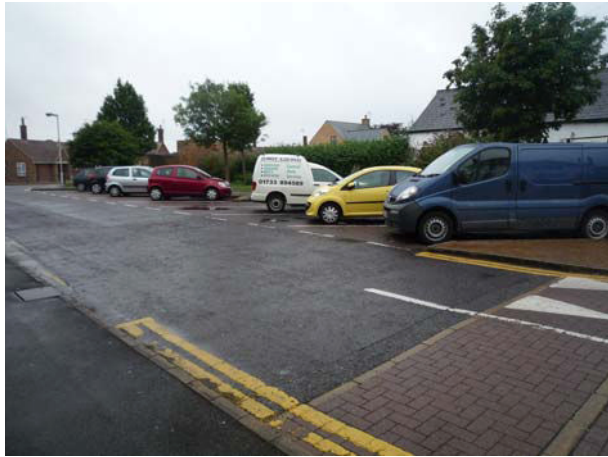
Top left: Parking on Lukes Lane

15.9	The route is level (i.e. with no gradient steeper than 1 in 20 and with no steps).		
15.10	Drainage gratings are not within the access route.		
15.11	The parking bays on Lukes Lane do not include any designated for Blue Badge holders. It could be argued that Blue Badge holders can park almost anywhere (subject to traffic regulations and providing they are not causing an obstruction) so that a bay is not required, however, providing suitable bays is recommended.	Provide a designated bay for Blue Badge holders on Lukes Lane.	3

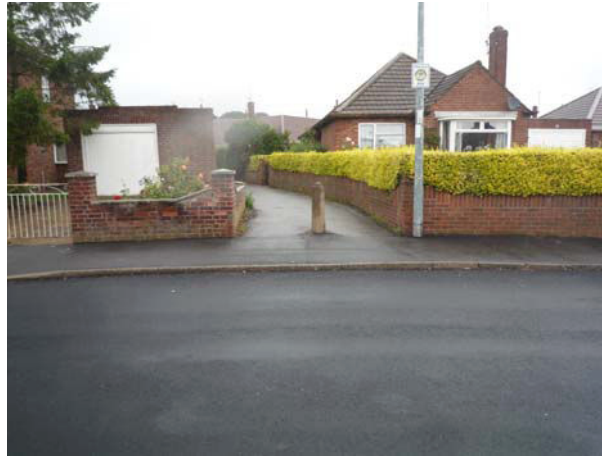
15.6	It is not free of hazards such as bollards, as these can be found at the ends of the Woad Court/Back Lane pedestrian only route.	Unless absolutely necessary bollards should be removed. If they cannot be removed they should provide good colour contrast against their background and incorporate a colour contrasting band.	1

Left: Bollards at the start of the pedestrian cut through to Woad Court

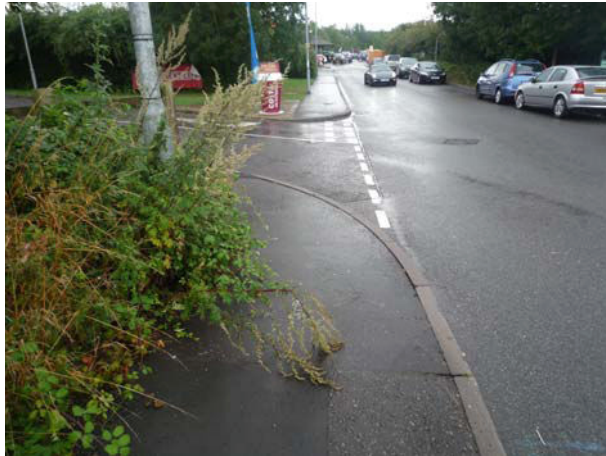
Ref	Observation	Recommendation	Priority
19.1	Generally there is not a continuous unobstructed access route along the footway. The footpath is not continuous and there is a large amount of traffic movement. With the hotel being present it is feasible that pedestrians unfamiliar to the area could be using this area.	Provide a continuous footway to the fast food outlet	1

Ref	Observation	Recommendation	Priority
19.2	The route does not have kerbs which have been dropped.	Provide dropped kerbs	1
19.3	Tactile paving has not been provided at pedestrian crossings points.	Provide tactile warning to dropped kerb locations	1

19.10	Drainage gratings are not within the access route.		
19.11	Vegetation was found to be encroaching on to the footway.	Cut back overgrowing vegetation	2

Looking towards the petrol station and fast food outlet. No dropped kerbs and vegetation encroaching on to footway.
