Disability Access Audit

Glinton
Nr Peterborough
Cambridgeshire

15th August 2013

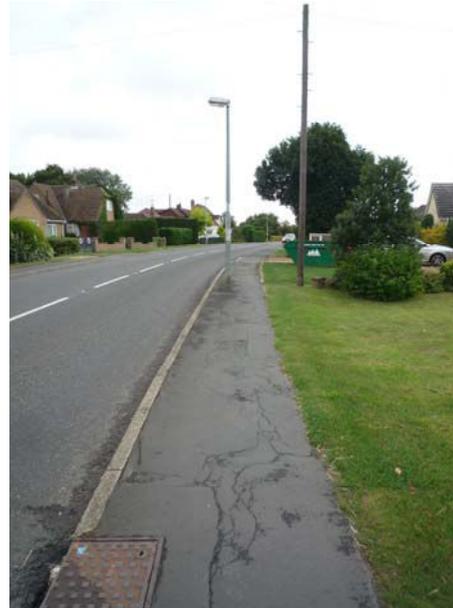
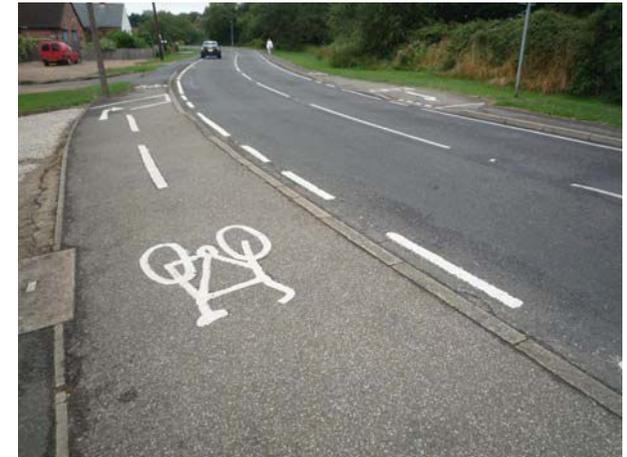
4.3	Tactile paving has not been provided at pedestrian crossings points.	Tactile paving to meet with current guidance should be provided at street crossing points. Where the footway is a segregated shared path between cyclists and pedestrians the recommended tactile paving and delineator should be provided.	1

Tactile Paving at uncontrolled crossing

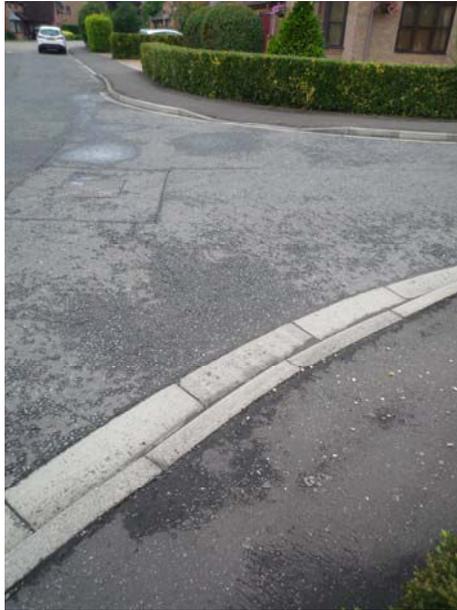
Dropped kerb location with no tactile warning

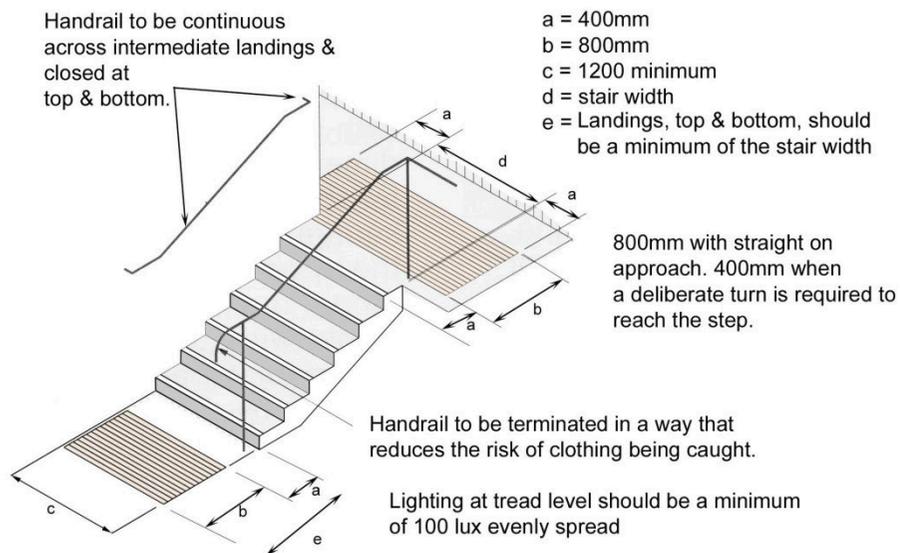
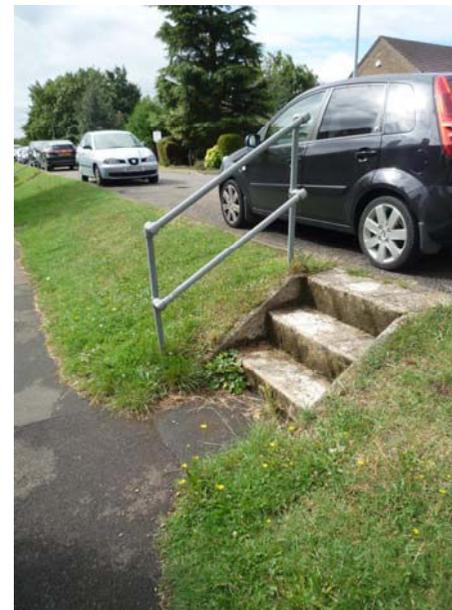
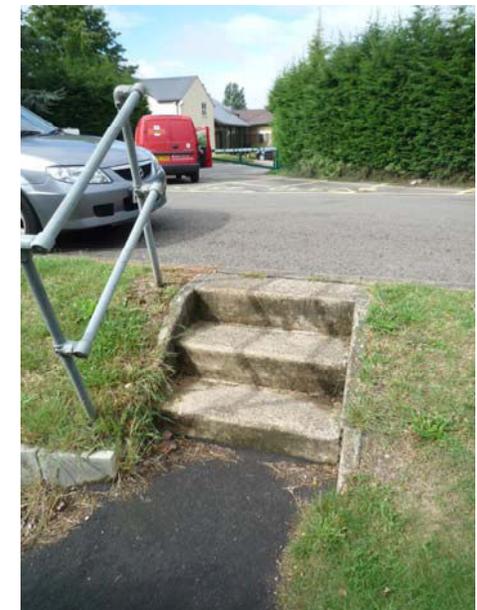
Ref	Observation	Recommendation	Priority
7.11	Steps to path opposite Ashburn Close: There is no alternative ramped access route between the steps, people who cannot negotiate the steps have to use the footway starting at either end which is approximately 90m. Consideration should be given to installing a ramp approximately half along the path length, this would also require no parking at the top of it.	Consider the provision of ramped access	
7.12	Drainage gratings are not within the access route.

Stairs, Tactile Warning & Key Dimensions

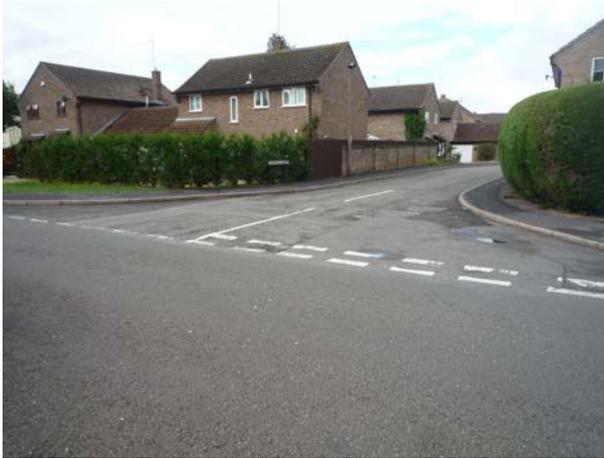
Example of road junction with no dropped kerbs or tactile warning

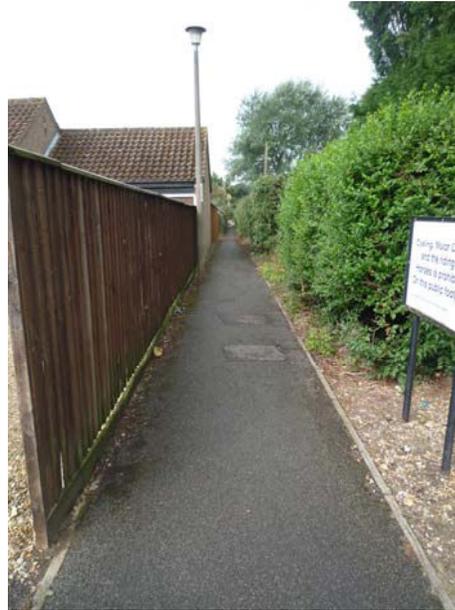
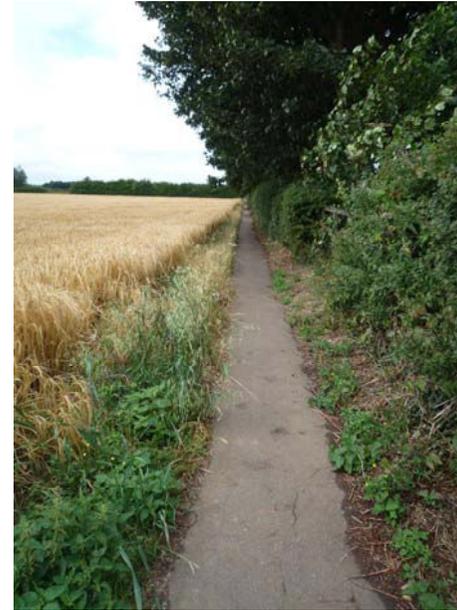
Ref	Observation	Recommendation	Priority
8.9	Drainage gratings are not within the access route.		
8.10	The cut-through which starts on Welmore Rd but passes along side St Benedict's Close provides a suitable width until it meets with the path from the playing field, from this point on to Lincoln Rd it provides less than 1500mm. There is vegetation from the sides and above encroaching on to the path, this should all be cut back. Increasing the width may not be seen as being reasonable, but suitable passing places should be installed.	Cut back overgrowing vegetation and introduce passing places	1

The cut-through which starts on Welmore Rd but passes along side St Benedict's Close provides a suitable width until it meets with the path from the playing field, from this point on to Lincoln Rd

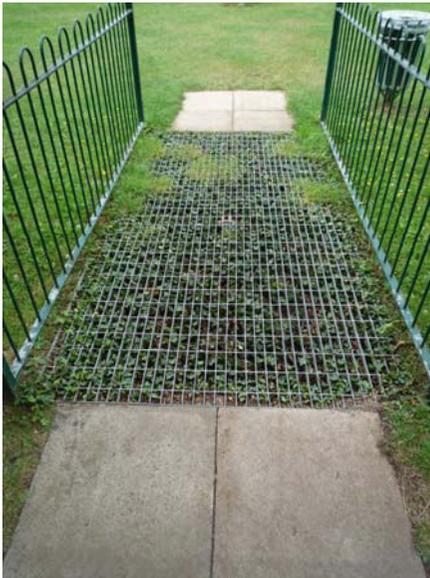
Ref	Observation	Recommendation	Priority
11.12	<p>From Saddlers Close there is a short path to the playing field where there is a children's playground. The path width is suitable with a firm surface.</p> <p>The playground has a fence around it with two access points, these have grates for the width and length of the opening, approximately 2000mm, this is to prevent animals, in particular dogs from entering this area, this however does discriminate towards people with assistance dogs who may be out with children wanting to play in this area. It also can be an issue for people using sticks, crutches, possibly some wheelchair users and people wearing high heels. The use of gratings should be reviewed with the intention of replacing with less discriminatory methods of keeping dogs out, e.g. gates.</p>	<p>Review the use of grates to play areas with a view to replacing with more accessible methods.</p>	1

Gratings to play area prevent people with assistance dogs entering the area.

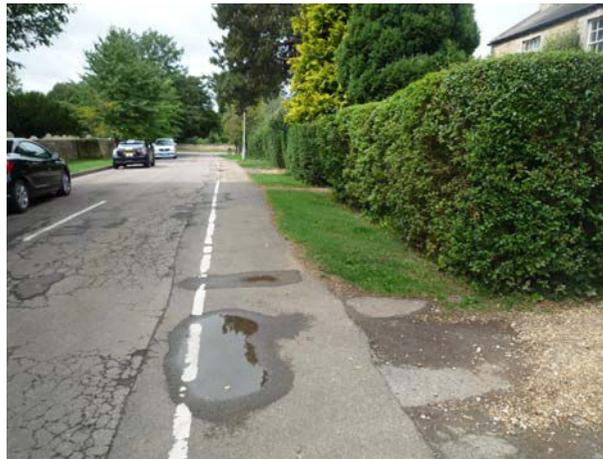
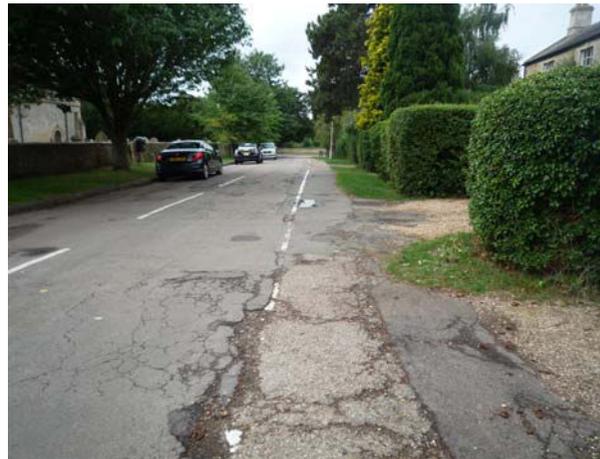
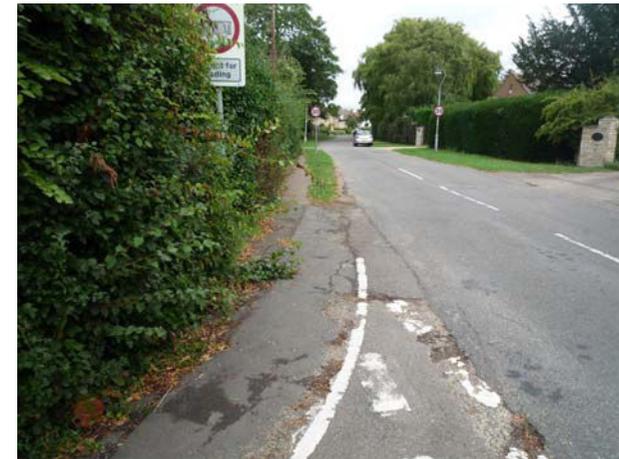
Ref	Observation	Recommendation	Priority
12.1	Generally there is a continuous unobstructed access route along the footway where provided. Along The Green to the rear of the church there is a painted white line on the carriageway marking the boundary between the highway and footway. On North Fen Road for parts there is no footway at all.

White line divides footway from carriageway

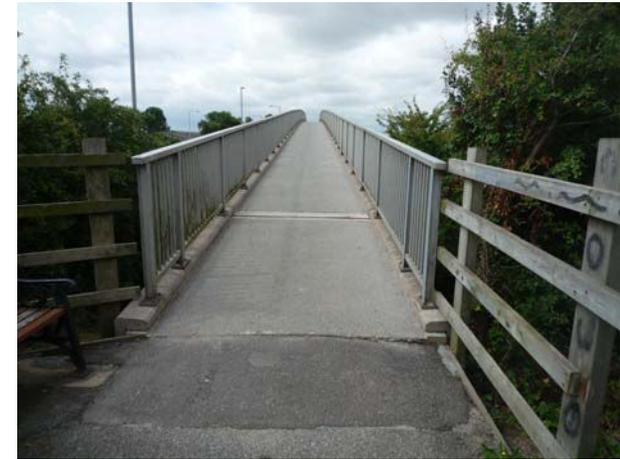
15.9	The route is level (i.e. with no gradient steeper than 1 in 20 and with no steps).		
15.10	Drainage gratings are not within the access route.		
15.11	At the end of Helpston Rd there is a pedestrian footbridge over the A15. This has a gradient and length that does not meet with current guidance, however, it is seen as not feasible to alter. Handrails have not been provided and should be to both sides.	Provide handrails to both sides at 600mm and 900-1000mm above the line of pitch.	2

Pedestrian footbridge with no handrails

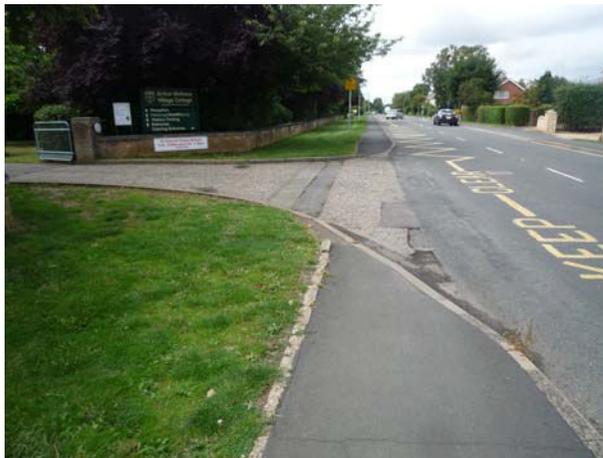
School entrance with no tactile warning
