ETHICAL
ARBORICULTURE

Review of information provided regarding the removal of a Mature Oak at 9 Barnards Way

Application reference 20/00652/TRE

Johnathan Harpham

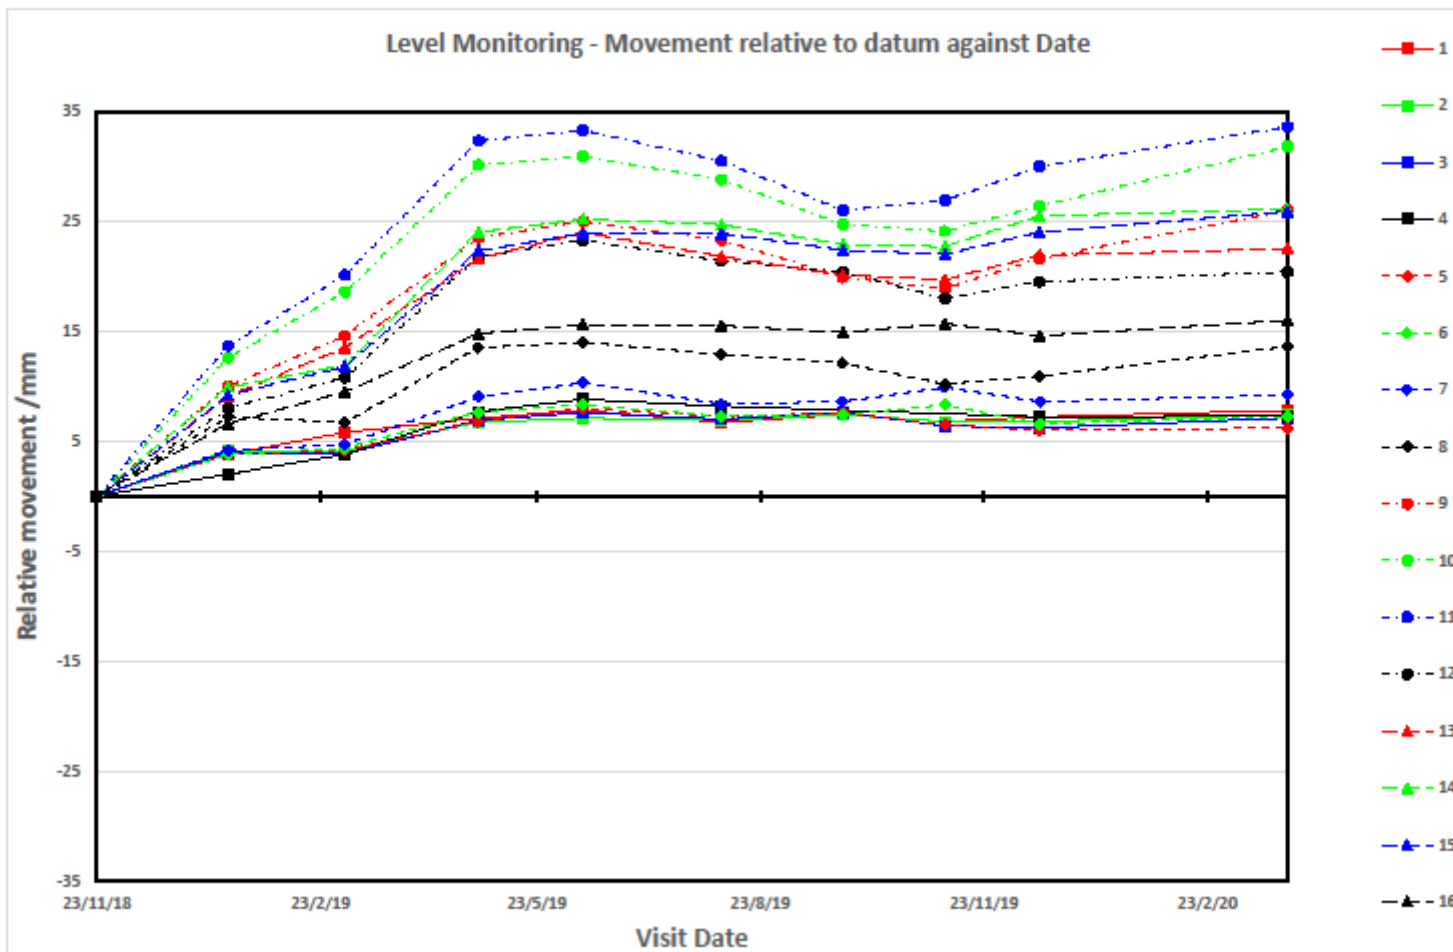
The level monitoring clearly indicates a **positive** figure across all 16 points, although these figures are greater to the points contained to the rear of the property. A positive figure usually indicates heave rather than subsidence. As clay soil rehydrates it expands, the volume of which is defined by the plasticity index. By plotting the dates with the highest increase in height against the rainfall obtained from the Cambridge NIAB weather station via the met office website, it would appear that these changes are in line with rehydration from rainfall in both the month prior and during the month of the level monitoring visit.

While there are differences in height increases from the front of the property to the rear, the rear being where there are the largest changes in height, these are greater on the conservatory than the actual house. This would be in line with the difference in loadings between foundations, the house foundation bearing more weight and being more substantial, rather than a difference in volume change potential, as indicated in the GSTL Liquid limit, Plastic Limit and Plasticity index report dated 05/03/2019 whereby TH1 test results indicates plasticity index of 23% at 0.85m depth and 21% at 1.35 while TH2 indicates at plasticity index of 40% at 1.3, 38% at 1.8, nothing recorded for 2.3 with 27% at 2.8

Level Monitoring illustrating a POSITIVE movement rather than negative

With the points raised above I struggle to see the justification behind the removal of the protected tree and believe that before any decision is made further investigation into whether this is a case of subsidence or heave, as removal of the tree would result in further issues if heave were found to be the cause, should be carried out by an independent structural engineer.
