Comments on
'Review of information provided regarding the removal of a
Mature Oak at 9 Barnards Way'
by Johnathan Harpham of Ethical Arboriculture dated 3 November 2021
for
Peterborough City Council

Summary

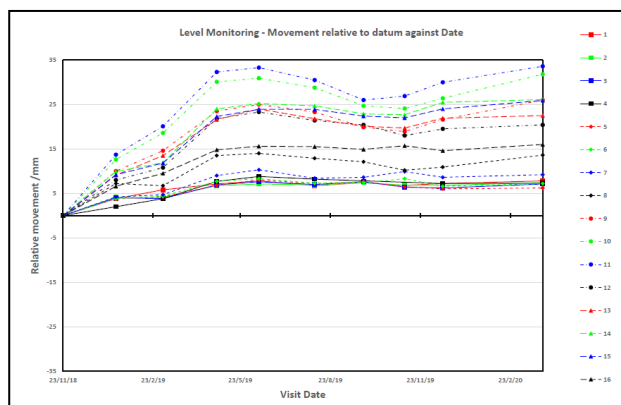
- It is correct that the level monitoring clearly indicates positive figures (ie above zero).

- However, whether the figures are positive or negative depends upon when, and at what stage of the ground moisture cycle, the monitoring started and is not in itself relevant to interpreting the monitoring. For example if the monitoring had started in May 2019 then the first readings thereafter would have been negative.

- Positive readings do not indicate heave (or recovery). What matters is the **pattern** of movement. Heave (or recovery) would be indicated by rising figures (whether positive or negative); subsidence is indicated by falling figures (whether positive or negative). The pattern of movement on the graph exactly mirrors the actual physical movement of the building.

- The allegation here is that the tree (on its own or in combination with others) has caused drying shrinkage of the clay subsoil. Because of prevailing weather (Mr Harpham has referred to rainfall records) the clay tends to dry, and shrink, in the summer and then rehydrate and swell again in the winter. We would expect that to be reflected in the pattern of movement of the house (reflected in turn in the monitoring). Thus we would expect the house to subside in the summer and to rise again in the winter. That is exactly the pattern of movement displayed in this monitoring.

- This pattern of subsidence in the summer and recovery in the winter is unique to drying shrinkage related subsidence (most commonly the result of moisture extraction by the roots of trees). The fact that it occurs here is proof that the cause of the subsidence is drying shrinkage of the clay soil. Since the drying shrinkage is virtually certainly the result of moisture extraction by the roots of trees it follows that the subsidence is connected with trees which, in this case, is the Council's oak tree, on its own or in combination with other trees.
- Mr Harpham has noted that the amount of movement is greater at the rear (nearer the trees) than at the front. The movement of the conservatory is greater than of the house; that is not surprising since the conservatory is nearer to the oak tree.
