ARBORICULTURAL ASSESSMENT REPORT

For:	Client:	[REDACTED]
	Insurer:	[REDACTED]
Site:	Policyholder:	[REDACTED]
	Risk Address:	9 Barnard Way, Bretton, Peterborough, PE3 9YZ
Refs:	PRI Ref:	134172
	Client Ref:	[REDACTED]
	Insurer Ref:	[REDACTED]

Arborist Name:	Richard Cope	Date:	03/07/2019
QC:	Thomas Peppiatt	Date:	04/07/2019
Reviewed:	Margaret MacQueen	Date:	15/05/2020

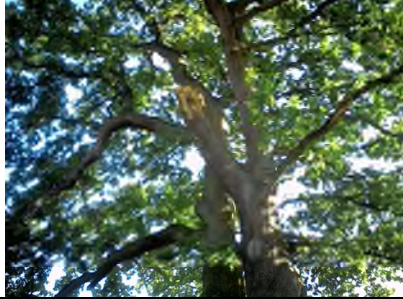
<p>T1 - Oak</p>	<p>T2 - Oak</p>

Tree No:	Species	Works Required
T1	Oak	Fell and treat stump
T2	Oak	Fell and treat stump

Peterborough City Council have confirmed that T1 is subject to a Tree Preservation Order but T2 is not. There are no Conservation Area controls.

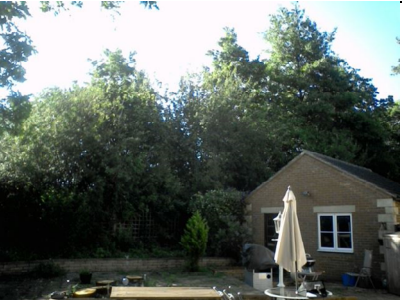
<p>SG2 - Mixed species group</p>	<p>SG3 - Mixed species group</p>

SG2	Mixed species group	Mature	Fair	2	1.0*	30	6.9	N	Subject to recent management	No work required		Species include Dogwood, Ivy, Euonymous, Rose,	9 Barnard Way, Bretton,	PH
