Optera Structural Solutions

SOW 6251 Quotation to install root barrier along the rear of the property for Tree Law on behalf of others unnamed.

POLICY HOLDER:	TBC
POLICY HOLDER ADDRESS:	9 Barnard Way, Peterborough, Cambridgeshire, PE3 9YZ
CLIENT REFERENCE:	6871066
OUR REFERENCE:	6251
ANTICIPATED START DATE:	TBC

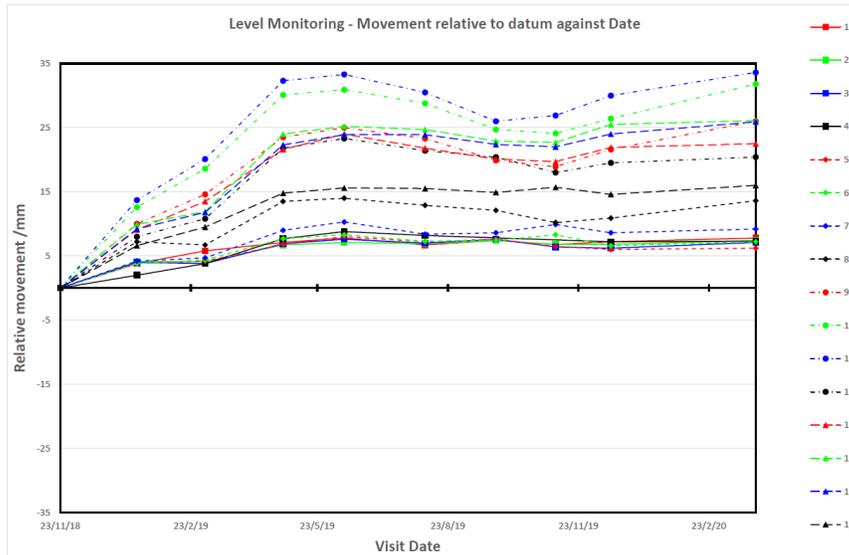
The level monitoring has been undertaken by CET over an extended period and indicates a cyclical pattern of movement. In fact the recovery of the ground following the dry summer of 2018 is most notable during the winter of 2018/19 with upward movements in excess of 30mm recorded in the conservatory and around the rear of the property which is entirely consistent with clay shrinkage subsidence.

Since the first winters recovery, we have seen a fairly sedate cyclical pattern of movement, consistent with the more benign weather patterns since the extremes of 2018. The more significant movement however is recorded towards the rear of the property.

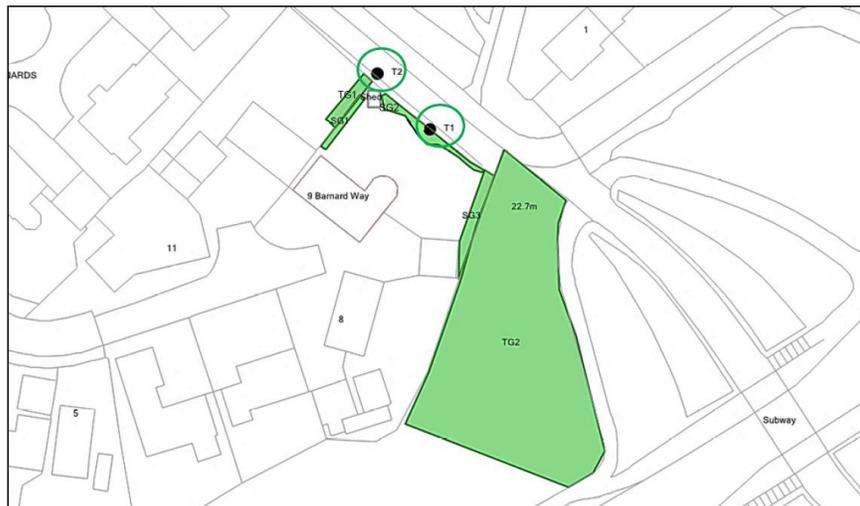
The arboricultural report produced by PRI, dated, July 2019 recommends that T1 and T2, Oak trees are felled and the stumps treated to prevent re-growth. The site plan indicates their relative positions to the property:

Given the position of T2, offset to the left of the property, a barrier would need to extend into the left hand neighbouring property to provide holistic protection and to prevent this being outgrown by the tree roots. A barrier is formed by excavating a 300mm wide trench to the prescribed depth. In this instance, we would suggest 3.5m. The spoil will be transferred to a dumper and conveyed to the driveway of the risk where it will be stockpiled on boards and periodically collected by grab lorry. The barrier is progressed in 5m sections to minimise the impact on prevailing weather on the stability of the trench. Once the first section is excavated, we will line the trench with the copper impregnated bio-barrier and backfill with 20mm single sized angular stone to within 200mm of the surface. The leading edge of the excavation is bunded with sheet piles to prevent the stone migrating into the active excavation and the process is repeated until all of the barrier is installed. Once complete, the trench will be topped up with lightly compacted topsoil and the turf reinstated. The site will be cleaned down and the area left tidy.

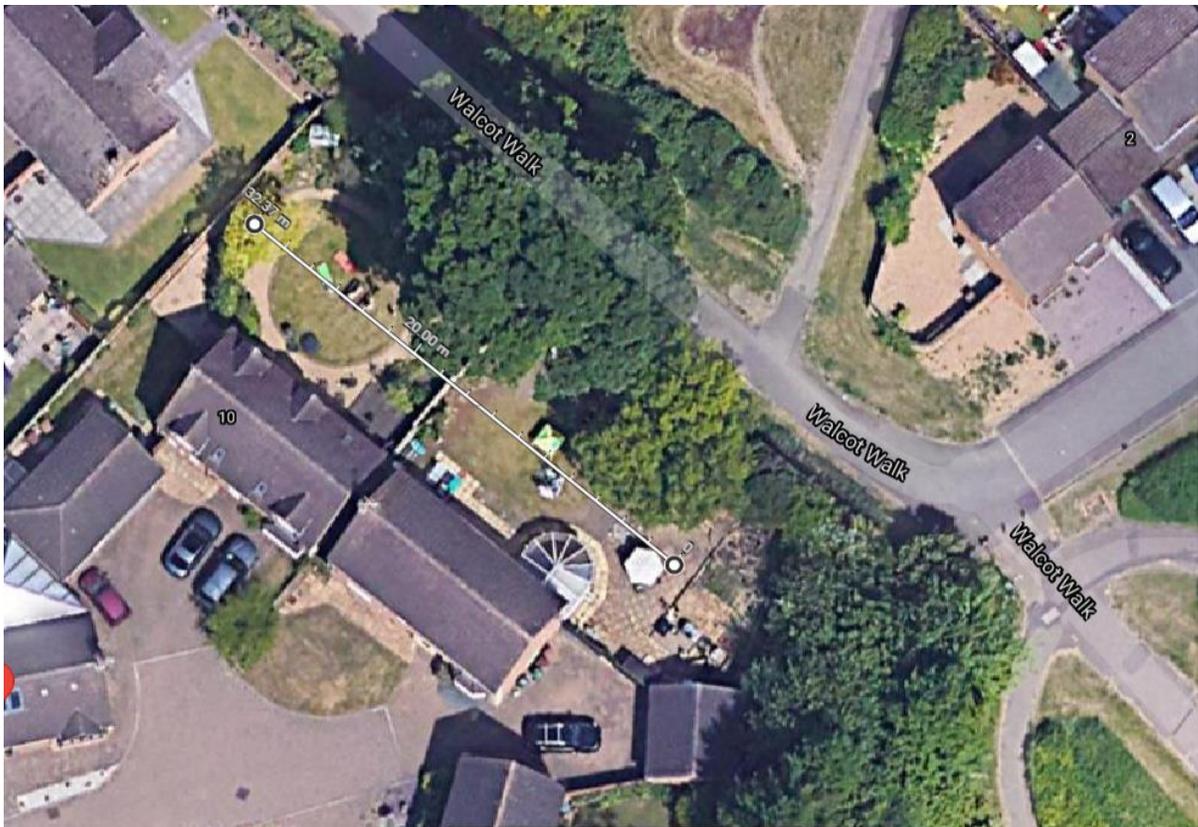
In this instance, our estimate is based upon a desktop assessment of information collated and supplied by Tree Law. It is unclear how much enabling and hard landscaping is required, but it appears minimal within the risk address with paved areas visible within the neighbouring property. It is impossible to ascertain the works involved from the aerial images available and we have assumed a turf based excavation for the purpose of the quote. The aerial image below indicates the size and position of the proposed barrier:

- Commence machine excavation of the trench, digging a 300mm wide trench to 3.5m in depth and all arisings are to be transferred to a dumper and conveyed to the spoil storage area. This will be periodically cleared by grab lorry.

- Once the first 5m has been excavated, line the trench with the copper impregnated bio-barrier and backfill with 20mm single sized, angular stone. The leading edge of the excavation is to be bunded with sheet piles to prevent stone migrating into the active excavation.

- Repeat the process until all 33m of the barrier is excavated and installed.
- Once all of the barrier has been installed, the trench will be topped up with compacted topsoil and new turf placed over the trench. .
