Appendix 2- 21 Cherryfields

Re. 20/00846/HHFUL Installation of external wall insulation, mosaic tile at first floor level to the front and rear, and installation of 3no. AC units, and associated alterations (Retrospective) | 21 Cherryfields Orton Waterville Peterborough PE2 5XD.

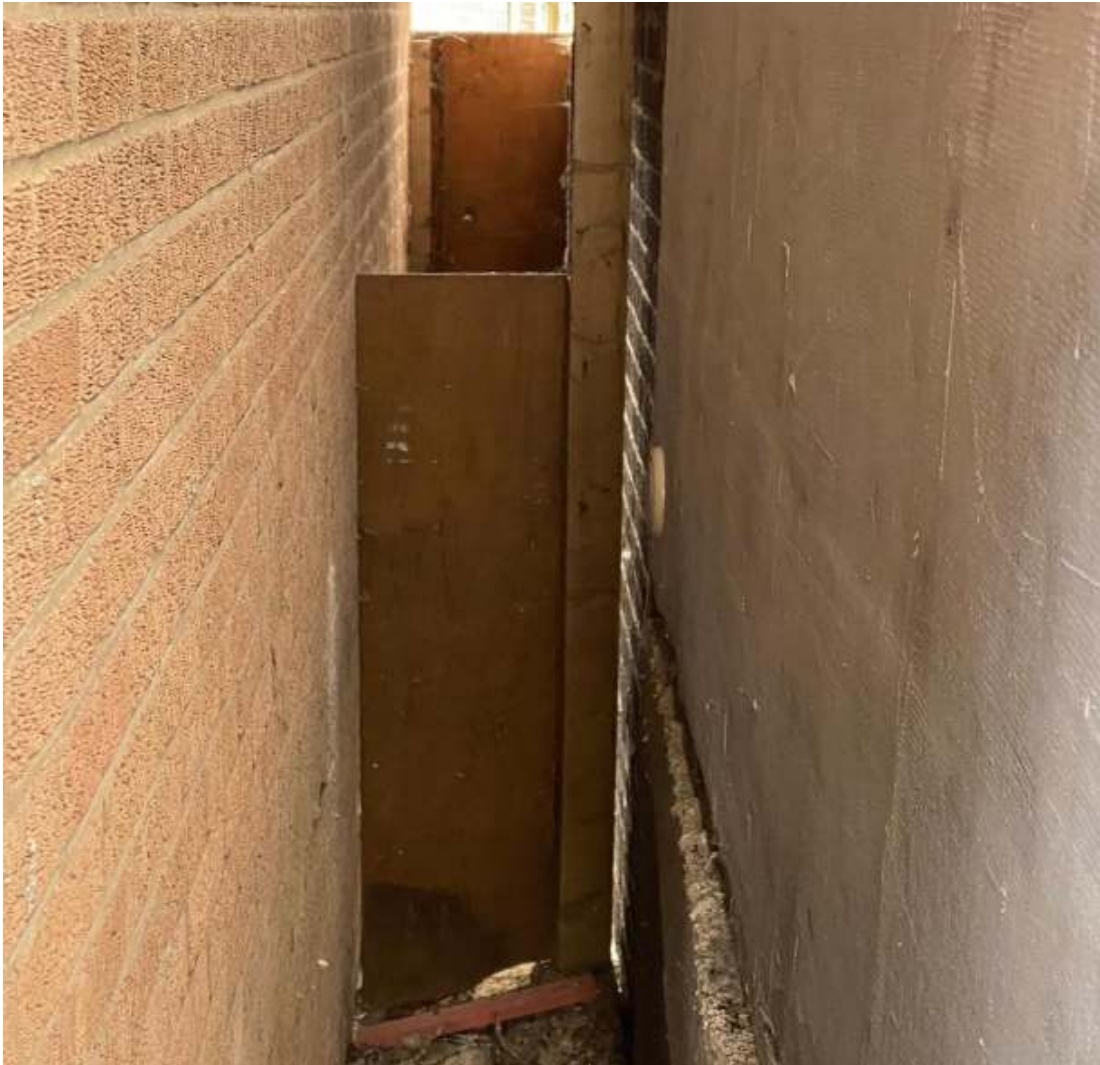
Pic. 1 shows the rear garage (no. 22) that runs along the boundary gap with no. 21. If you look closely you will see a circular outlet/vent in the wall of no. 21 kitchen area. We don't know whether this is connected to a air conditioning unit or a tumble dryer, etc., but moist air has been extracted in to the void between the two properties. There is an annoying noise associated with this extraction. There isn't a great deal of natural ventilation in the gap because of the overhang of the garage roof and guttering. This could result in damp exterior walls. **The vertical wooden beam is propping up / supporting the overhang to the roof of 21 Cherryfields.**

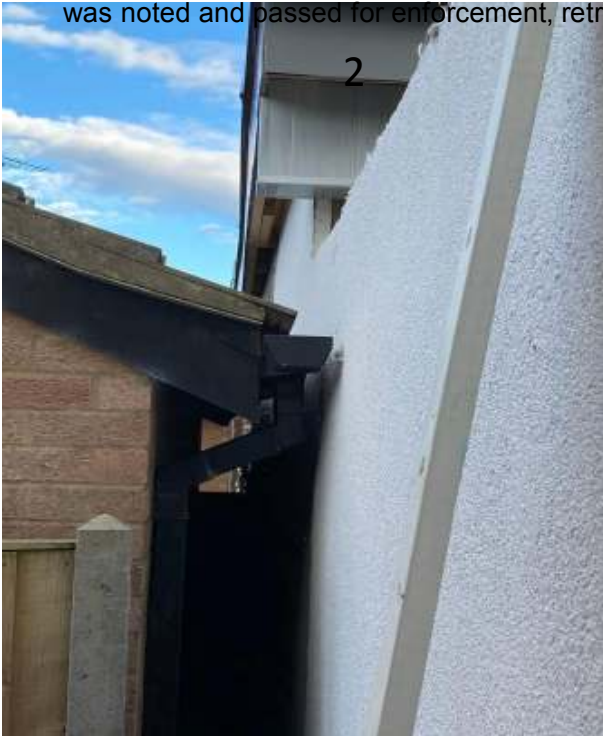
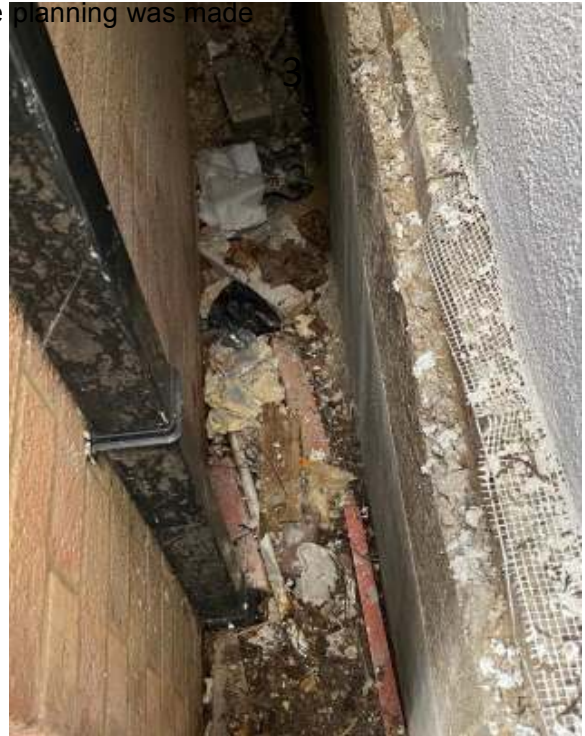
Pic. 2 & 3 shows the roof and guttering overhang and the left over building rubble. Since the ground floor exterior wall amendments of no. 21 (not as to planning permission) there is less room for maintenance for no. 22 brick built garage/storage building. **The approved plans show a dog leg in the building**, the building has been pushed to the limits of the plot and footings, when this was noted and passed for enforcement, retrospective planning was made

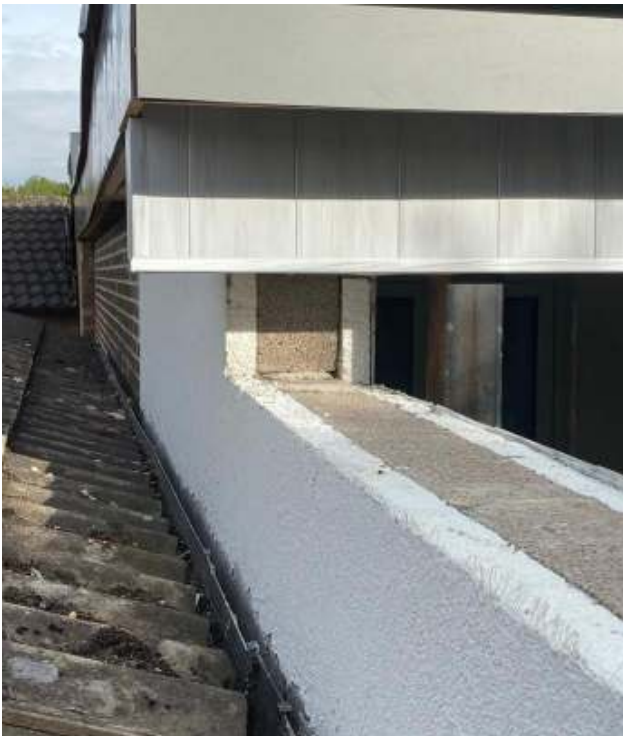
Pic. 4

shows how close the new wall is and that it is not built as per approved planning permission it is now included in retrospective application only **AFTER** enforcement officer contacted

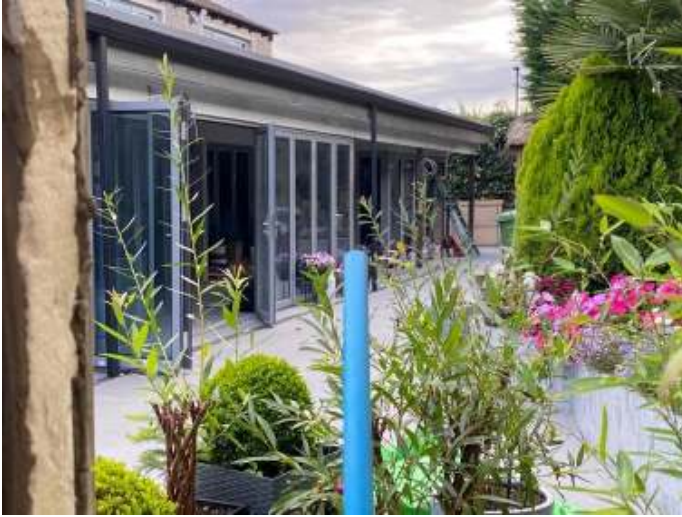
5

Pic 5, 6 & 7 show the extent of the newly built rear structure.

This structure was to be part open but fully covered on the **approved** application, but it was fully glazed increasing the total internal footprint it now appears in this format on retrospective planning application only **AFTER** Enforcement officer contacted.

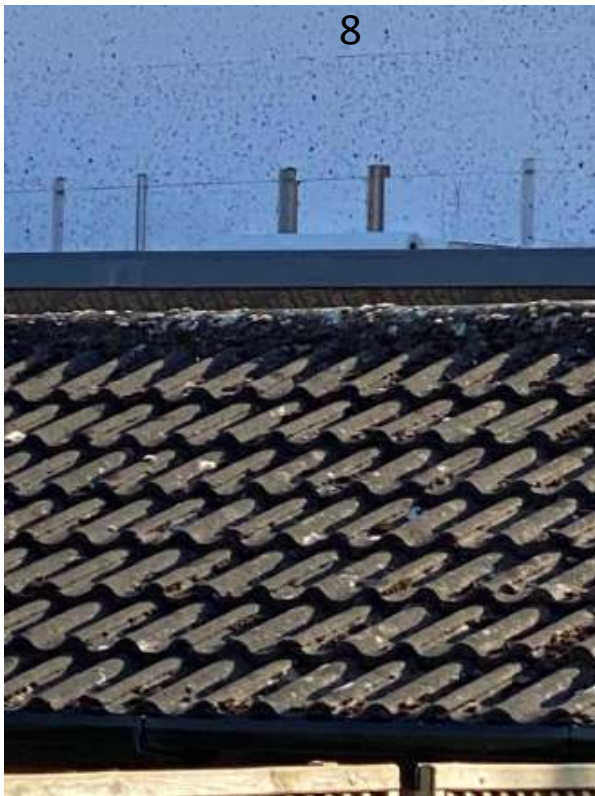
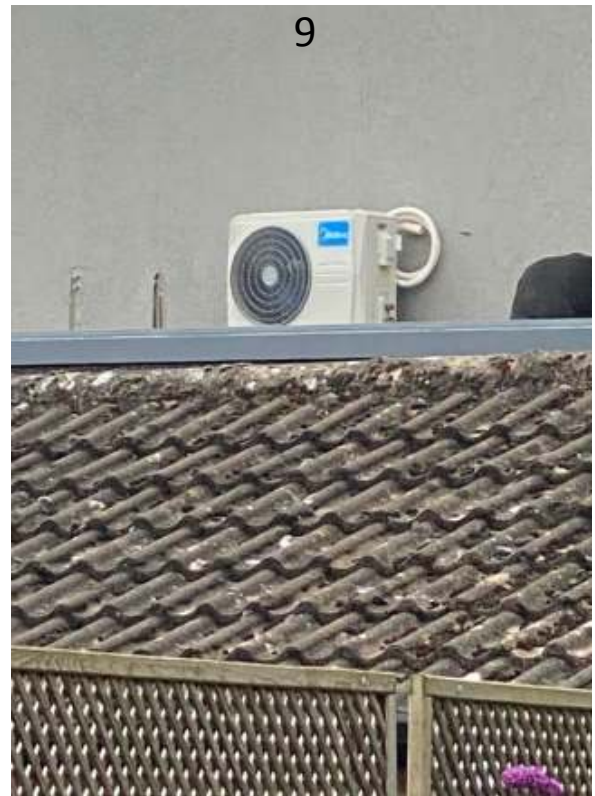
Pic. 8 & 9 shows the installation of three sets of brackets ready for 3 air conditioning units and the air conditioning unit that is now installed, connected and working, no application was made until **AFTER** reported to enforcement officer, now on retrospective application along with other units never declared when installed “years ago”.

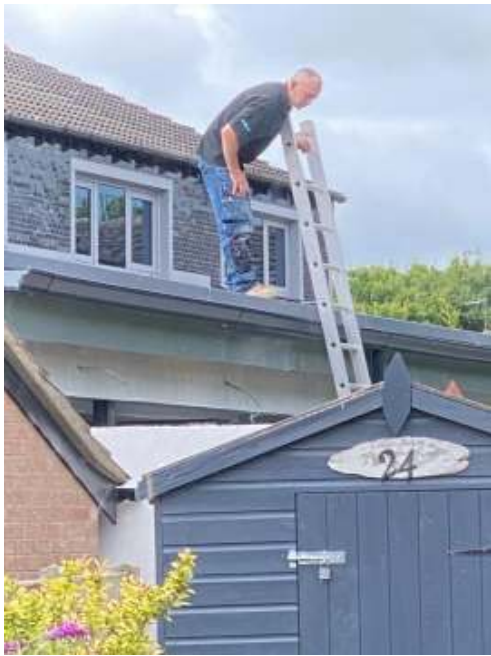
Pic. 10 viewed from the garden of 24 Cherryfields. The shiny tiles not declared and not approved, only now seeking retrospective planning **After** enforcement officer involved. The bulky flat roof/canopy are in full view from the garden, kitchen and dining room.

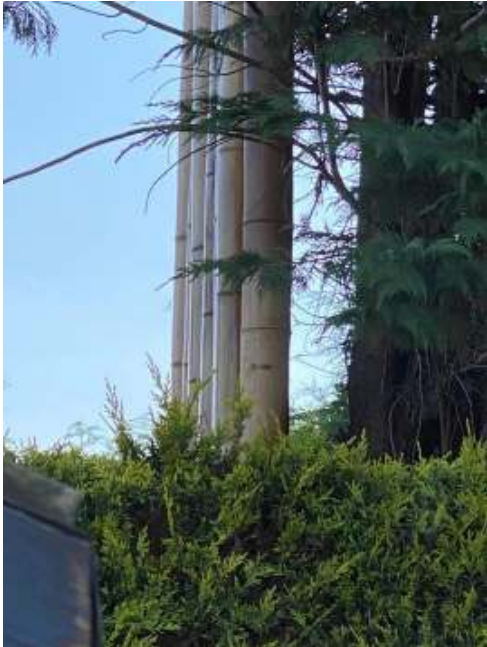
Pic. 11 A very tall bamboo structure, in excess of 3M has been installed.

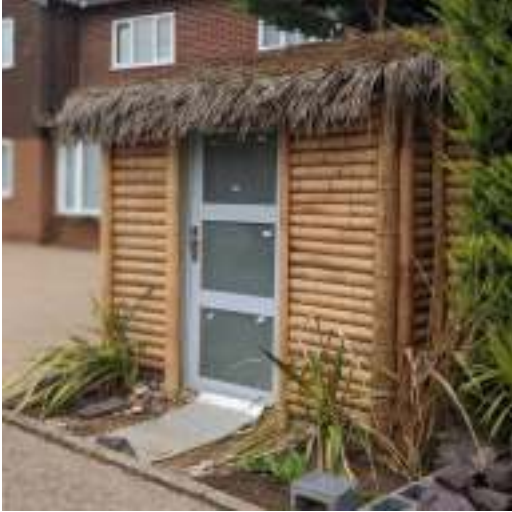
12

Picture 12, this structure was not on the original application plans, then it appeared on an amendment, **after** enforcement officer was contacted, but on the current retrospective application it is missing again, but as you can see it is directly on the road and in no way conforms to any building materials on the existing building or in the local area, would probably be more at home on a beach? As amusing as it appears this is just blatant disregard for the residents of Cherryfields and the Peterborough planning department.

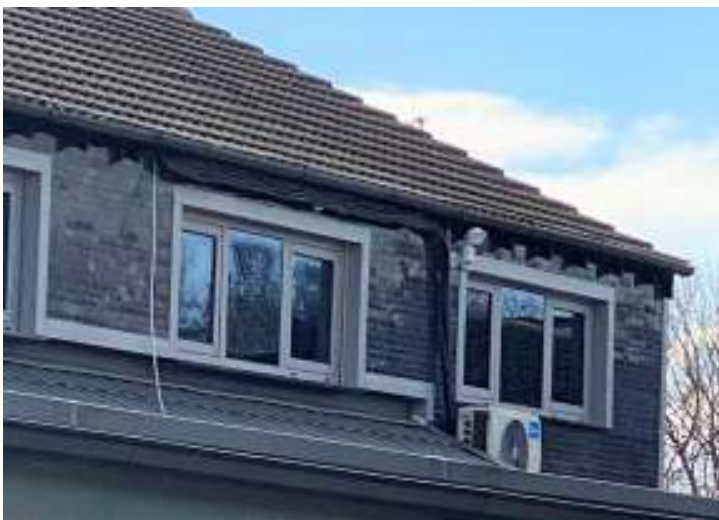
Picture 13 Reflective tiles to rear (also to front), not on original application, only appeared on retrospective Application **after** enforcement officer contacted, owner states original finish was Black brick, but **Pic 13 Before** shows it was not the case, now to be replaced to the front elevation with render, due to policy?? But also need to be rendered at rear elevation for the same reason, one policy for the front and not the rear?

Also air-conditioning pipes / cables running unsupported down the side of the building, unsightly and to building regulation?

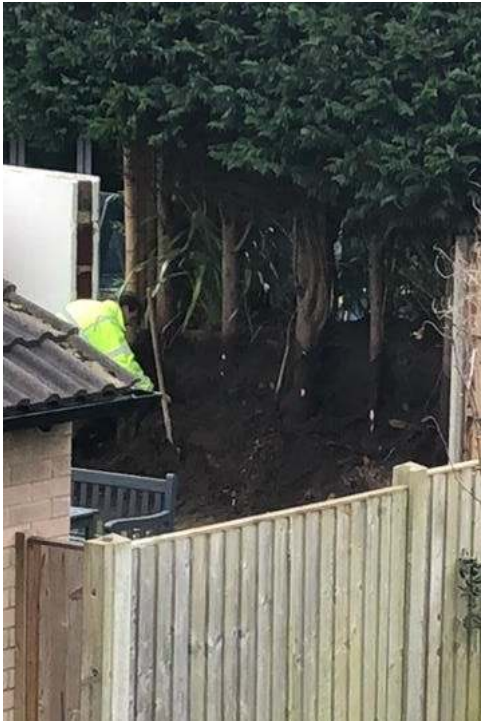
Picture 14 shows over 1.2M of topsoil that was just piled against the fence of 24 Cherryfields with no thought to the boundary or adjoining property, this just indicates how little regard the owner has for their neighbours.

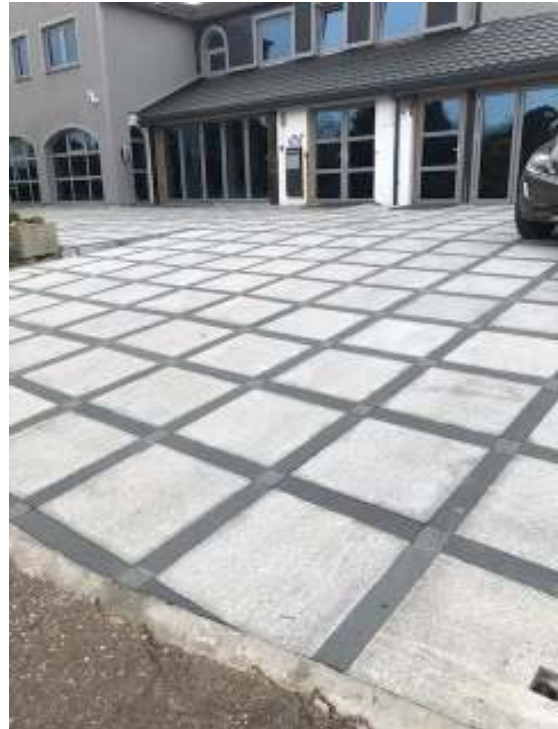
Pic 15 Shows the drive, fully tiled in non permeable material, no drainage visible for any surface water, Again no regard for impact to neighbours, environment or planning department
