## Peterborough Cathedral Conservation Plan - Volume 2: the Gazetteer

## List of contents

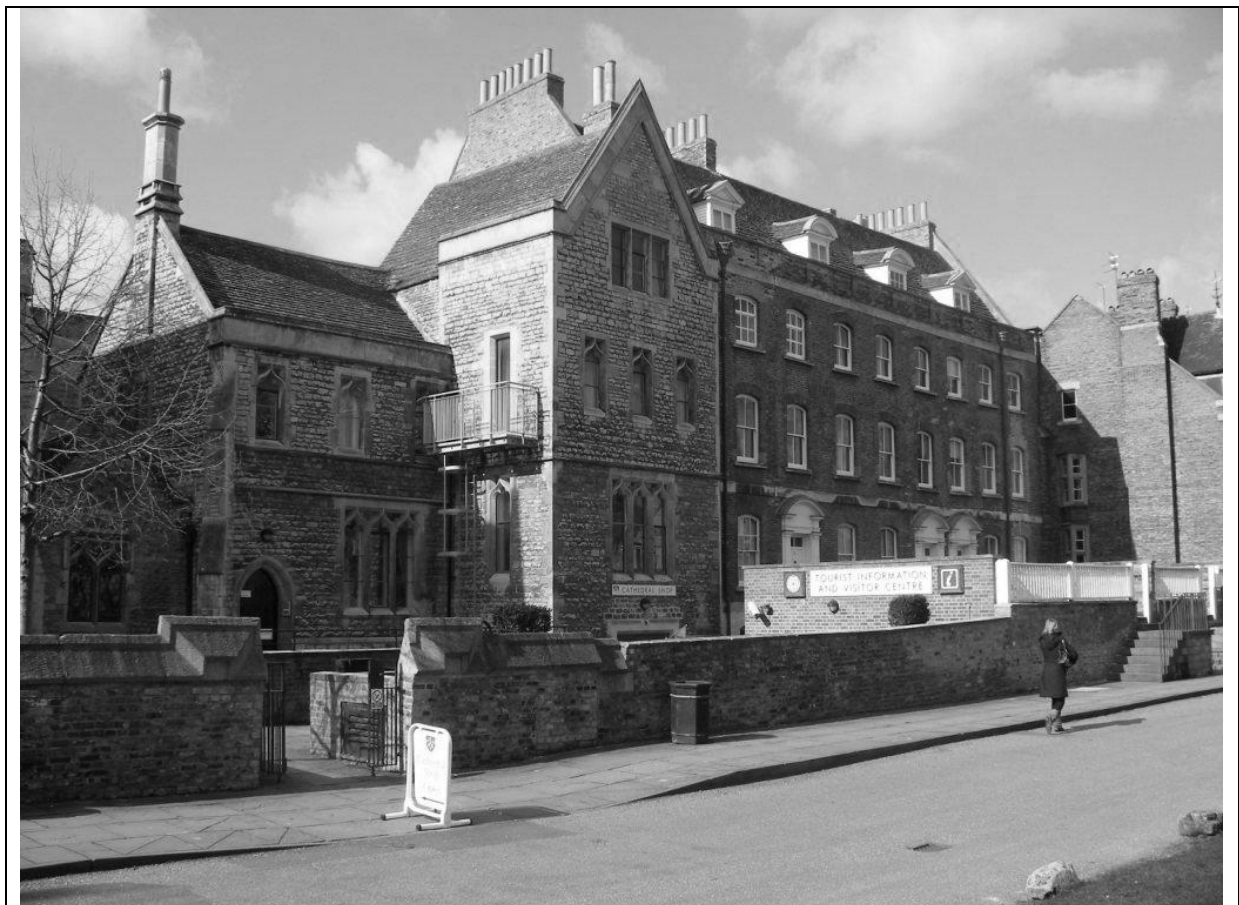
3-5 Minster Precincts, right of centre, with the three and two-storey sections of 2 Minster Precincts to the left.

The buildings are generally in good condition, and their use as private flats in multiple occupancy per house should ensure good ongoing maintenance and

decoration by Chapter and the tenants. Maintenance and repair of the roof could become an issue in the future, as the closure of the Collyweston slate quarry some years ago has left this material in very short supply. It may be possible to effect small-scale repairs through the use of salvaged material from elsewhere, but any larger programmes of work might need a more creative approach. This could mean moving good slates from the barely visible rear slopes to the front. This would require careful consideration, and Peterborough City Council's Conservation Officer would need to be consulted.

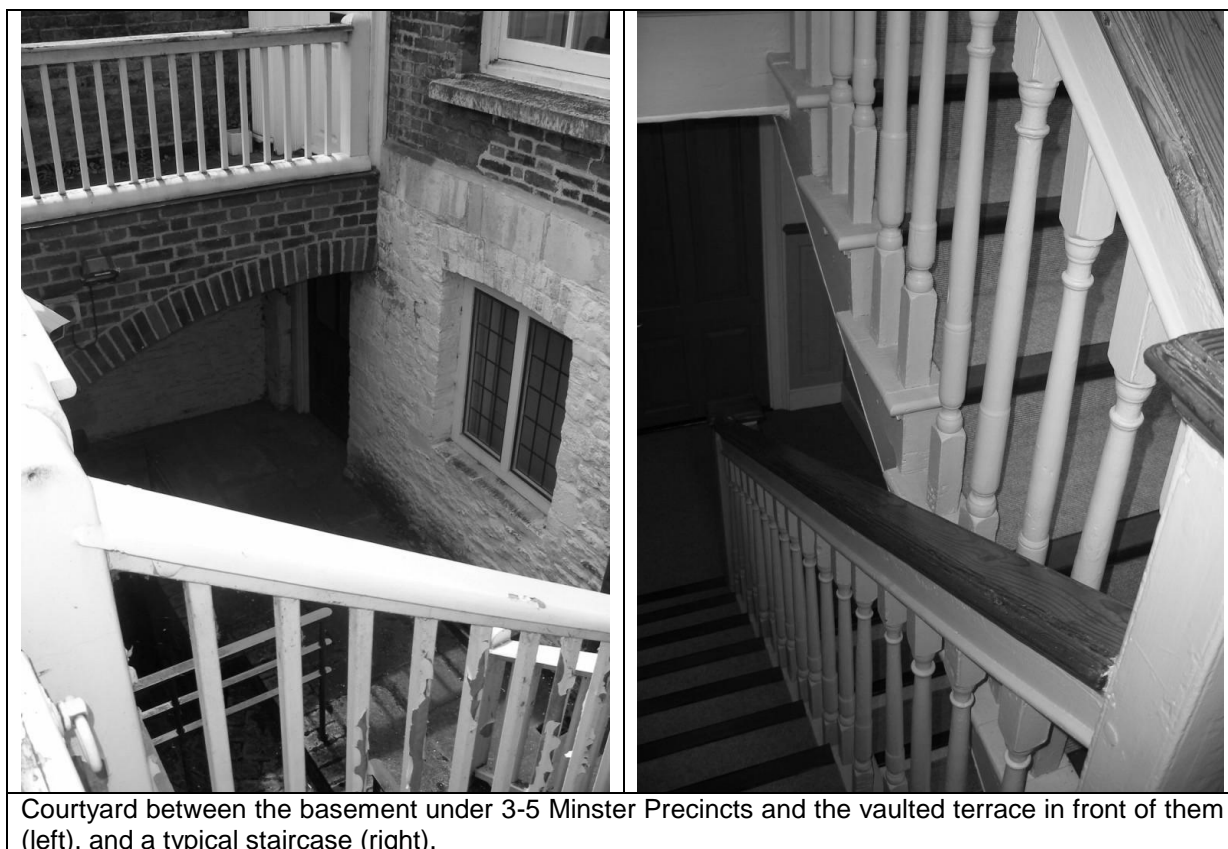
The east-facing elevation is of yellow brick with red brick window frames (the basement wall is of stone). The brickwork is now somewhat dirty. There are three windows per house to the first and second floors and two on the ground floor to

accommodate the front doors. No 3 retains 12-pane sashes on the ground floor and nine-pane ones on the second floor, but otherwise the rest are of four panes, presumably replacements (perhaps of 19th-century date). There are ashlar string courses above the ground and second floor windows. In the former case the string runs across the tops of the three door cases. These have semi-circular broken pediments on reeded pilasters, framing six-panel doors. The upper panels are wholly or partly glazed. The attic contains four dormers looking out towards the Cathedral. They are located above the 'even' bays of the frontage windows (ie 2, 4, 6 and 8) so that the outer ones (with triangular pediments) sit over the middle windows of 3 and 5 Minster Precincts, while the inner pair (with semi-circular pediments) are above the outer windows of No. 4. The Collyweston slate roof has end and central chimneys. The one at the south end is offset on the east side of the ridge while that at the north end lies on the west side. The two central chimneys are on the party walls between 3-4 and 4-5, both also on the west side of the ridge. These retain their stacks and clay pots except for the truncated one between Nos. 4 and 5.

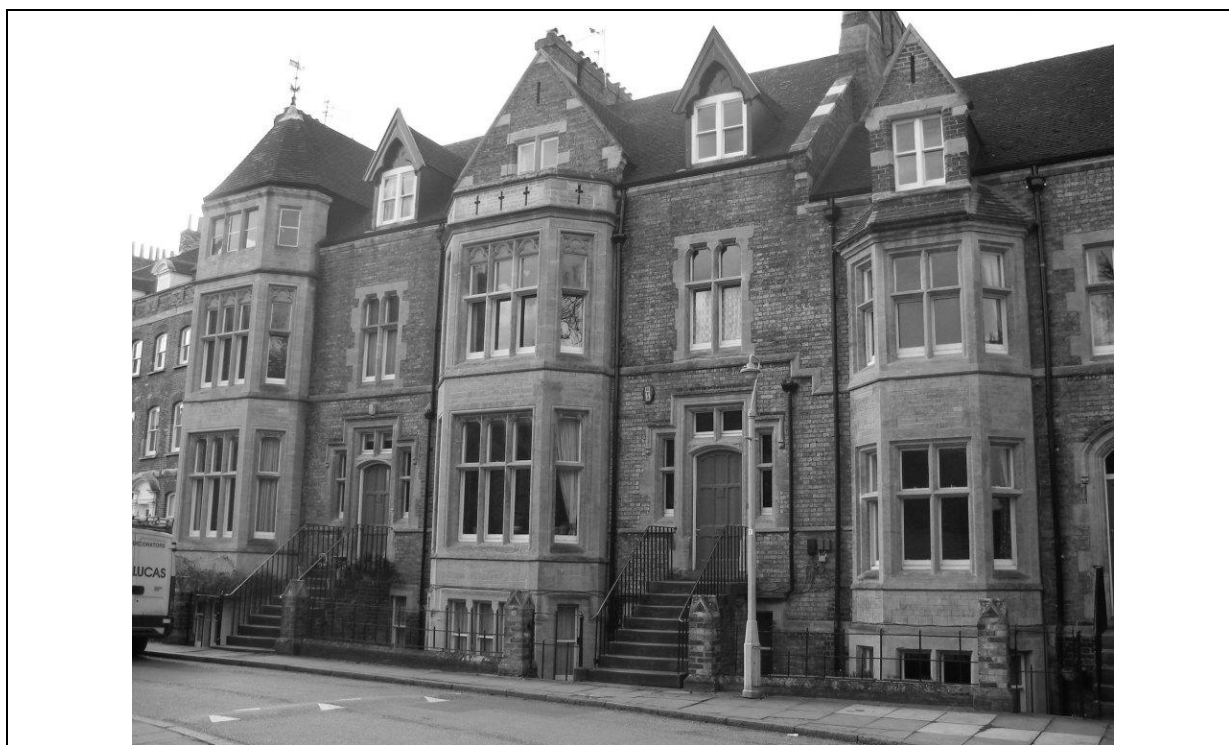
6-7 Minster Precincts, with the first bay of 8-9 Minster Precincts to the right.

The Church Commissioners own these private dwellings. They are well maintained and appear to be in good condition. The Commissioners have embarked on a substantial programme of property disposals within the Precincts in recent years. Where possible the Chapter will seek to purchase the freehold when this happens so that the integrity of the Precincts as a whole is maintained in full. This places significant strains on Cathedral resources, however, and could cause major problems if the programme of sales continues or accelerates.

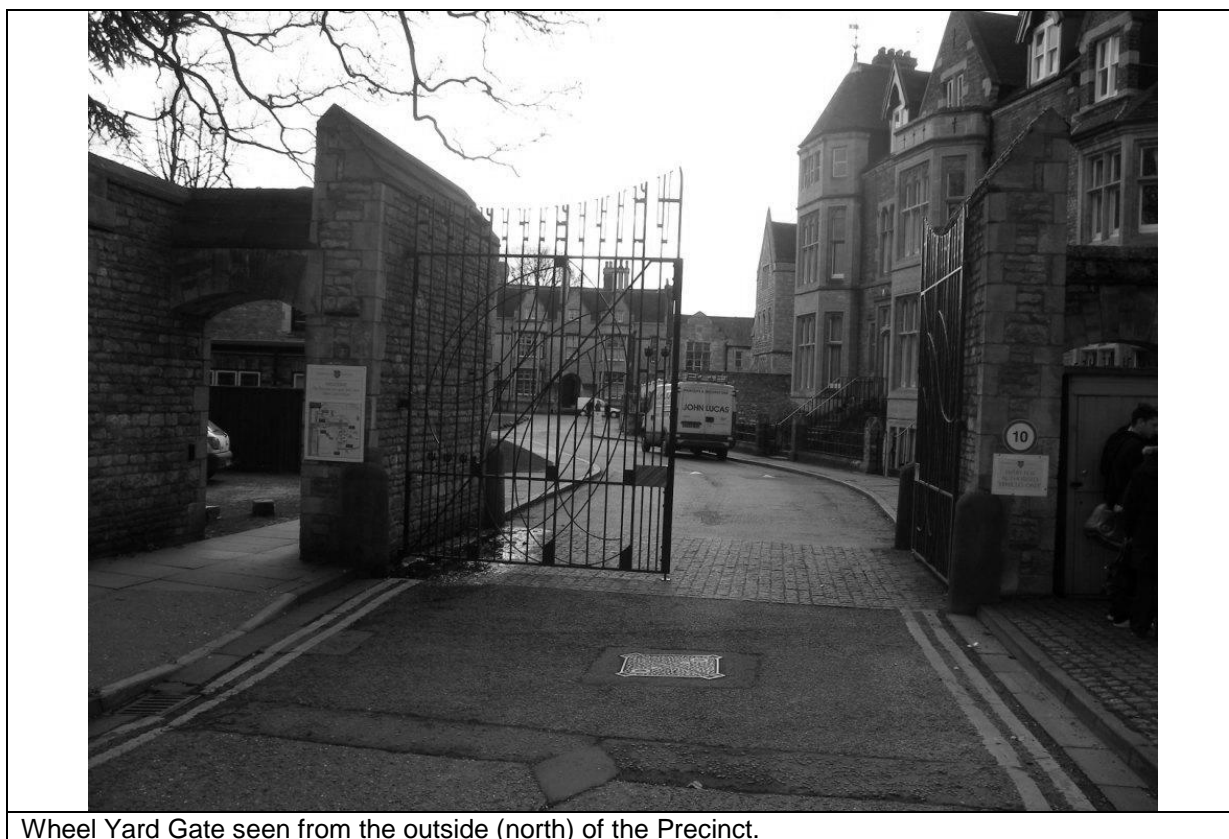
Wheel Yard Gate seen from the outside (north) of the Precinct.

The gate is in very good condition, and is well maintained. The associated roadway and pavements are also in good order. It is assumed that there is a division of responsibility between the Chapter of Peterborough Cathedral and the city council (as highway authority) to either side of the gates. The latter have reflective panels to warn approaching drivers of the collision hazard. External signage provides

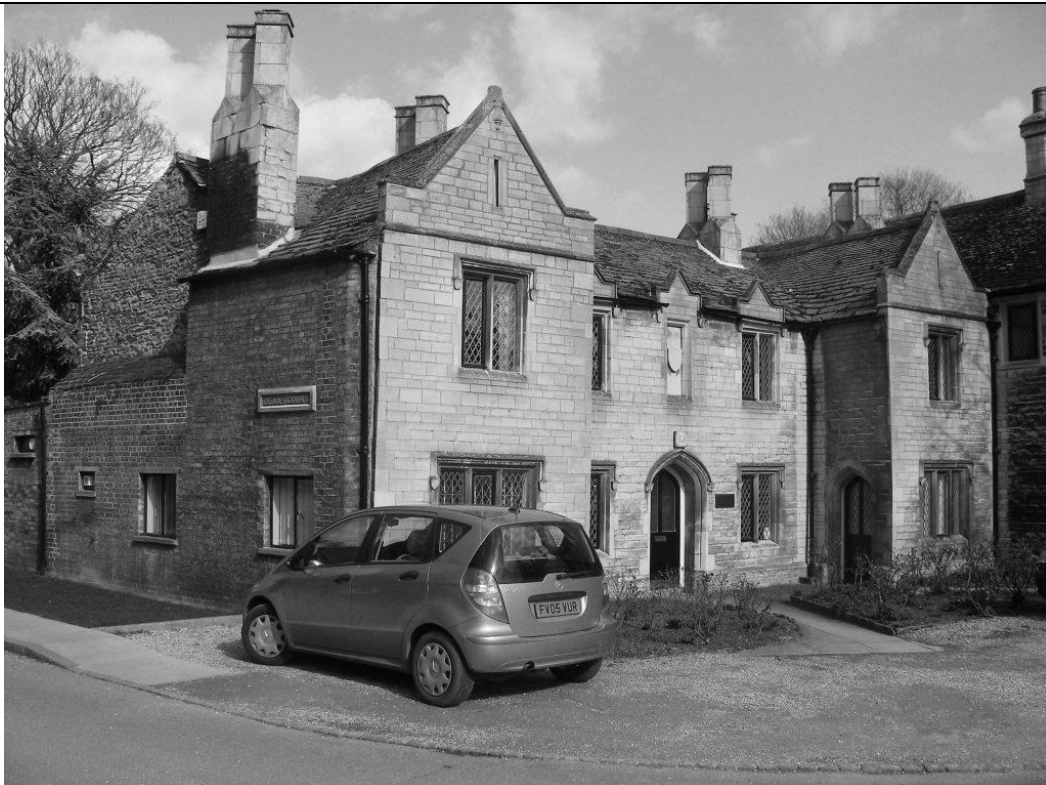
10 Minster Precincts seen from the south-west.

The building appears to be in good condition, and to be well maintained. The interior is in good decorative order but, as already noted, is generally plain and featureless. The possibility that earlier phases are represented deserves further exploration. The modern extension is mildly **negative** but provides valuable office space.

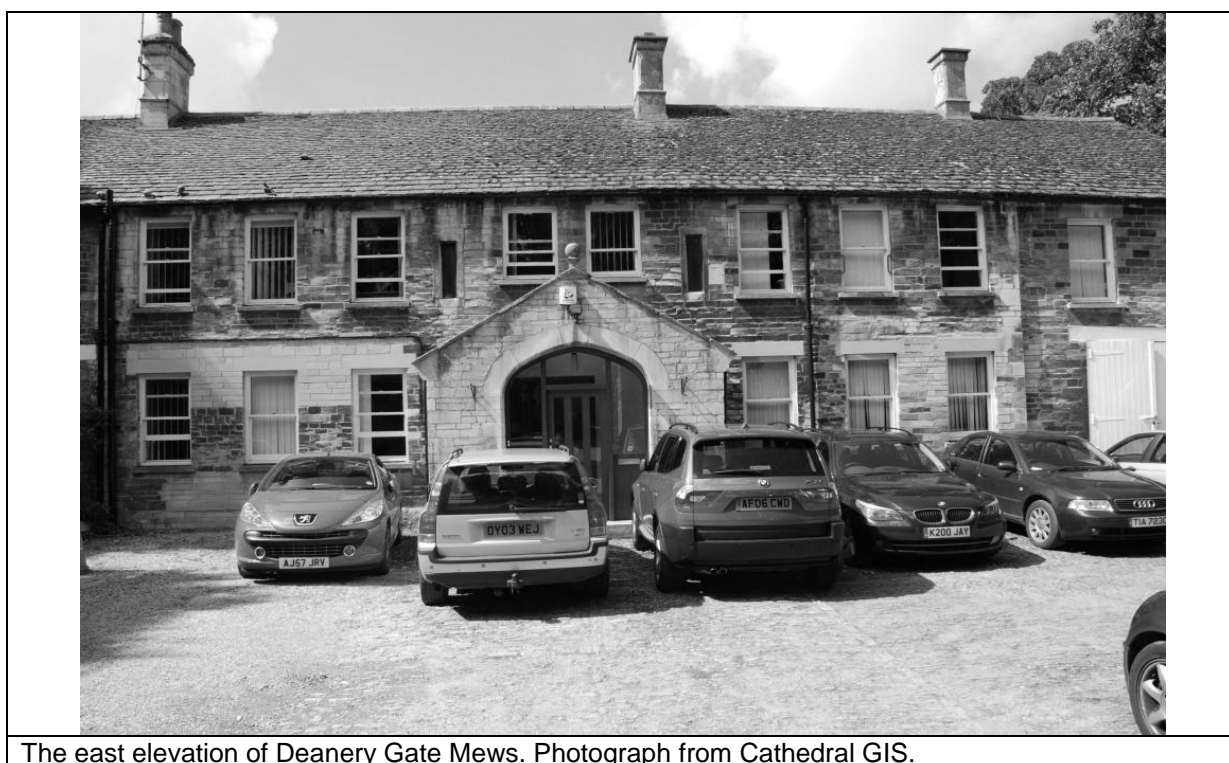
The east elevation of Deanery Gate Mews. Photograph from Cathedral GIS.

The building is generally in good condition, though a substantial crack was noted in the rear (west) elevation. This is only visible from rear windows in 10 Minster Precincts. The crack appears to be old and inactive, but it may be advisable to point it up with lime mortar and install a tell-tale monitor to check this. The interior is generally in good decorative order.

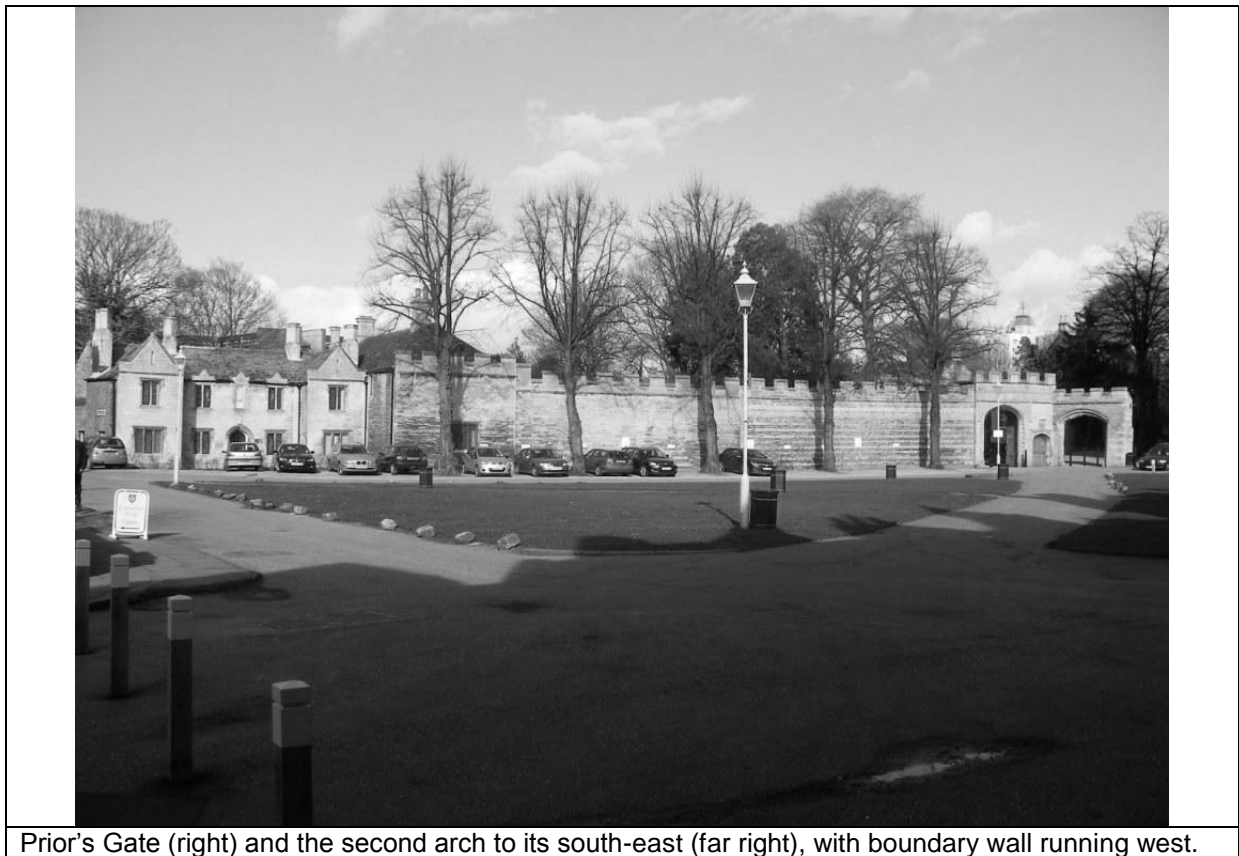
Prior's Gate (right) and the second arch to its south-east (far right), with boundary wall running west.

Prior's Gate and its boundary walls are in generally good condition, though the masonry displays a considerable amount of erosion locally. Unfortunately this has badly affected the decoration and drip moulding over the pedestrian gate. The temptation to replace the eroded masonry and restore the original design has been resisted. Lead 'eyebrows' have been inserted above the remaining masonry of both arches as protection from water penetration. Fortunately the armorial and foliate panels above the arches survive in much better condition. The building would benefit from a full measured archaeological survey to record its current state, and especially that of the decoration.

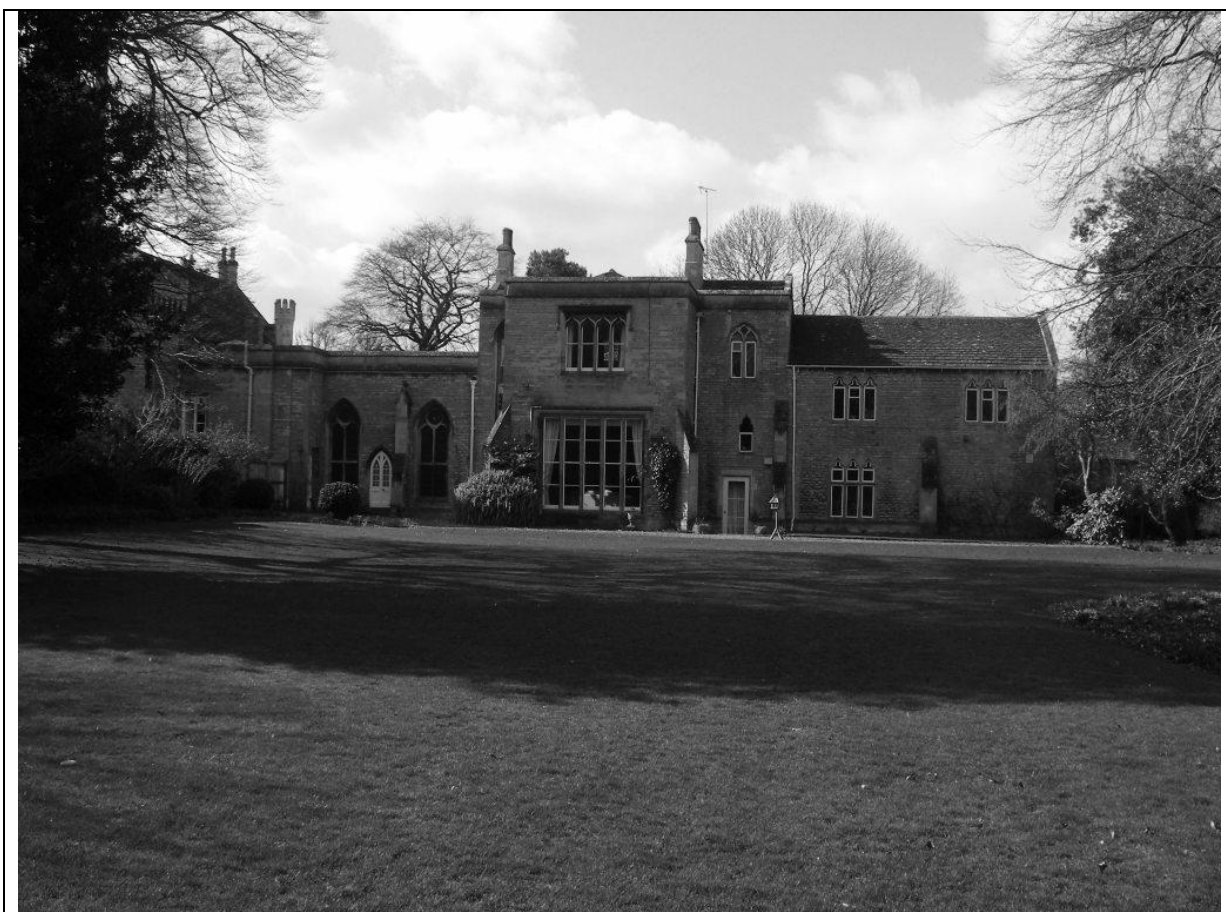
The eastern elevation of the Deanery.

The Deanery is an impressive building, as one would expect given the status of its occupants over the centuries, although both internally and externally it displays a mixture of architectural periods and styles. Broadly original (or at least restored) late 13th-century windows sit alongside Victorian Gothic cusped and trefoiled examples, while the drawing room on the ground floor features a fine mullioned and transomed picture window looking out over the eastern gardens (see below). The mixture of styles, and indeed the varying heights of the different blocks (most of which are essentially of two storeys), creates a visually pleasing if somewhat confused appearance. The eastern elevation is now dominant, although this only appears to have been established in the 19th century when the orchards and Tout Hill were taken into the gardens. Before then it is likely that the western elevation would have

The Deanery is in very good condition and decorative order throughout, with no obvious issues in this area. The use of the building is clearly the most appropriate possible for a residence of this quality, long-standing (but not continuous) official status and historic associations. The visual character of the house and gardens are extremely important to and within the Precincts, and particularly its northern half, and merit strong protection as far as the Chapter and Peterborough City Council are concerned. The gardens themselves are largely private but are opened to the public on several occasions each year, and are well maintained by the Cathedral gardeners. The boundary walls are mostly in fair to good condition, although they need to be monitored regularly (part of the internal face collapsed from the southern garden wall in early 2009 but was rebuilt later in the year).

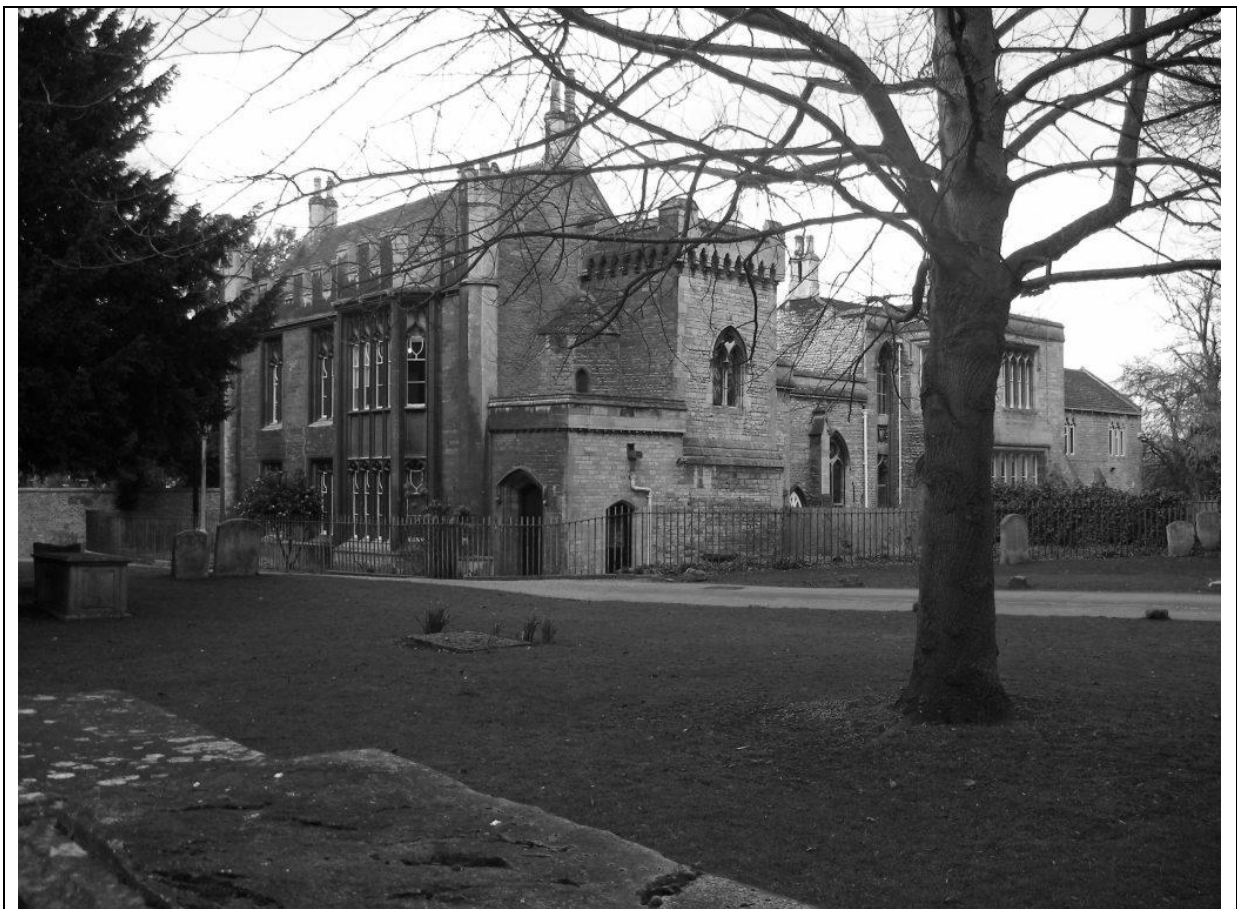
Little Prior's Gate – the south (left) and east (right) elevations, with the Deanery further to the right.

The building is generally in good condition and decorative order, although there are instances where panelling, plaster and paintwork have cracks or are flaking. These would merit some remedial work. None appeared to be particularly serious or severe, but they should be monitored. The office use is reasonable given that there is an obvious need for such accommodation for Cathedral and Chapter officers. The Deanery is still a very substantial house even without the use of these rooms, but it would be easy to convert them back to domestic use should that be required in the future.

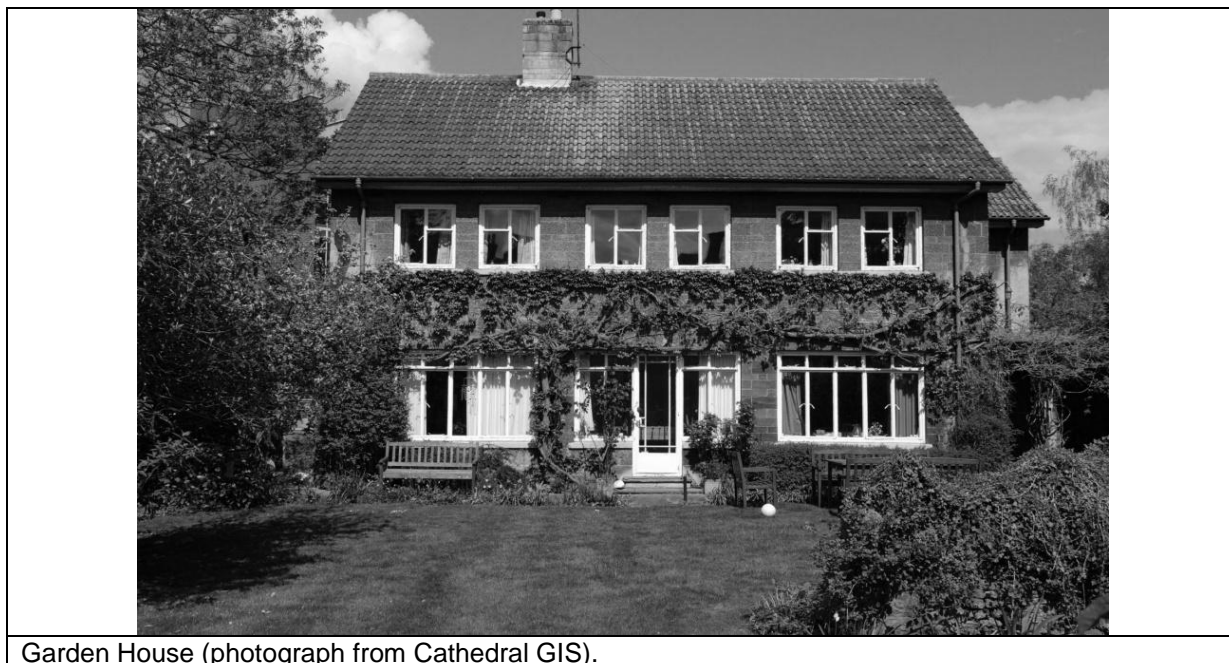
war years; the GIS entry suggests a date of c 1937. It is a substantial two-storey property with long picture windows flanking a French window on the ground floor (west elevation), and six windows on the first floor. These all appear to be the original Crittalls. The overall design is rather like that of a custodian's house on heritage sites of a similar date.

Garden House (photograph from Cathedral GIS).

The building appears to be in good condition, is well maintained and in good decorative order. It is good that the Crittall windows appear to have survived the seemingly irresistible tide of uPVC replacement, but this is of little consequence given the age of the building.

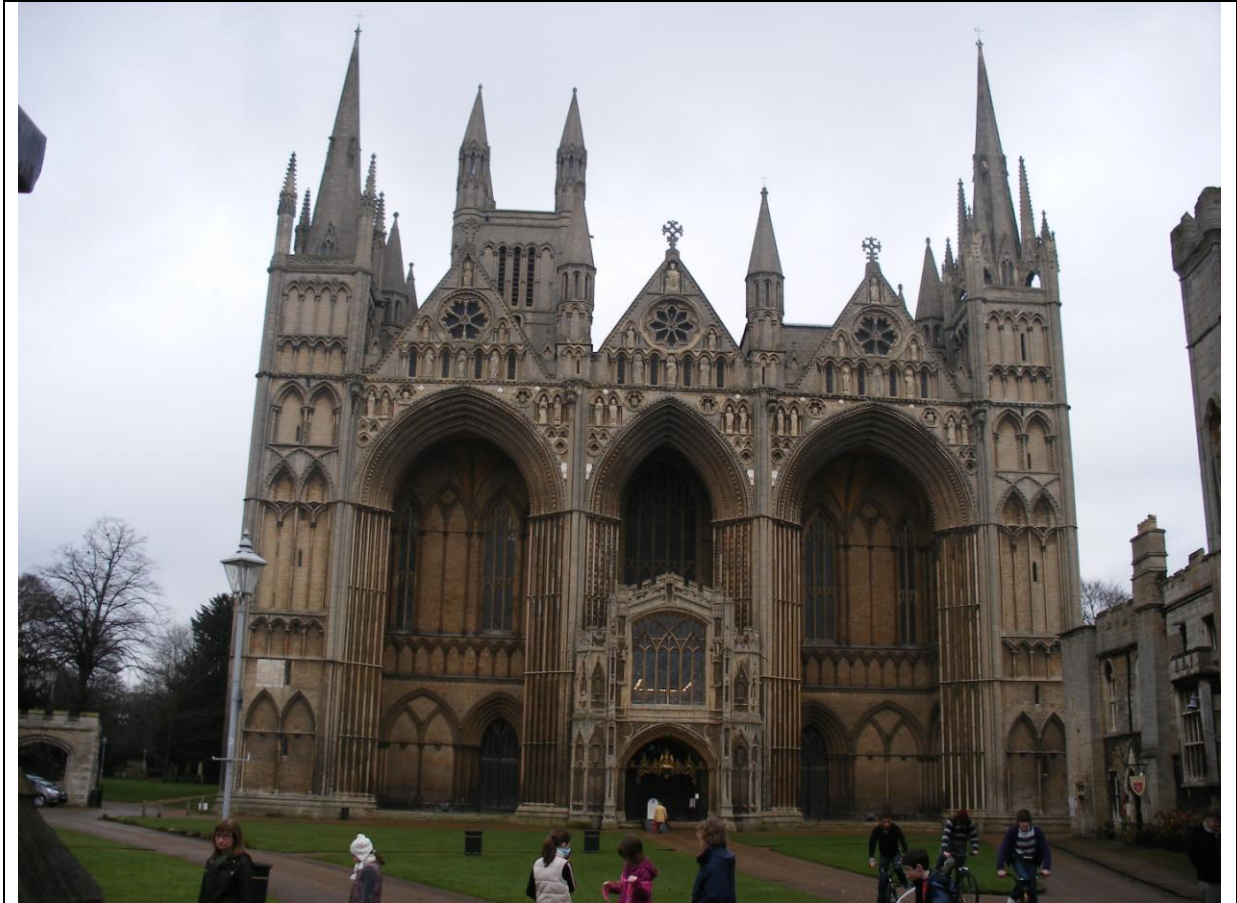
The West Front of the Cathedral from Galilee Court.

The gables over the central three bays of the West Front feature numerous niches, which contained figure sculptures. Some of the medieval originals survive, but others are 19th and 20th century replacements, some of which are of poor design quality.

The Cathedral is generally in very good condition, and is subject to a regular programme of inspection, maintenance, conservation and repair. This is laid down in the Cathedral Architect's quinquennial inspections. These define the condition of the building at set intervals and establish a prioritised programme of work going forward across five-year terms. The inspections also identify works that may be desirable or that could require attention over a longer time-span.

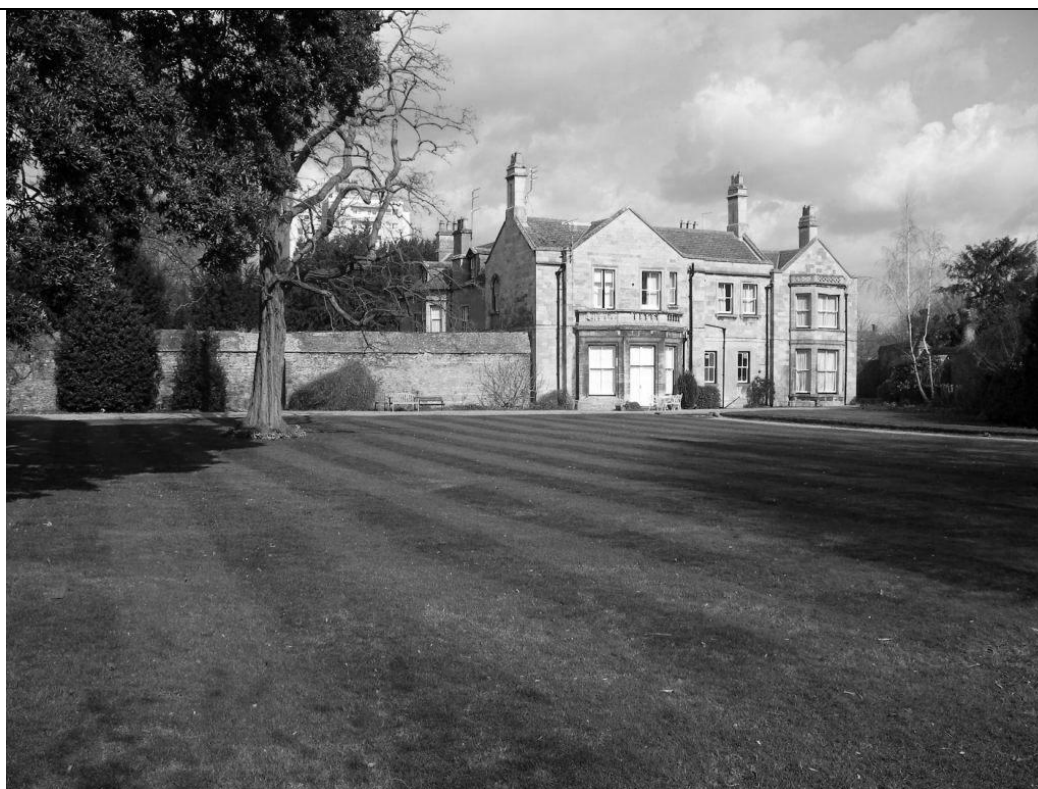
The west elevation of the Vineyard.

The building appears to be in good condition, with no immediately obvious conservation or maintenance issues. The interior was not visited but again seemed to be in good order from what could be observed externally. The gardens are also well maintained, but largely plain and surprisingly lacking in character (except for the remnant of terrace). Although the building's scale is imposing, its marginal location means that it has very little impact on views to or within the Precincts. This is one of several remaining properties in the ownership of the Church Commissioners, who have been reducing their portfolio in the Precincts substantially in recent years. Disposal of the Vineyard could be less of a concern for the Chapter. It does not lie within a core area of the Precincts for the Cathedral, while its substantial scale probably would not fit in with the requirements of clergy or administration.

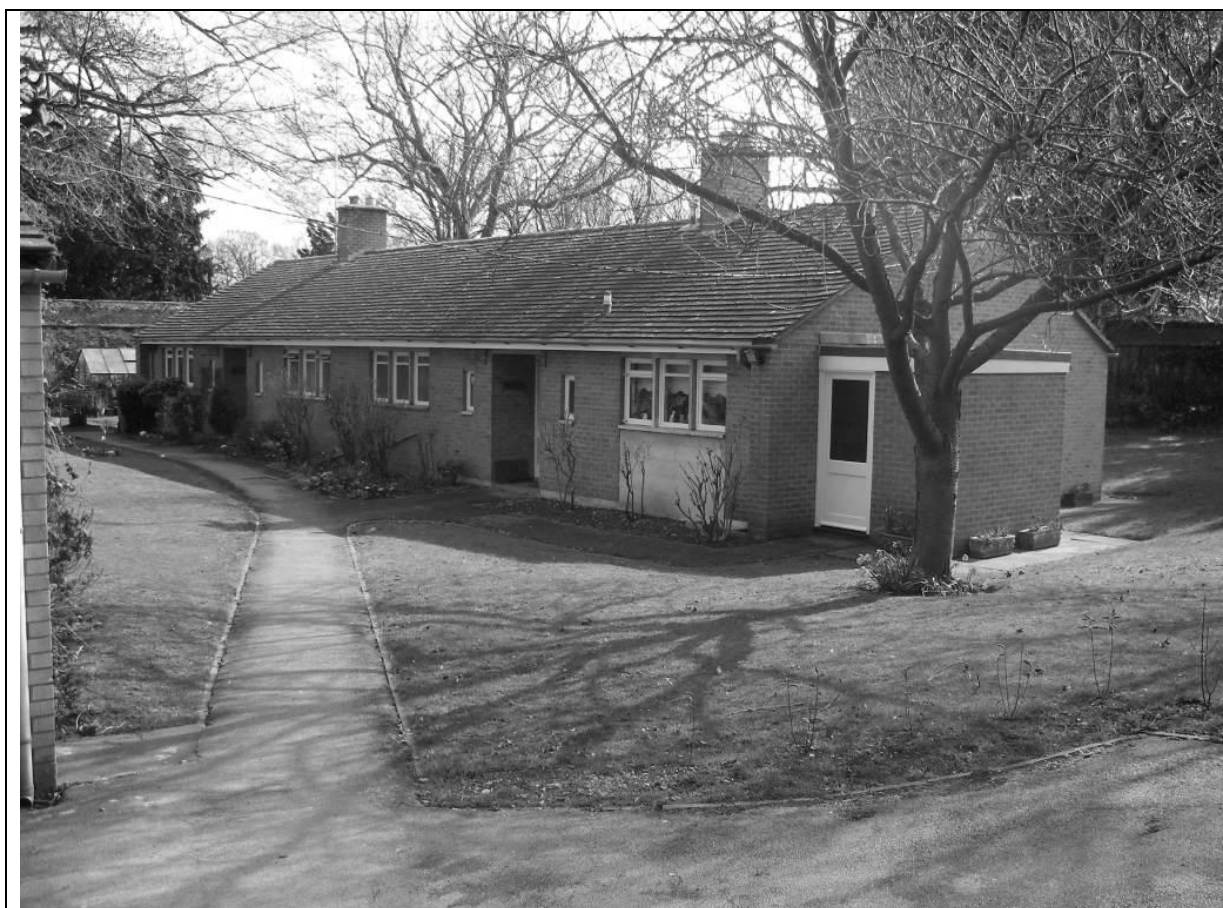
The north elevation of Ashton House and Mandell House.

The bungalows appear to be in good condition, well maintained and well decorated. The gardens are also well looked after. The site is very largely hidden from the rest of the Precincts and, like the Vineyard, feels somewhat peripheral. The Church Commissioners own the bungalows as well as the Vineyard. The Chapter may have more concern over and interest in this site if the Church Commissioners were to decide that it is surplus to their requirements and sell it. The site is adjacent to an important area of properties as far as the Chapter are concerned (Canonry House, the Precentor's Lodging and the education centre). The bungalows are also of a convenient domestic scale and could be useful as clergy or staff accommodation.

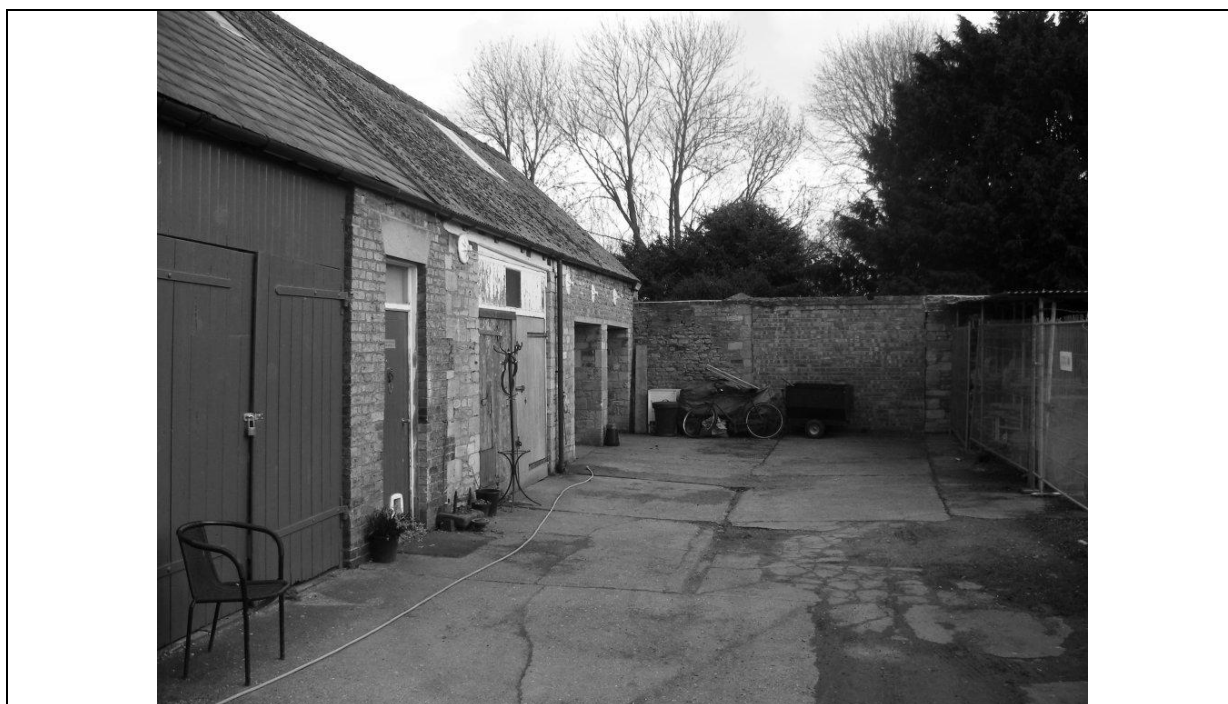
This single-storey range in the south-east corner of the Precincts consists of four garages. The central and eastern two garages are of uncoursed but good quality stone masonry, while the western one is of brick and is probably an addition. The pitched roof over the central and eastern two garages is of corrugated sheeting and the remainder is of slate. The eastern two garages have open-fronted doors and are used by the Chapter's building contractors as their stores together with the central garage that has hinged timber doors. The western garage has two hinged timber doors and a small separate office that has its own front door, and is used by the Cathedral's gardeners. A tarmaced forecourt extends to the south of the garages. These buildings may originally have been stables for Canonry House.

The south side of the garages.

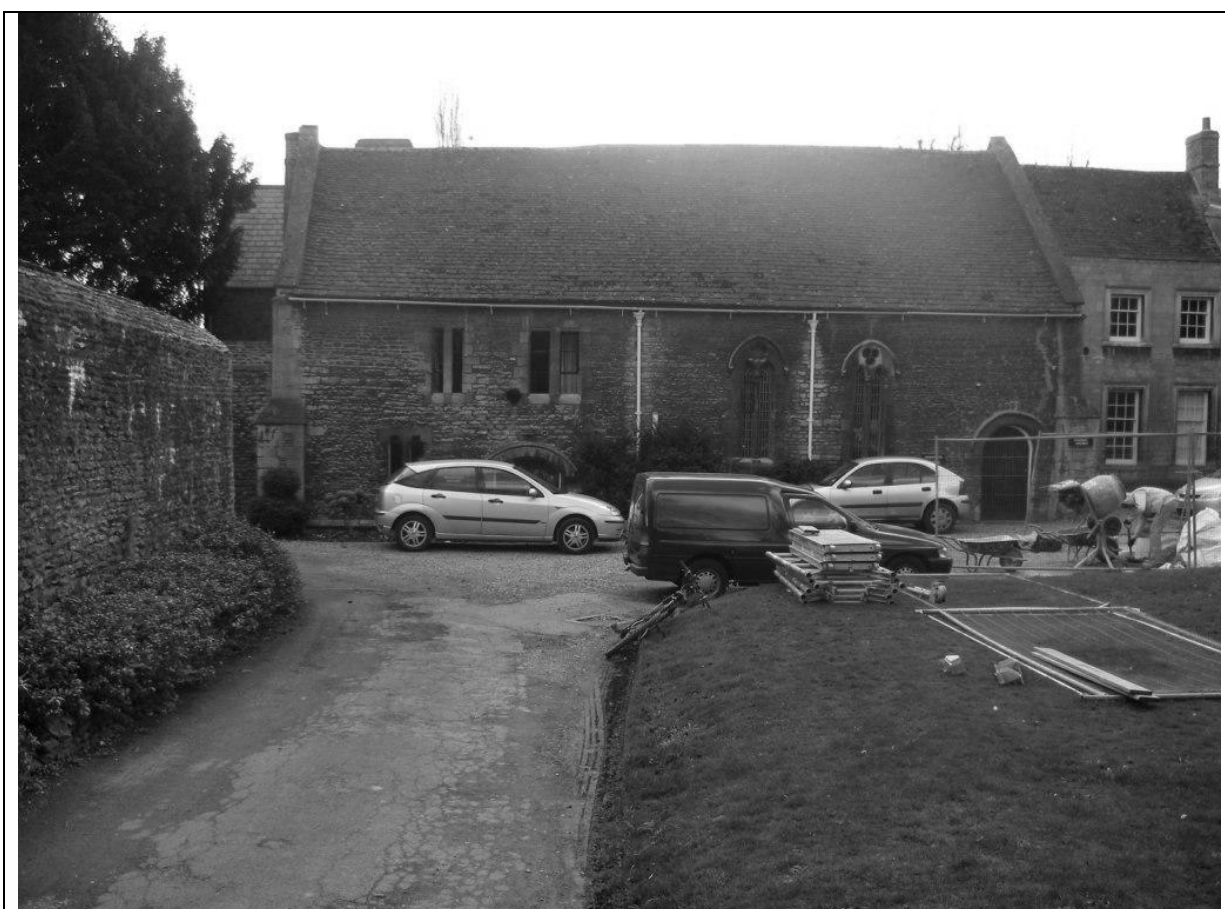
Canonry House (central part with lancet windows, and right with sashes) and the Precentor's Lodging (left) with mullioned windows. The left-hand of the two downspouts marks the approximate boundary between the two residences.

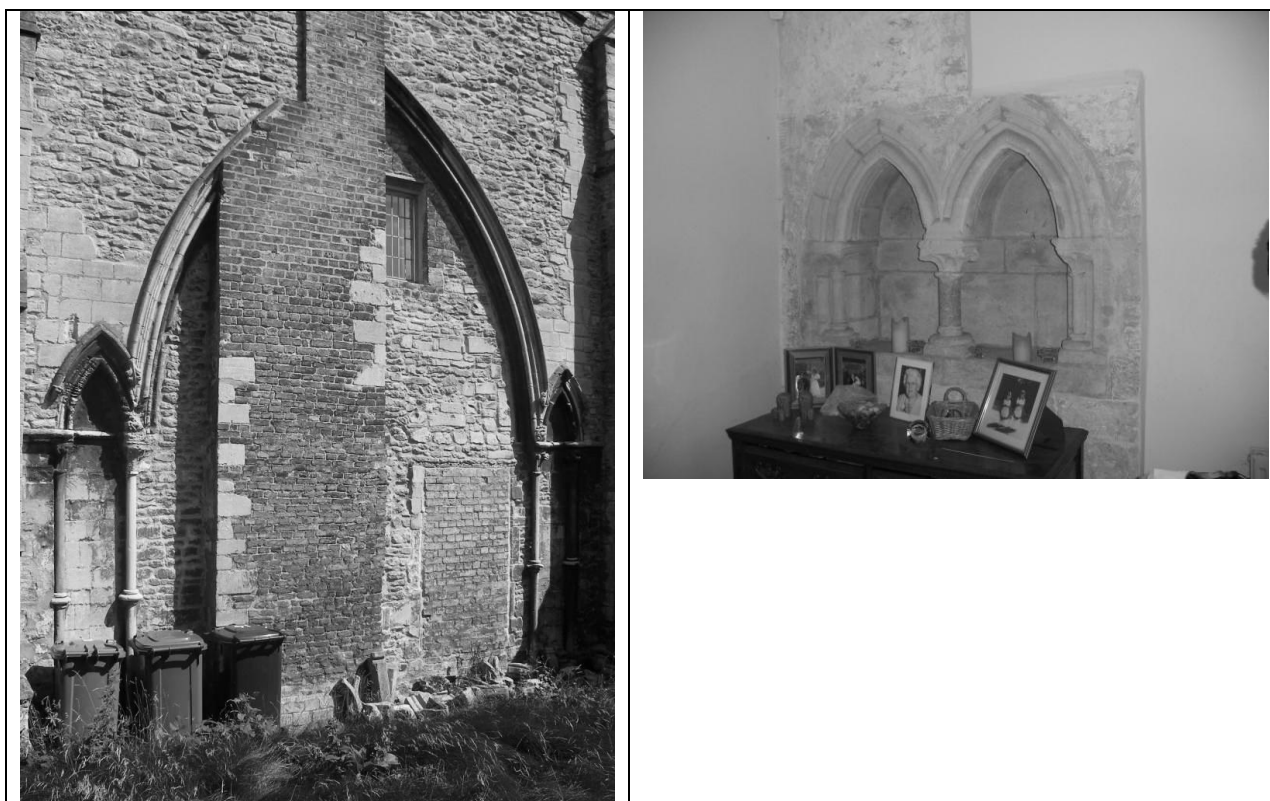
door, also blocked in stone, and there is a window lighting the first-floor bedroom in the upper part of the arch. An inserted brick chimney stack runs up the left-hand side of the blocked arch. Internally the chancel side of the arch is visible in the lounge, where the inner orders survive in reasonable condition on the north side of the fireplace. The bases and capitals also survive on the south side, but the shafts have been lost here. The upper part of the arch is also visible internally in the bedroom above, while a fragment of the arch for the east window is also visible in its en-suite bathroom. Finally an exquisite piscina survives in the lounge, at the east end of the south wall. It had been blocked up during the post-medieval period but was re-exposed in recent times. Squat engaged shafts support the twin pointed arches, with a central colonnette. The whole feature is in excellent condition.

The blocked chancel arch in the east elevation of the Precentor's Lodging (left), and the piscina (right).

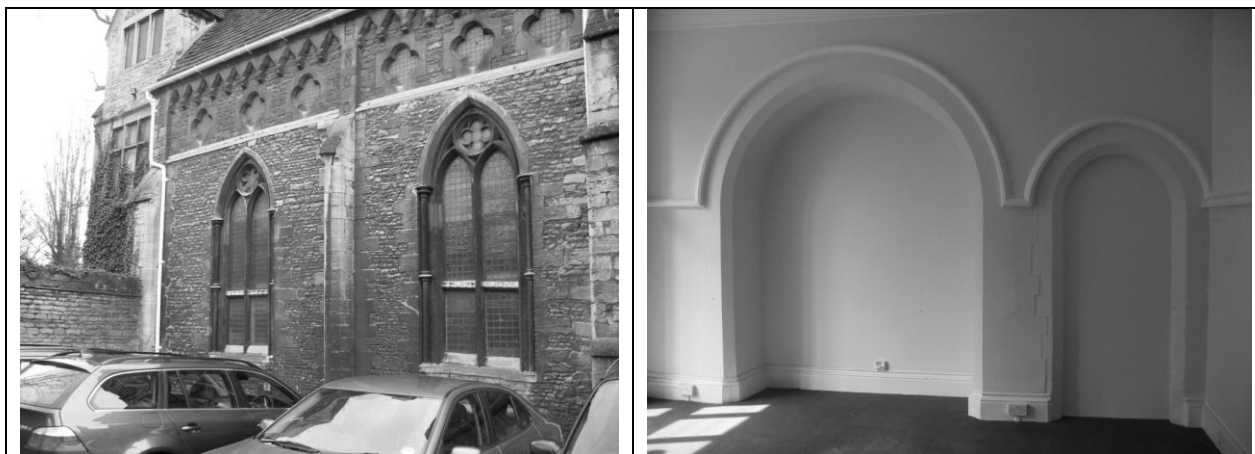
This substantial building retains extensive medieval fabric along its north side, with tall shafted windows of later 13th-century date, and traces on the south where there are contemporary buttresses. This part of the building was a hall immediately south of the infirmary, and perhaps associated with it. There is one major *officium*, which has yet to be identified, and that is the Sacristan's. The principal ground-floor room at the west end retains one large arched former opening and a door to its north, with traces of early fabric associated with them. These seem to have been incorporated from the medieval building, but their simple round-headed form suggests an earlier, possibly 12th-century, date. They certainly establish a link between this building and the attached Norman Hall to the west. The ashlar buttresses on the south elevation may also be of medieval origin. Unfortunately little more than these features and the north wall with its 13th-century windows survive, although these features are exceptionally fine.

The north elevation of Archdeaconry House (left), and the blocked arches/doors in the western ground floor room (right).

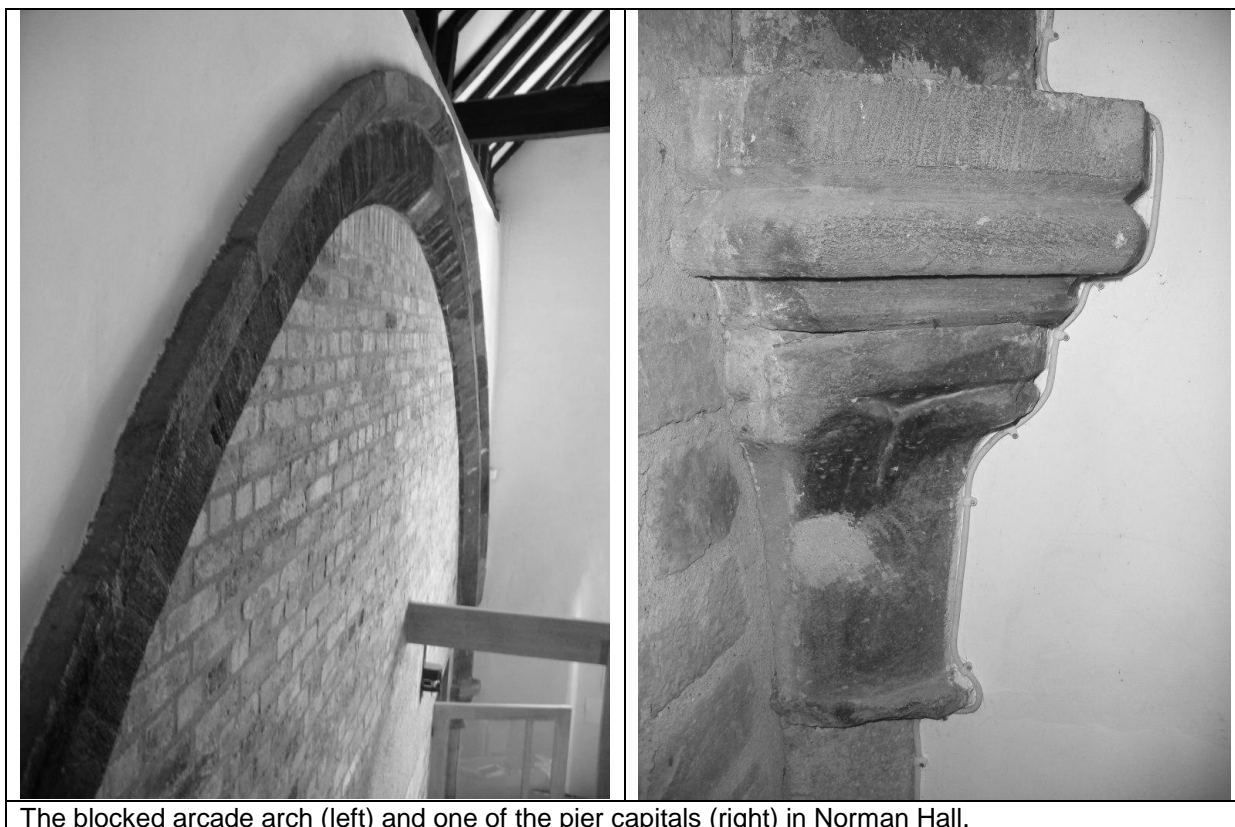
principal room at the west end that is open to the ceiling. There is a mezzanine floor over the east end of the room, accessible via a modern timber staircase inserted alongside the southern partition wall with the adjoining passageway. The remainder of the building is of two storeys with attics and appears unremarkable except for some timber framing and a few features such as doors and windows. Fortunately the main downstairs room makes up for this, as it contains a wide 12th-century arch of truly impressive proportions. Though blocked, the form of the arch is clear to see. It is chamfered and rises off water-leaf capitals at each end, though these and the responds they surmount have suffered some damage in antiquity.

The blocked arcade arch (left) and one of the pier capitals (right) in Norman Hall.

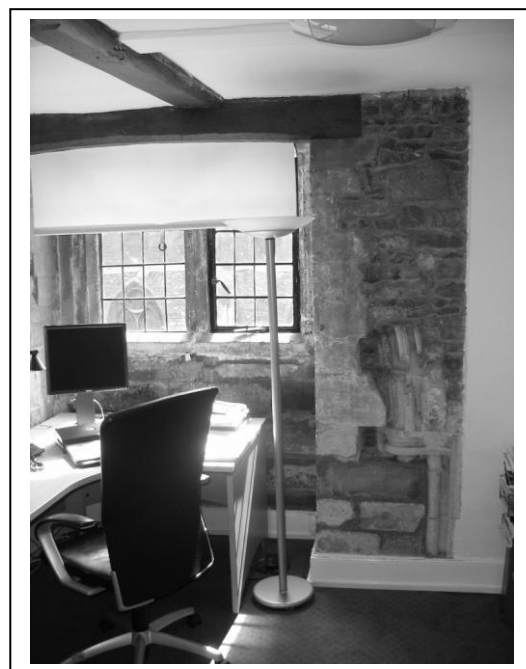
the masonry is rather dirty from soot/sulphates. This seems to be a particular problem for north-facing elevations within the Precincts (including the Cathedral itself) and is presumably related to atmospheric and environmental conditions spreading pollution in this way. Internally the arcades are in very fine condition, including at least one stiff leaf carving that is in very close to original condition (others have suffered some local damage, especially at the intersection of carved planes).

Unusually for the Infirmary Hall complex, traces of the aisle windows are also visible internally on the southern side of the building at first floor level. These include the upper parts of engaged colonnette shafts, their capitals, and the arches springing from them (right). They all display some degree of later disruption, and at least one area of masonry (on the staircase up from the ground floor) has clearly been moved from its original location and reset here but the wrong way round. Even so these are rare and important survivals. Fortunately these features are reflected in the external southern elevation, where the eastern two bays retain the near-intact frames for tall 13th-century windows under flat arches (see photograph above). There is a massive buttress between them. The windows have been blocked but have later windows inserted in their tops. The blocking of the western window, however, shows that it would have been of two lights, with a slender mullion between them. There is a suggestion of a transom position as well, but this is not certain. The frame also retains good engaged shafts with carving below the later first-floor window inserted in the top of the arch. Unfortunately all of this kind of detail has been lost from the eastern window, but its outline is still visible clearly enough. There are two narrow lancets to the east of the blocking, at ground and first-floor level, obviously later insertions into the blocking of a third tall window that would have continued to the east of the current gable end of the house. An important point to note is that there is a reduction in detail in the original windows facing north, showing that the principal aspect was to the south.
