## Peterborough Cathedral Conservation Plan - Volume 2: the Gazetteer

## List of contents

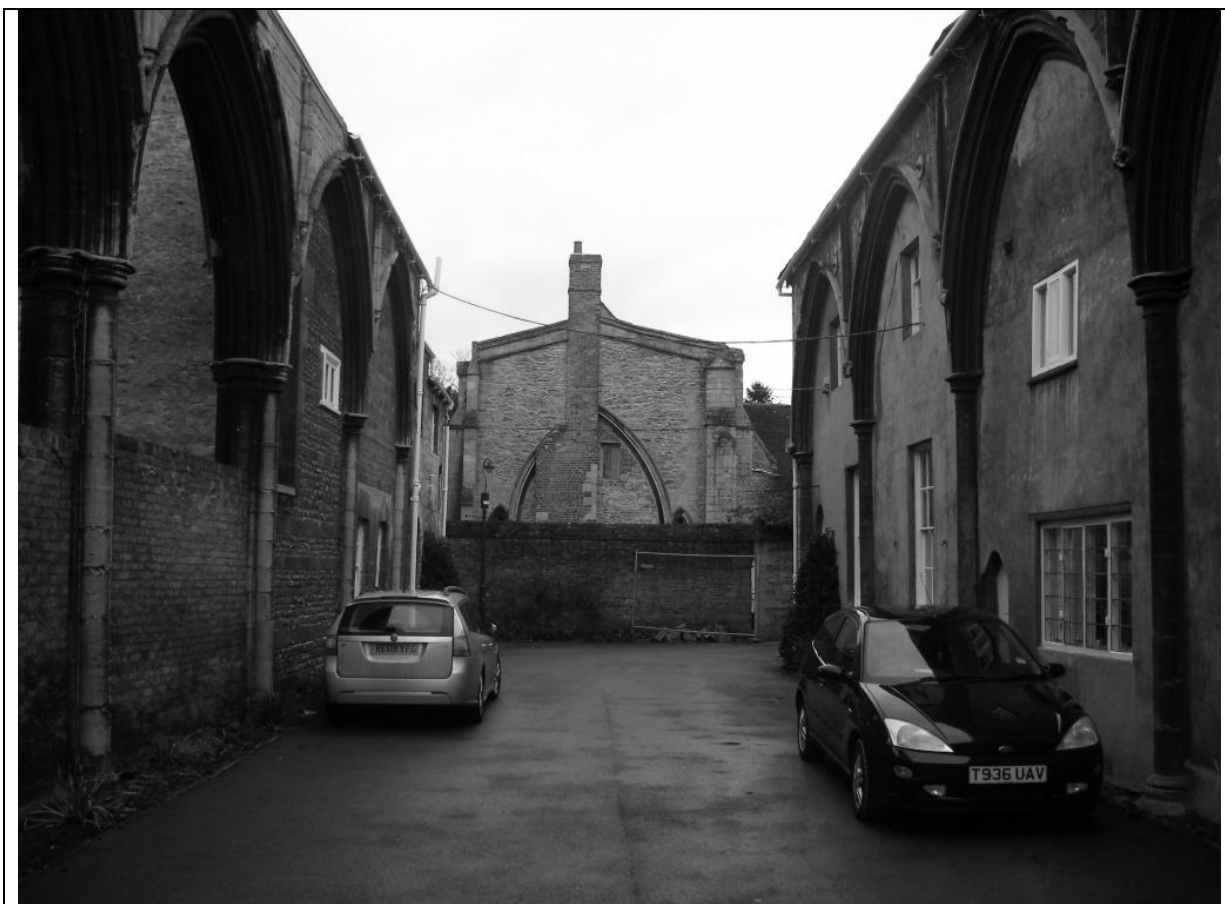
18 Minster Precincts (left) and 19 Minster Precincts (right), with the surviving part of the Infirmary's west end wall between them.

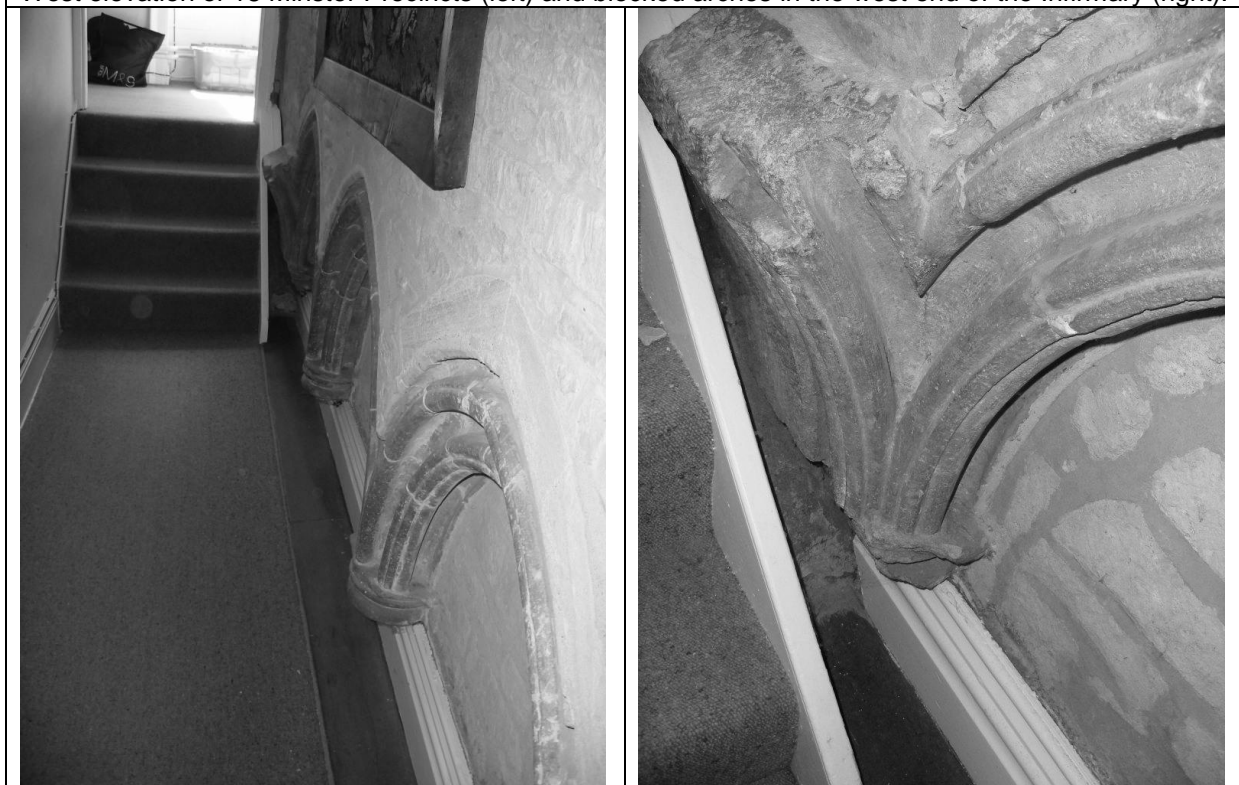
The arches at the west end of the Infirmary Hall's south aisle (left), with a detail of the return arch springing (right).

The insertion of the house into the south aisle occurred after the Dissolution, but the exact date is unclear although it must have been within a few years of the setting up of the Cathedral establishment. The parts of the building that extend south and west beyond the original limits of the Hall appear to be of 18th-century date. A plaque bearing the date 1772 high in the west gable end seems to confirm this (the date is 10 years after the one on No. 16). Two windows on the front (north) elevation have 18th-century double hung sashes with glazing bars. It may be that the original insertion was earlier than this, and that the house was extended in the 18th century. Further alterations occurred in the 19th century, when the current main entrance was established. This has moulded shoulders under a flat arched head. Both the outer and inner doors of the entrance vestibule are of very fine quality, with timber panelled lower halves and coloured glass in leaded framing in the upper halves. The outer door also has leaded glazing in the arch above, while the inner door has leaded fanlights using both plain and coloured glass, the latter in checkerboard pattern. The interior has many other fine panelled doors, including several with neo-classical fixtures. The main staircase up to the first floor is of good quality but appears to be a later, possibly Victorian, replacement for an earlier one. The house also has some excellent living and reception rooms, including a finely proportioned dining room to the east of the entrance, a lounge at the west end, and an excellent library/office in the wing off the south side towards the west end.

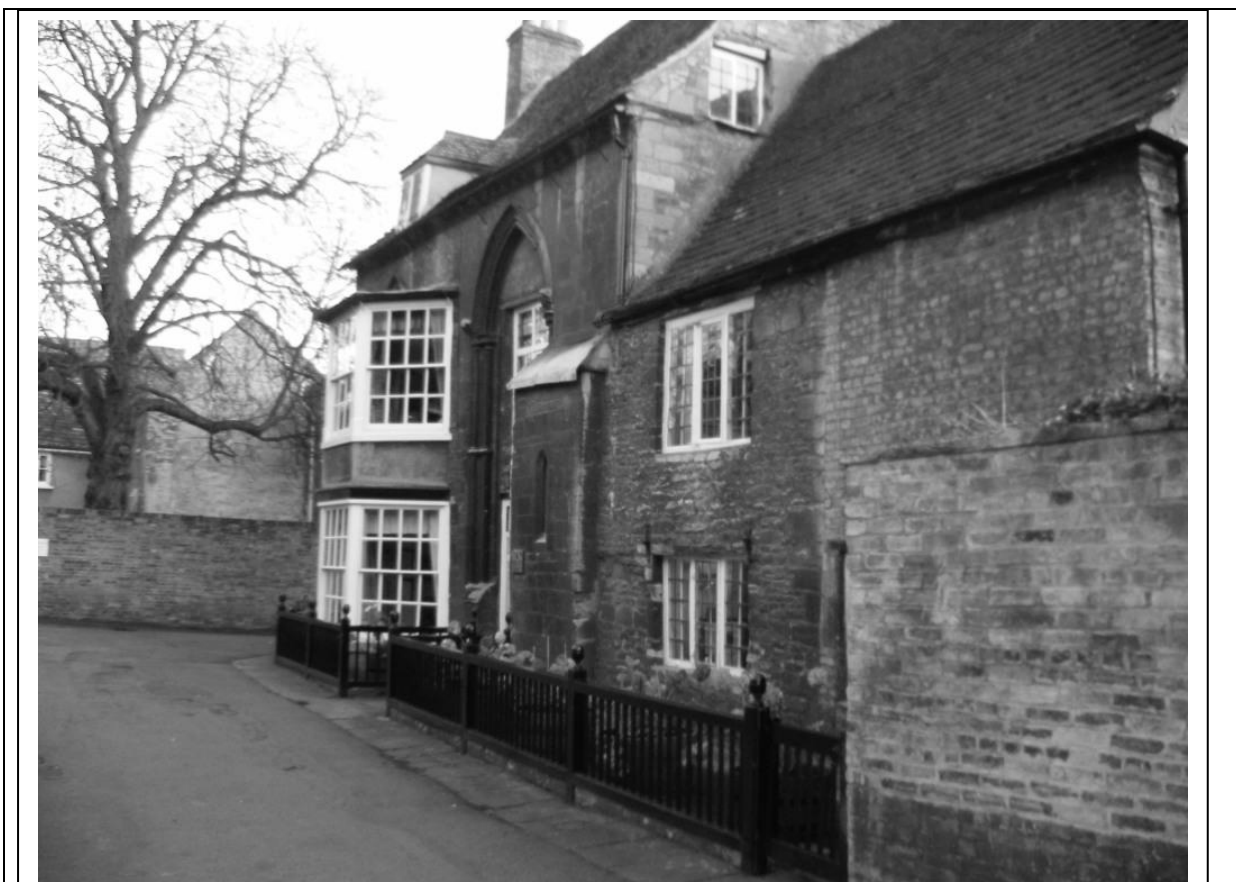
The north elevation of 19 Minster Precincts.

The building is generally in very good condition externally and internally, though the masonry on the front (north) elevation is quite dirty and encrusted with soot and sulphates. There is some evidence of past problems with the rainwater goods in the form of clean areas of stonework immediately below the gutter, probably caused by overflow or splashing from blockages. This appears to have been resolved, and as noted elsewhere rainwater goods are now checked and cleaned twice per year as a matter of routine maintenance. The interior is maintained in generally excellent decorative order, though less attention seems to be given to the attics. These are mostly used for storage and printing facilities where a high level of decorative quality is not necessary, but even here the level of maintenance is perfectly adequate.

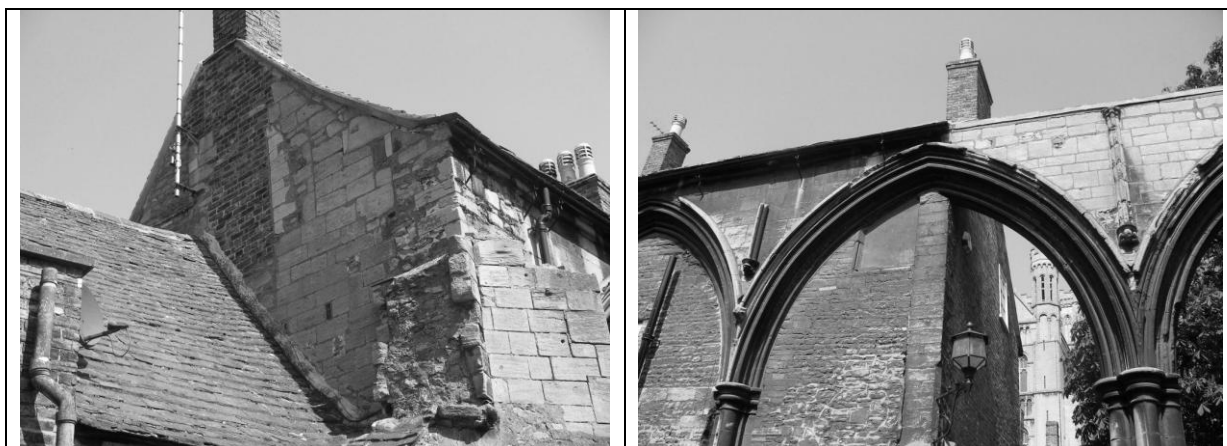
19 Minster Precincts: the west gable of the Infirmary Hall with the later extension to it (left), and walls of the house inserted into the Hall arcading (right).

The insertion of the house into the medieval fabric is dated to the early 19th century in the listed building description, though the blocking of the arcades and thus the origin of the house may be earlier than this. This was presumably at the same time as the rest of the Infirmary was adapted to its new uses under the newly created Dean and Chapter. The front (north) elevation is of stone (rendered between storeys), and has a good hipped dormer, leaded casement windows, and early 19th-century three-light bay windows, with double hung sashes and glazing bars to the ground and first floors at the east end. These have been inserted in front of a tall pointed arch that remains visible only at the tip and is presumably an original aisle window of the Infirmary Hall. The central tall recess under a second pointed arch has one four-light window with leaded glazing, above a six-panel door with rectangular ornamental fanlight. Three re-used 13th-century human mask corbels can be seen,

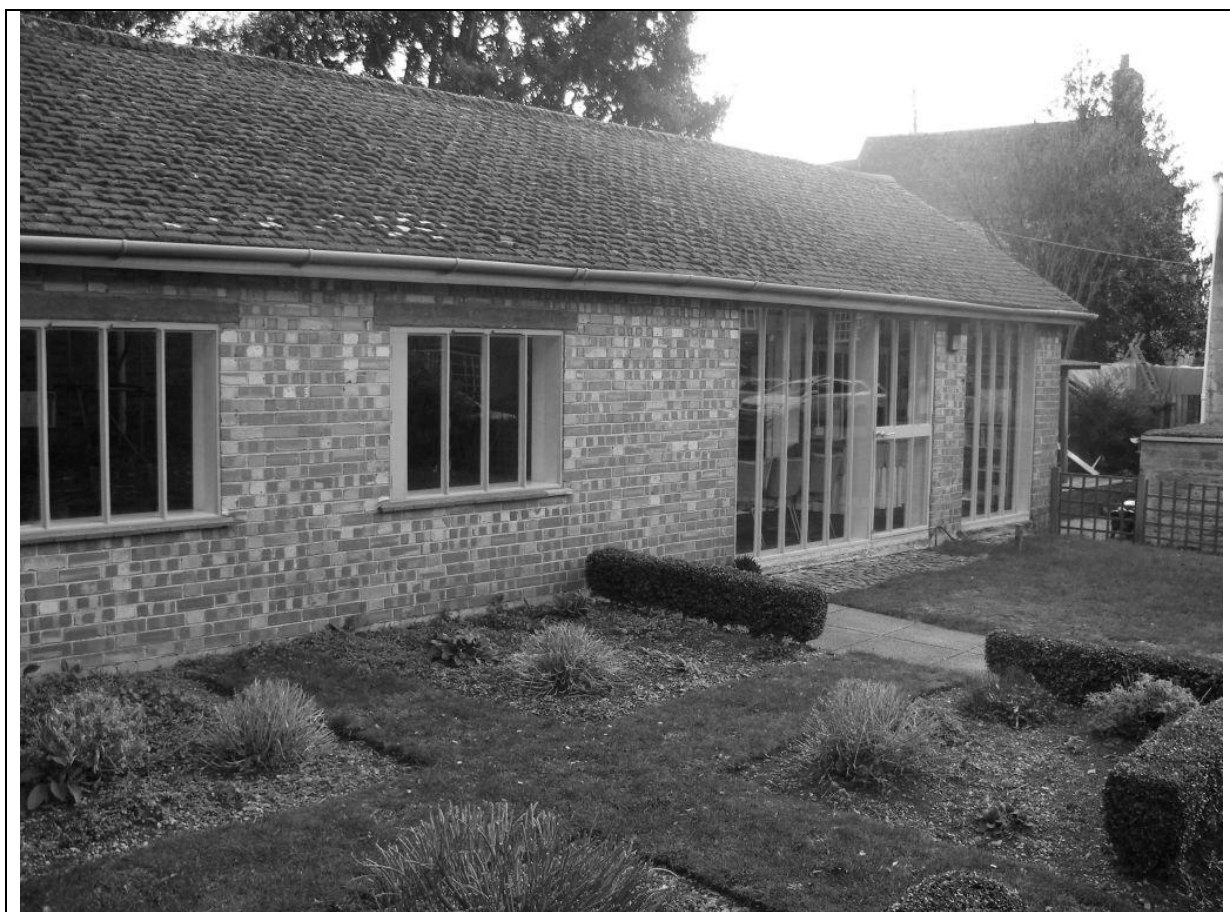
The education centre and herb garden, seen from the north-west.

The buildings generally seem to be in good condition. The education centre in particular is very well maintained and decorated, though presumably there will be a relatively frequent and recurrent need for some re-decoration if it is heavily used. There may also be concerns over noise emanating from the education centre as far as the occupiers of adjacent properties are concerned.

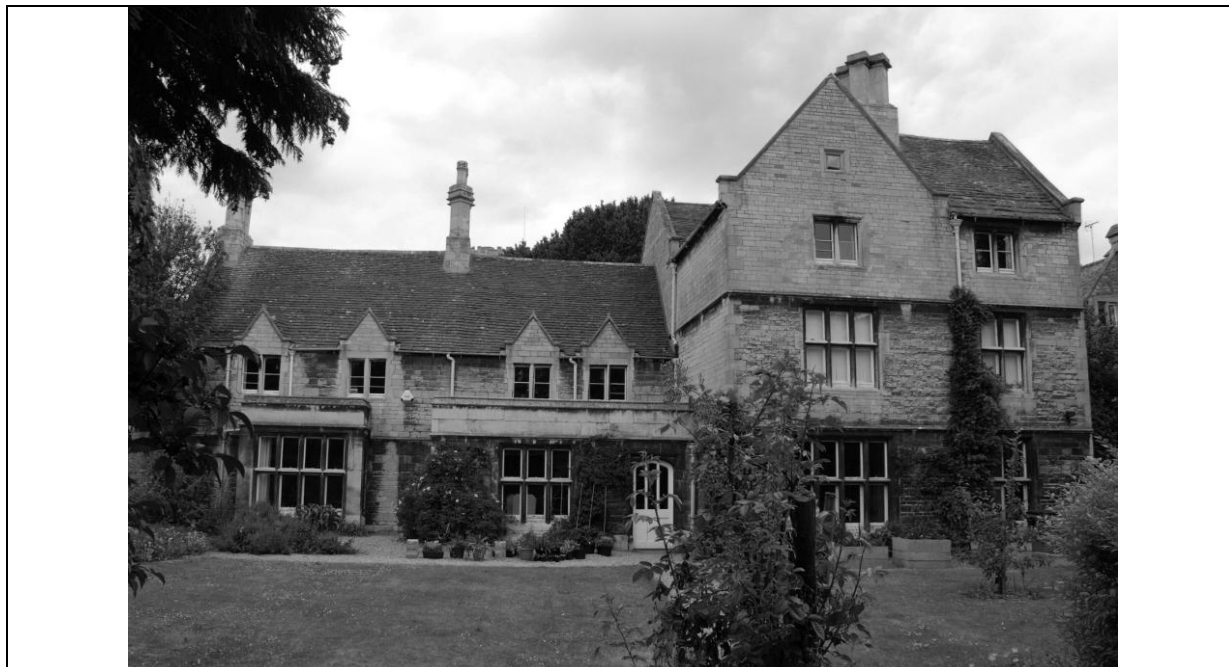
The south elevation of Prebendal House (photograph from Cathedral GIS).

The condition of the building generally appears to be good, though the arcade remnant accessed from the Norman Hall area and looked after by Chapter is overgrown and probably in need of attention. Otherwise the college looks after the maintenance and decoration of Prebendal House. The educational function is not wholly appropriate for a former house, but it is too large for the residential needs of the Chapter, clergy or staff of the Cathedral in this respect. College use is therefore reasonable, and provides welcome variety from the commercial office function of many other former houses within the Precincts.

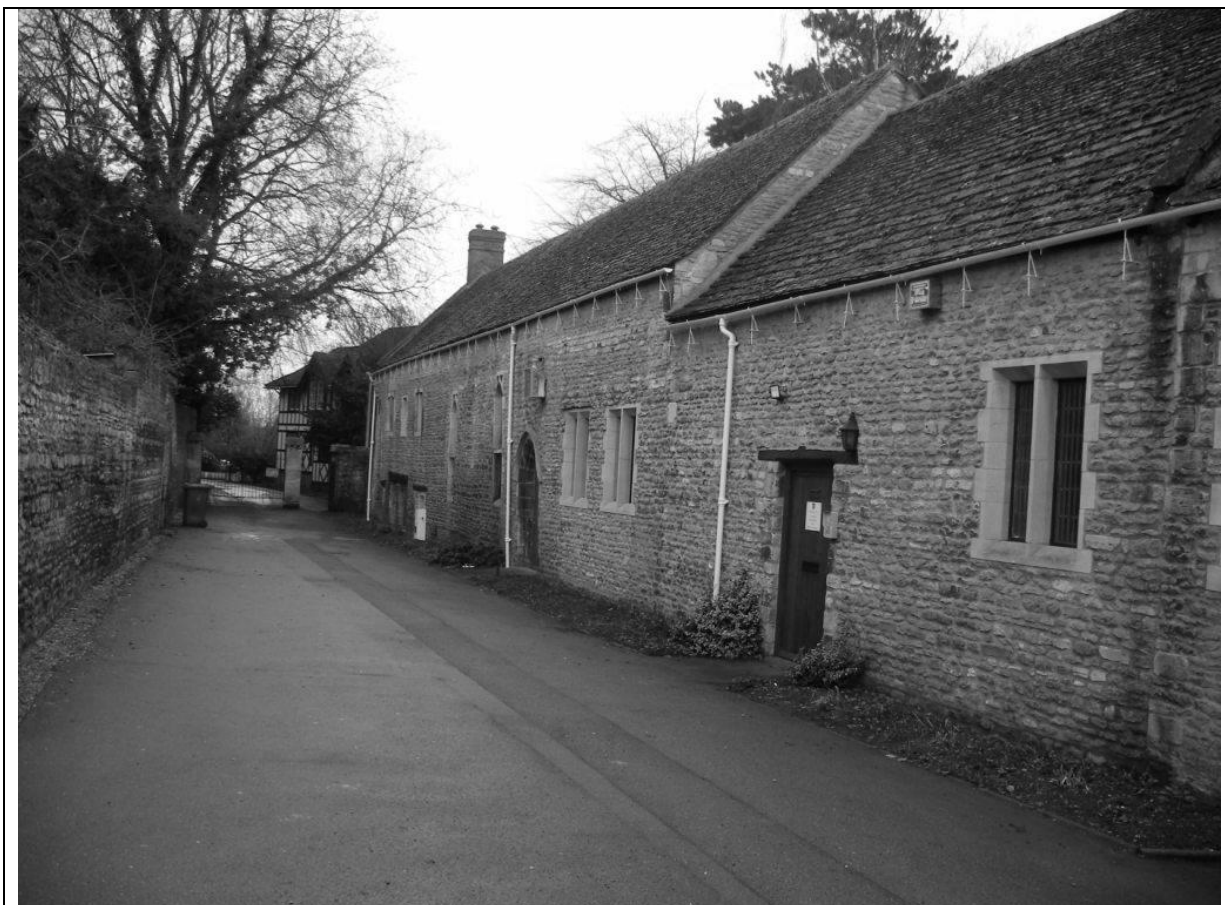
presumably original (though perhaps re-set). Others are mullioned and later, though it is difficult to suggest an accurate date (the original list description suggests an 18th-century date for parts of the building). Some are modern, probably dating from the complete restoration of the building in 1989/90. There is a single door in each of the lower western and slightly taller eastern halves of the range, again on the north side. There is also a blocked door at the east end of the same elevation, at first floor or mezzanine height. The other elevations are largely plain, though there are a few windows on the south elevation, which overlooks Bishop's Road gardens and forms the Precincts' boundary wall at this point. There is a brick double garage built on to the west wall and at the south-east corner of the Bishop's Palace gardens.

The north elevation of Almoner's Hall.

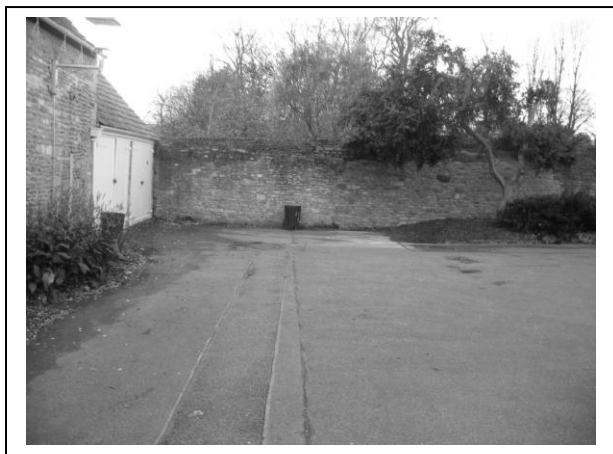
much as anything else). The brick double garage built onto the west end of the Hall is of **little significance**. It is mildly **visually intrusive** seen from within the Precincts (ie from the north along Hostry Passage and east along Gravel Walk, left), largely because of its white-painted double doors.

Almoner's Hall is in very good condition following its recent restoration. It is also well maintained and decorated to a high standard, although the neutral paint schemes are unimpressive. The current use of the building is not over-intensive, and seems appropriate. A function more closely aligned with its historic antecedents may be worth exploring in the future, but the location on the edge of the Precincts might militate against this. It could all too easily appear to marginalise disadvantaged groups, for instance, while the several internal stepped changes of level would hinder its accessibility. The visual impact of the double garage could be ameliorated by a different colour of paint on the double doors, but this is not a high priority.

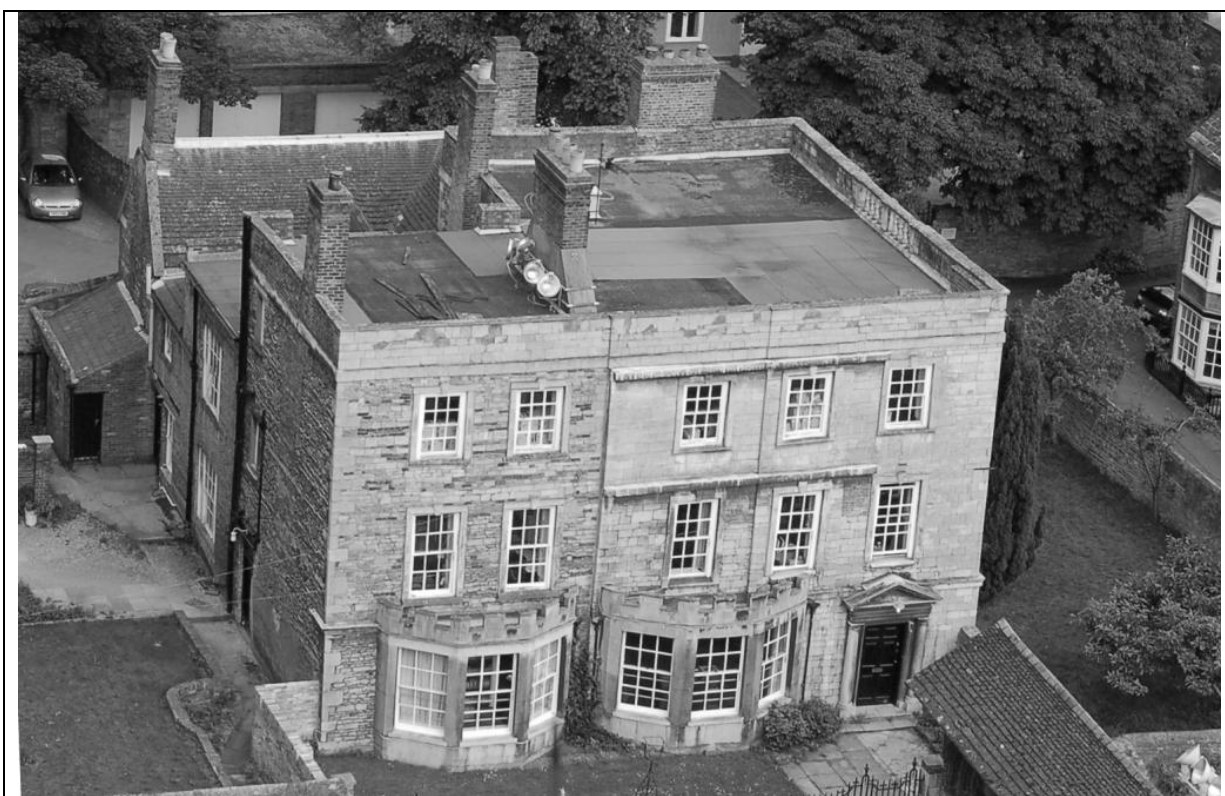
Laurel Court House seen from the cathedral. Photograph by Jackie Hall, from the Cathedral GIS

Laurel Court is in poor condition both internally and externally. The interior has many problems on all floors and in the majority of rooms. The main western rooms are well maintained and decorated, but otherwise there seems to have been little investment in maintaining the property. Many of the rear and upper rooms have wallpaper and other decoration of a particular vintage – 1970s or thereabouts – that does nothing for the building. Fortunately most of these problems are superficial and relatively easy to deal with, though in some areas (including the staircase and the main ground-floor room on the south elevation) there are more serious problems such as holes in plaster finishes and damp penetration. Externally some of the masonry is in poor condition with damaged or eroded stonework, areas of pointing that need attention, and vegetation growth. The west elevation retains timber baulks above the first and second floor windows (both timbers protected by lead ‘eyebrows’) from former retaining/restraining props, visible on an aerial photograph taken in 1955/6 (Cathedral GIS image 1012). Clearly there was a major concern over the stability of the masonry, although equally clearly this seems to have been resolved successfully or the support works would not have been removed. Overall the condition is worrying but not severely so, and all issues look to be readily addressable subject to funding.

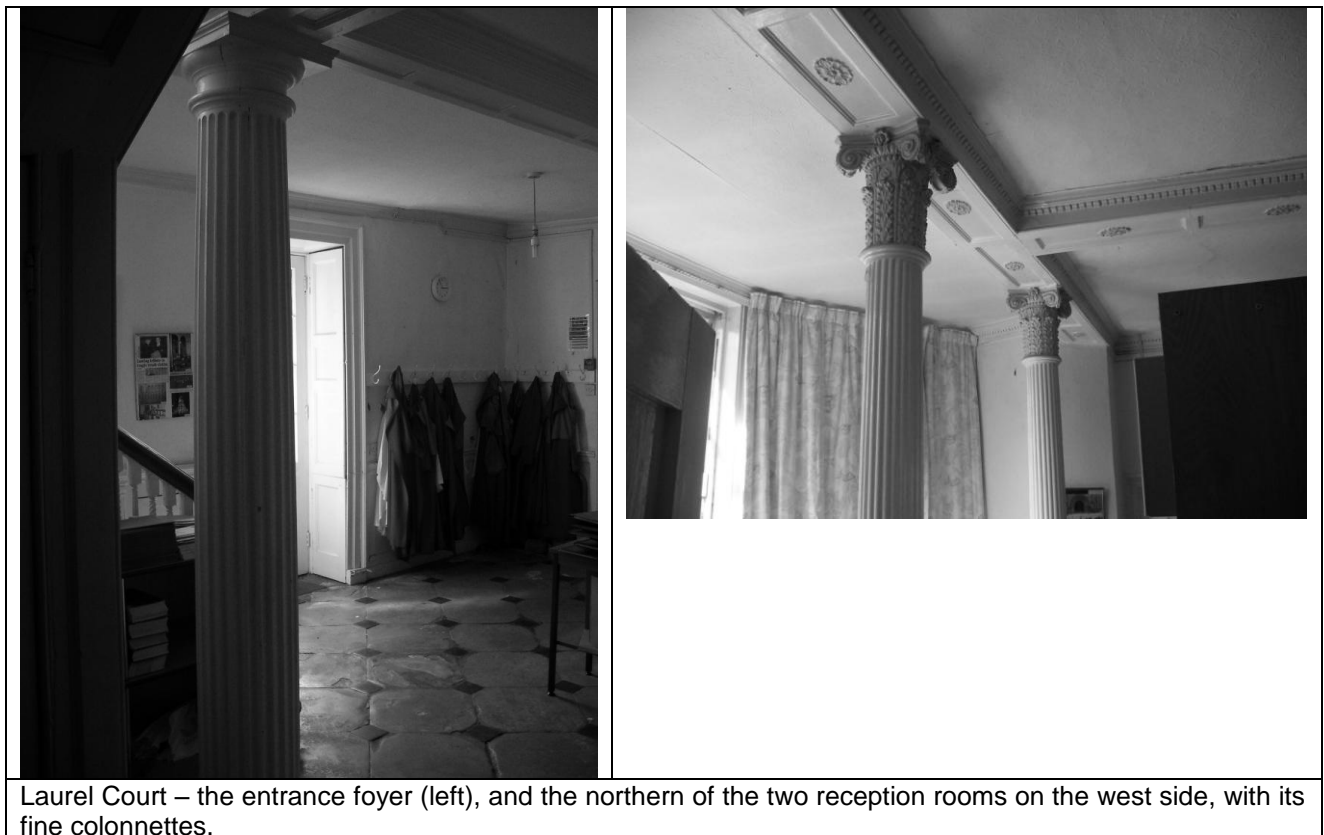
Laurel Court – the entrance foyer (left), and the northern of the two reception rooms on the west side, with its fine colonnettes.

Internally the ground floor has a fine stone-paved entrance hall with simple fluted Tuscan columns in front of, but not supporting, the principal staircase. This has elaborately turned balusters and very ornate ends to the treads. The inner side of the staircase has good panelling. There is a slight irregularity in the flooring at the north-east corner of the entrance hall, where the tiled floor of the corridor from the back door (ie that in the north elevation) continues into and behind the stone floor. This may suggest that the area was configured in a slightly different manner originally, but it is difficult to determine the form of this. There is a secondary staircase opening off the rear corridor, with good balusters but less elaborate than on the main stairs. It is assumed that the secondary staircase was designed for access to servants' quarters originally on the second floor. The ground floor also has three very fine reception rooms, one behind each of the bay windows on the south and west elevations. The western rooms in particular retain exceptionally fine decoration, with Corinthian

colonnets supporting the ceiling in the room to the north and an elaborately moulded recess in the room nearer the entrance hall and projecting into it. The southern room is not as impressive, but this may reflect losses rather than a different original treatment. The room is now the main choir practice room. The main rooms on the first floor retain good quality panelling, doors, coving, fire places and other features. They were bedrooms but are now used as choir offices. Most rear rooms on this and throughout the second floor are plainer and in a poor decorative state. The same applies to the two-storey extension.

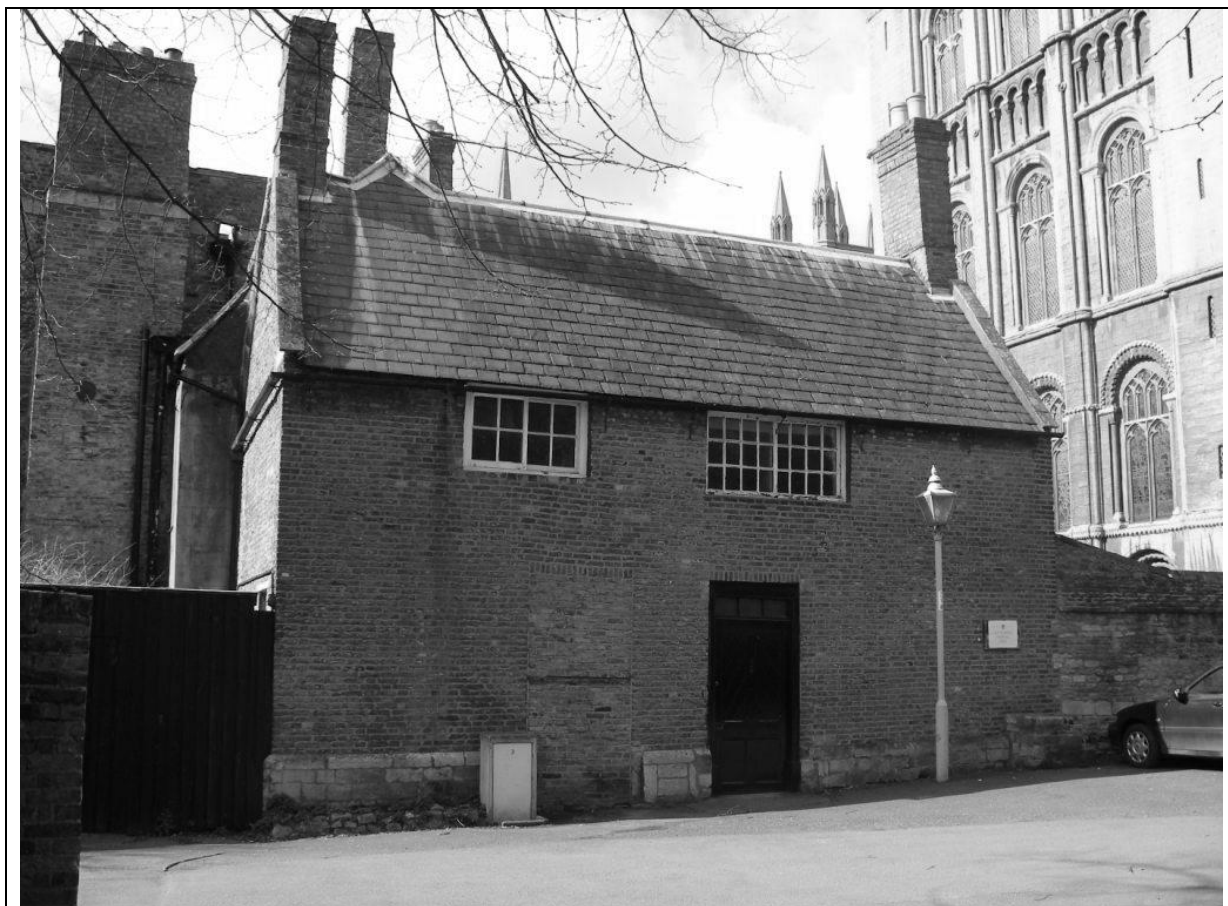
Laurel Court Cottage – east elevation.

The Cottage is in good condition and well maintained. The low grade use is appropriate to a former outbuilding, but conversion for other use (including residential) would be possible with careful and sensitive planning. The Grade I status seems to reflect the listing of Laurel Court itself – a form of curtilage definition, perhaps – rather than the character of the Cottage itself. It is notable that the masonry wall to the north and the mounting block are Grade II listed. In some ways this would appear to be a more appropriate grade for the Cottage. Set against that, however, the stone plinth hints at foundations of an earlier building, perhaps of monastic origin, which if proved would **enhance significance** and justify retention of Grade I status. Nevertheless it may be appropriate for English Heritage to consider the current grading of the building to determine whether it should remain at Grade I.

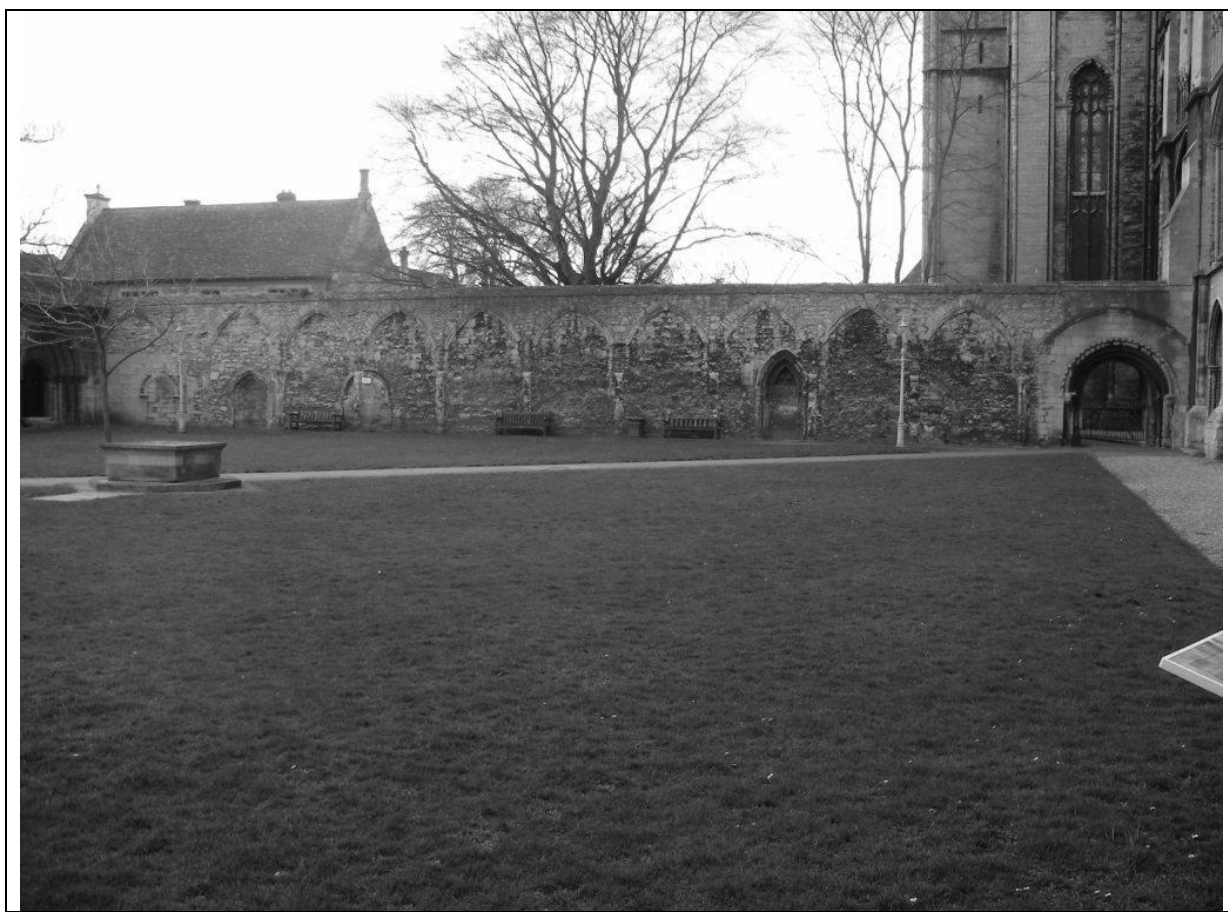
The Great Cloister looking west, with the west wall and the gate to Galilee Court on the far side.

The Great Cloister is well maintained despite, or perhaps because of, its ruinous state. The remaining masonry and its detailing are of excellent quality, and the condition is as good as one could expect for buildings that have been left without roofs for several hundred years. Replacement of weathered and eroded details with new stone seems to have been kept to an absolute and necessary minimum as a matter of policy over a long period. The new is clearly distinguishable from the old, and will remain so for many decades to come. Meanwhile good conservation practice continues to be applied to this most precious of spaces through the work of the Chapter, their professional advisors and the Fabric Advisory Committee. Removal of the diagonal path across the cloister garth would be beneficial for interpretation, although there is a risk that the route would continue to be used (it is an obvious desire-line across the cloister). This would be detrimental to the grass. The garth might also benefit from an alternative planting scheme, eg as a herbarium. This would aid interpretation and provide a valuable sensory experience, thus extending and improving access.

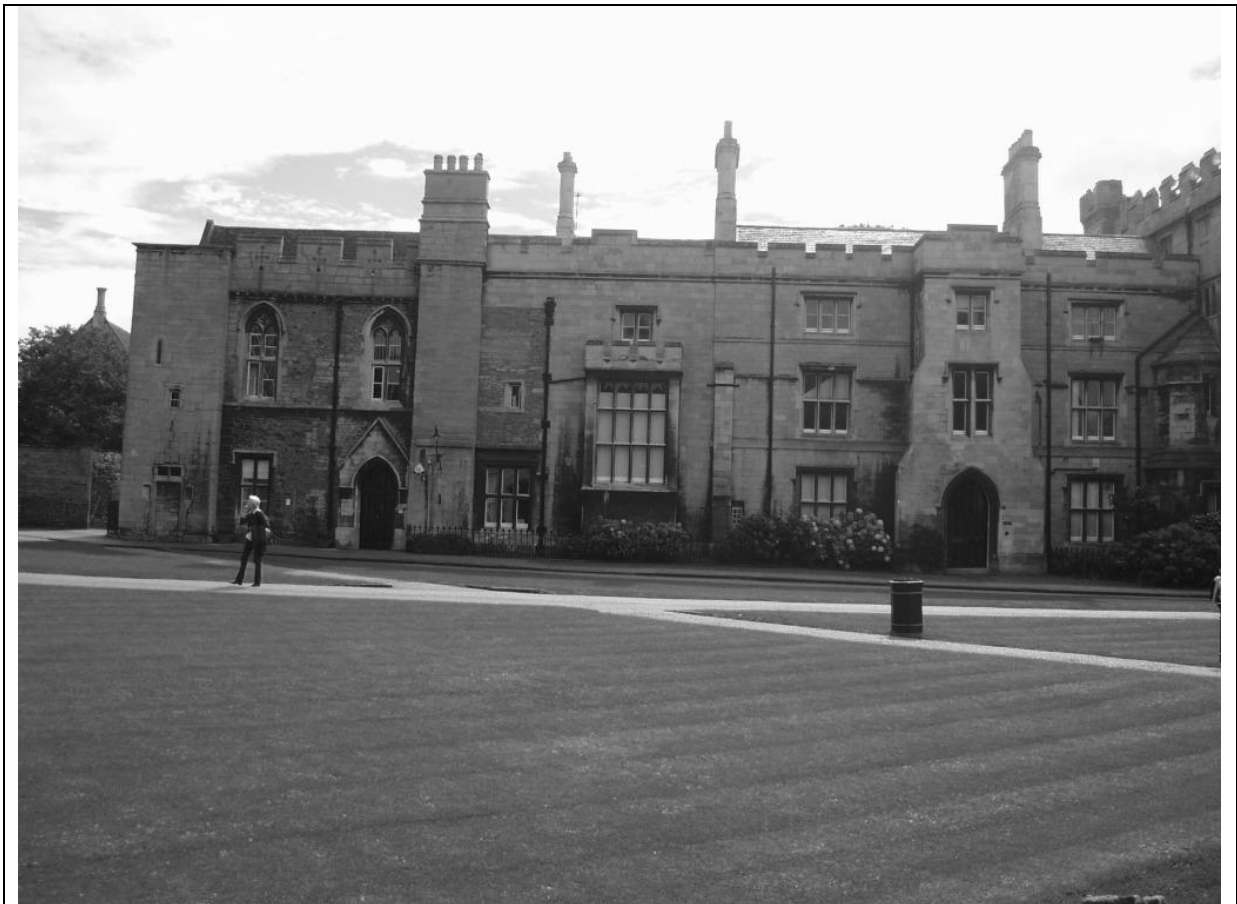
24 (left) and 25 (centre and right) Minster Precincts.

No. 25 is mostly in good condition, but the north (front) porch and the rooms above it display cracks and have moved away from the rest of the building. This will require remedial work to prevent further movement. It is well maintained, and appears to be in very good decorative order internally. Its continued use as a private residence is wholly appropriate. Along with other properties on the south and west sides of Galilee Court it retains a strong sense of group value while still having a distinct visual and physical presence of its own. This should be retained unless there are overwhelming reasons for alterations.

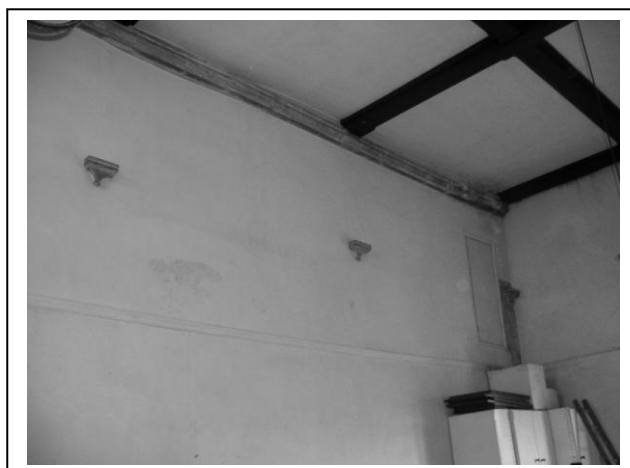
The room above the gateway is now of full height, with the former internal floor having been removed. It is known as the Knight's Chamber, reached via a door in the western wall of the passage, behind the line of the gates, leading to a Jacobean timber staircase in a block off the south-west corner. The panelled door at the top of the stairs has the same type of right-angled hinges seen in many 19th-century buildings in the Precincts (eg Archdeaconry House). The roof appears to be a replacement for an earlier one, the corbels for which still survive on the side walls. There is a door high in the south-east corner of the room giving access to the roof from the original upper floor, but now stranded (above right). Its cill shows roughly where the floor would have been. There is a string course just below this which runs into the window splays just beneath the lintel of the lower (first floor) windows. The room also features a fine hearth in the west wall, with the chimney flue standing just proud of the wall face above this. It seems to be little used now, with ageing paintwork and a

poor quality kitchenette at the south end. The spiral staircase has an accumulation of plaster and other detritus on the floor and treads.

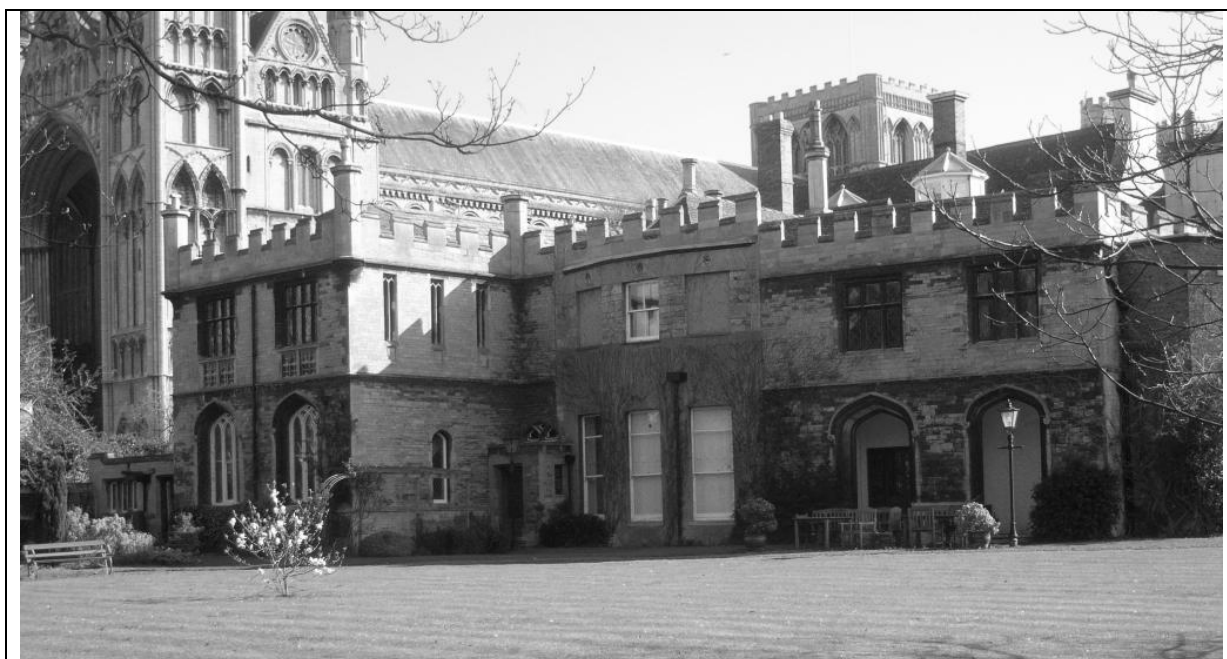
West elevation of the Bishop's Palace, with the Cathedral behind (photograph from Cathedral GIS).

The Bishop's Palace and its grounds are in good condition and very well maintained (by the Bishopric's Estate). The interior is maintained to a high standard of decoration. The continuing episcopal use represents an unbroken tradition now spreading across many centuries. The Diocesan use of the solar wing is also appropriate and has some pedigree, in that the abbot and the successor bishops would have had their household and official staff nearby. These would quite probably have been housed within the palace complex. There is no issue of appropriateness about the Diocesan Offices, therefore, not least because the residential part of the Palace is still more than adequate.

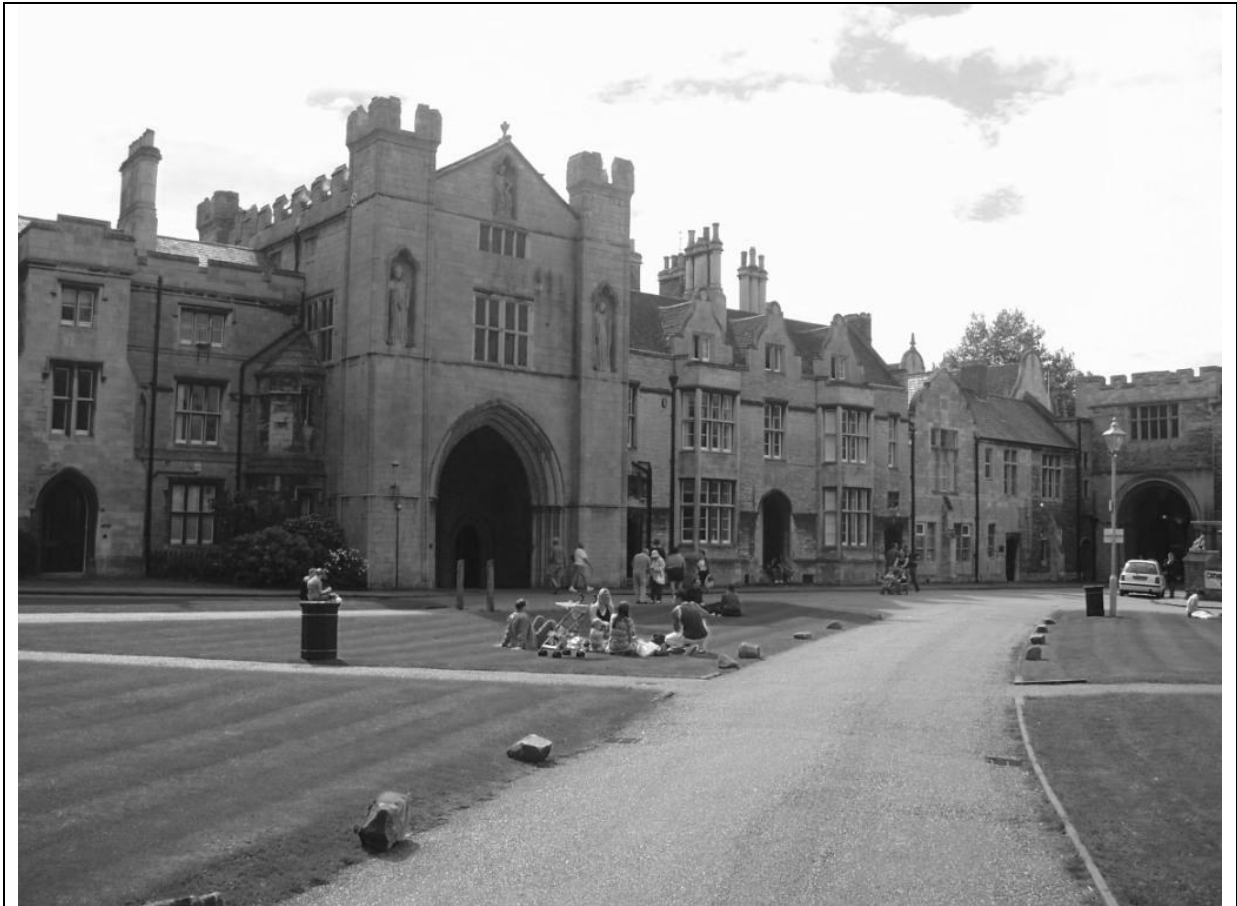
The Bishop's Gate (centre-left), and 26-28 Minster Precincts.

The buildings are in good condition, well maintained and appear to be in good decorative order. They are in residential use, which is clearly appropriate; the former uses of 27A do not affect this assessment.

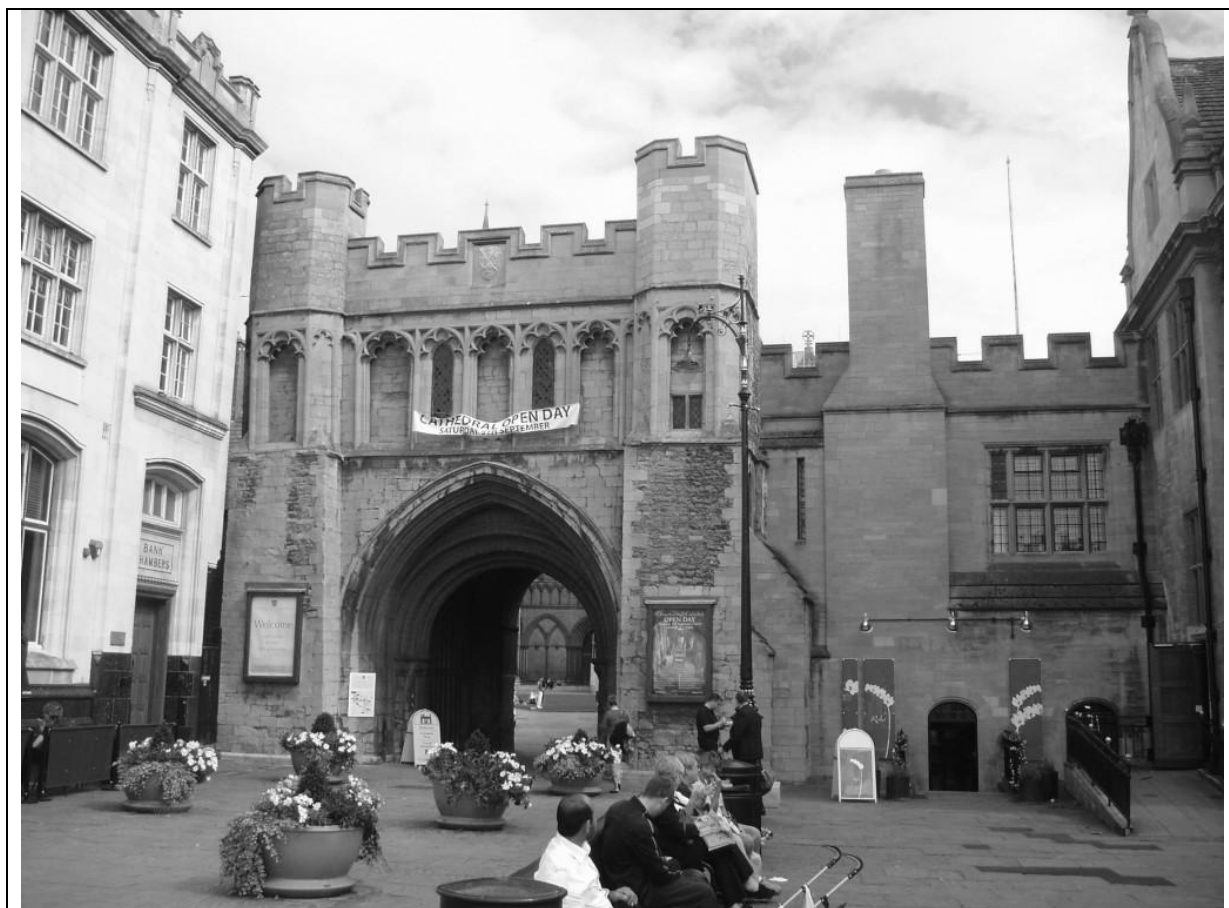
The King's Lodging (right) next to the Norman Gate.

The so-called King's Lodging was quite extensively rebuilt around 1930 though much of this work is restricted to the west elevation. Internally the structure retains very fine vaulting with short circular piers supporting slightly chamfered arches and ribs. This vault is below the external ground level and is thus approached down steps. It now forms the main shop space. Two further rooms have 12th and 13th-century vaults. The so-called Condemned Cell might be of medieval origin, and other parts of the King's Lodging were formerly within the post-medieval town gaol. The remainder of the interior is more plain and affected by alterations, and thus of lesser interest.

The building is in good condition, well maintained, and is in good decorative order internally. The commercial use is perhaps unfortunate but economically sensible in a prime location such as this. There are few if any negative consequences for the fabric, though internal fixtures and fittings must have no impact on the historic fabric. Externally no further advertising, signage, lighting or similar paraphernalia should be installed.

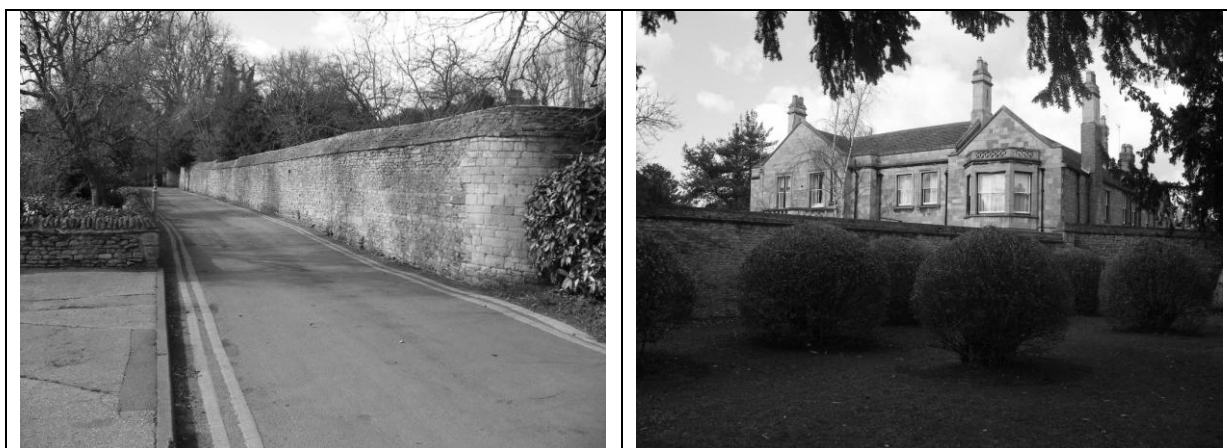
The Precinct boundary wall along Gravel Walk looking west (left), and along the east side with the Vineyard behind it (right, looking north-west).

The boundary walls are generally in reasonably good condition, and the Cathedral Architect reported on their state in 2005. There has been a substantial programme of repair and conservation since then, but further work is required. Chapter is aware of this. Regular repair and conservation includes de-vegetation when needed. Root systems are left in place but killed if their removal would cause more harm than good through damage to the masonry. There are areas where failed pointing and/or

missing facing stones are an issue, especially in the section along Gravel Walk. These do not appear to be a cause for serious concern at this stage; they will continue to be monitored on a regular basis and repaired and conserved as necessary.
