MARHOLM CONSERVATION AREA APPRAISAL REPORT AND MANAGEMENT PLAN

Prepared by: Planning Services, Peterborough City Council

Date: March 2014

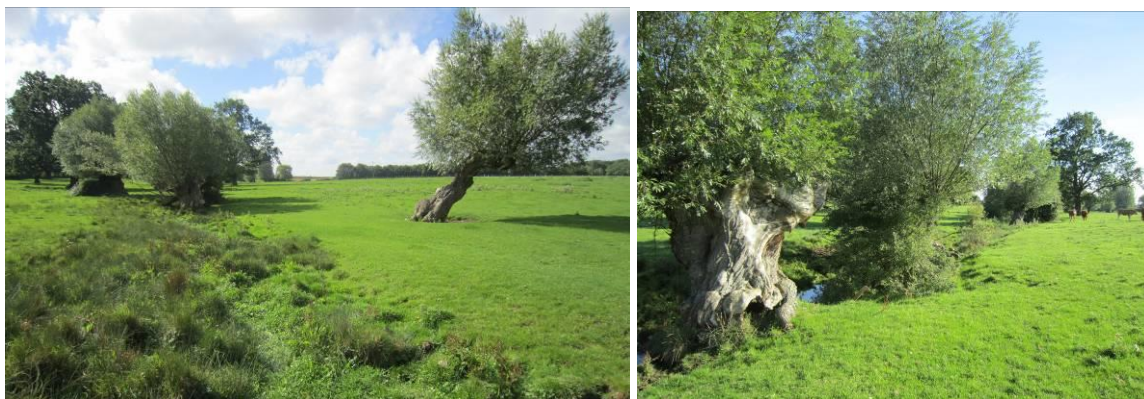
There are two areas close to the village where the landscape appears to retain features from the post medieval period. The first area is the pasture / parkland to the south of the church. This includes the meandering stream along which are a number of pollard willows that are perhaps 300 years old.

Pasture south of church retains the stream and ancient pollard willows

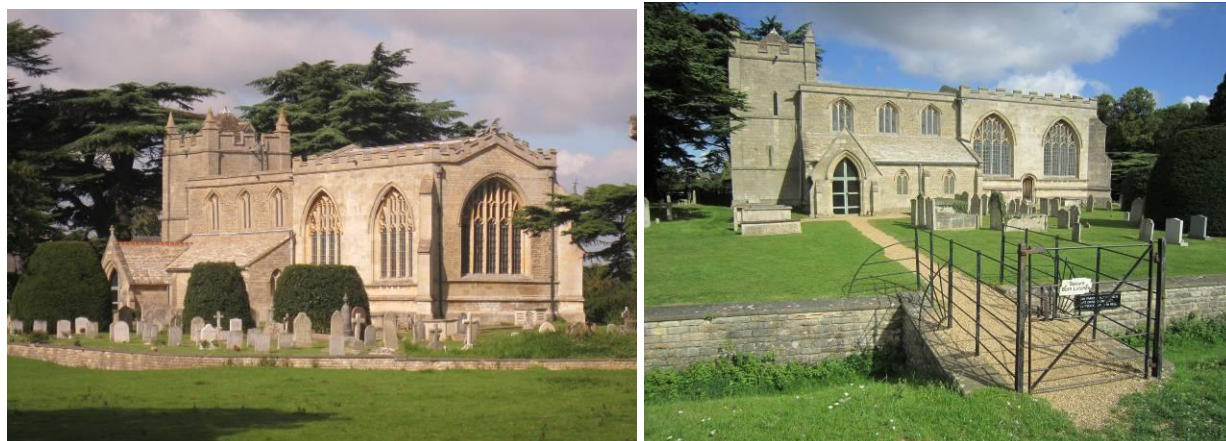
St Mary the Virgin church is the only building that survives from before 1600. It was constructed from the 12th and 13th centuries with subsequent alterations in the 15th, 16th and 19th centuries.

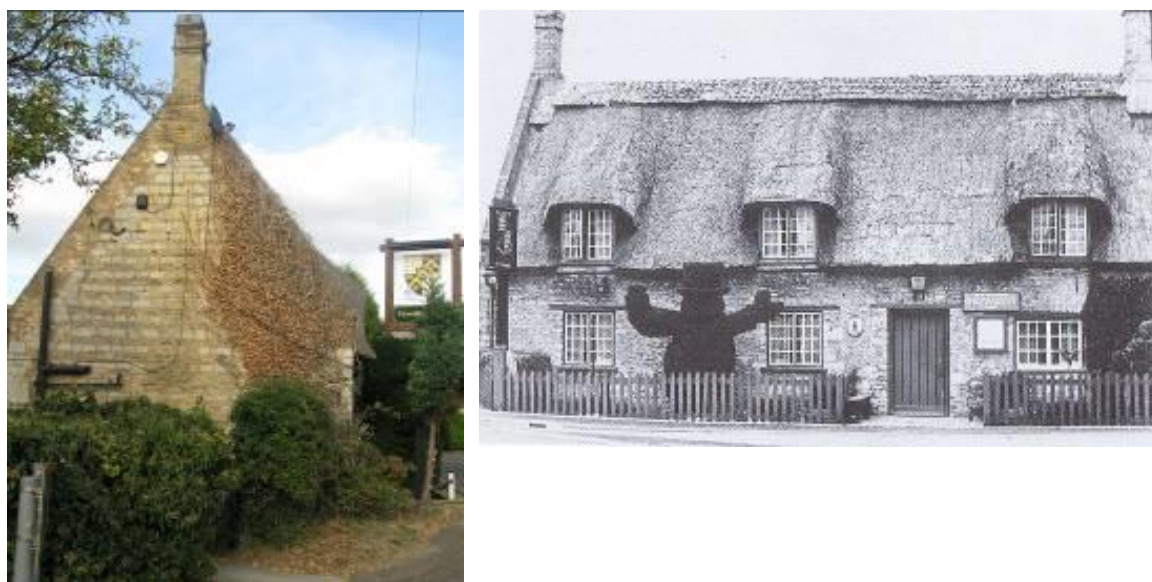
Gable of Fitzwilliam Arms showing late 19th c alteration and front elevation, probably in the early 20th c.

Many of the properties from this period have been re-constructed and doors and windows replaced. The photograph below of the gable end of the Fitzwilliam Arms shows that at one time, it was a single storey building with attics. The original stone gables have been added to in brick, probably in the late 19th century. At this time, the doors and windows were also changed.

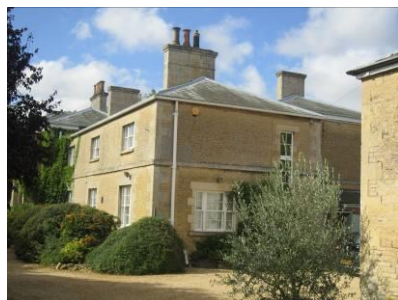
The Old Rectory represents formal domestic 19th century building, based on classical principles and developed from the Georgian symmetrical approach to house design. Steam power now allowed stone to be mechanically sawn and the coming of railways to Peterborough in the 1840's made mass produced Welsh slate available. The Old Rectory adopted both and this is reflected in its design.

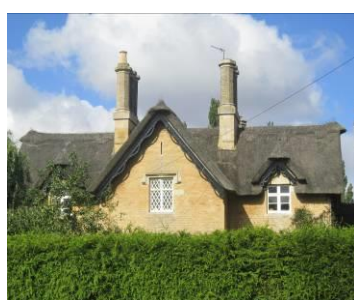
The Foresters House adopts a different approach; it could be described as Victorian romantic or Gothic and is in rustic stone with a steeply pitched straw thatched roof. The building incorporates the diamond paned cast iron windows also used for the Duke of Bedford's model agricultural cottages in Thorney and has exaggerated octagonal chimney stacks on stone bases, stone hooded window lintels and gable slits formed around dressed stone surrounds.

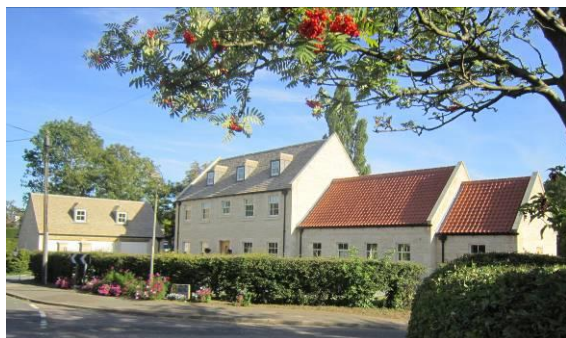
Only one building has been constructed in the 21st century, this being on the site of the former school house. This has the long rectangular plan form of buildings from earlier periods such as Home Farmhouse and Manor Farmhouse.

It also adopts the 2 storey + attics with visually subservient single storey outbuildings form, typical of 18th century farmhouses in the locality. The use of local stone, replica Collyweston slate and clay pantiles mark a return to the building tradition that formed the special character which the conservation area status seeks to protect.

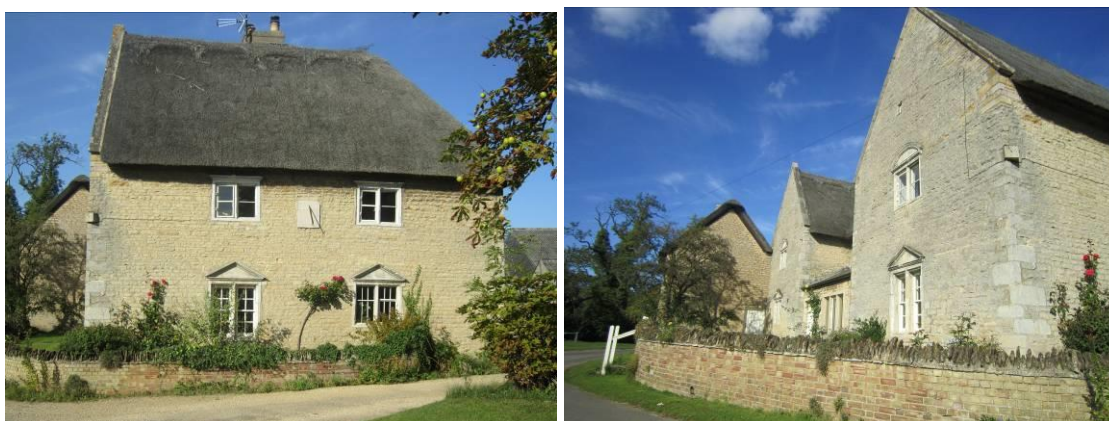
Marholm Farm is a typical 17th century farm house. It is based around a long rectangular main range, one and a half rooms deep with two wings giving an “H” shaped plan form. It is of a full 2 storeys with a thatched roof.

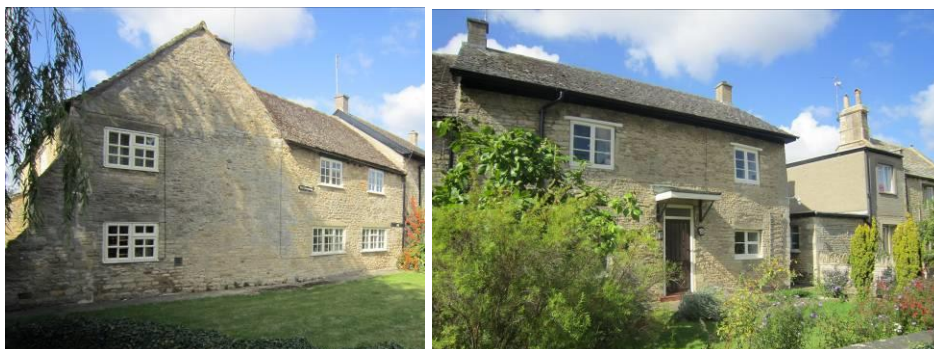
3 Church Walk

2, 3 and 4 Church Walk are dwellings that originated in the 17th century and once would have been properties of people of some significance. The original plan form would have been “L” shaped, 2 rooms deep and 2 storeys in height. However, they have been much altered and the steep pitch roofs, windows and other significant historic features have long been replaced.

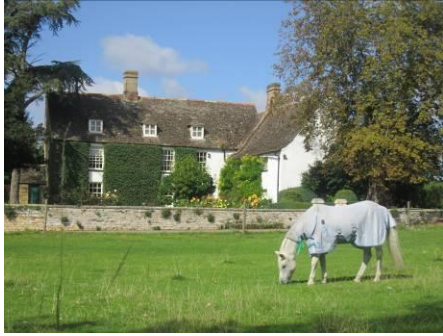
The Manor House is a typical 2½ storey 18th century house constructed for a relatively well off yeoman farmer. The main range is a 3 bay building with long rectangular plan form, one and a half rooms deep. It incorporates an earlier 2 storey wing, probably 17th century giving an overall “L” plan form. Poplar Farm is typical narrow plan and 1½ storey.

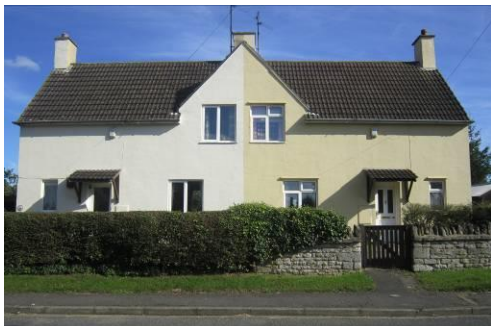
The public housing of the first half of the 20th century is to standard plan forms, 2 full rooms deep and 1.75 / 2 storeys in height, in semi-detached forms. Similarly, the interwar bungalows are to standard, over-square plan forms; all covered by the shallow roof pitches possible with concrete tiles.

one of three pairs of inter war semi detached houses

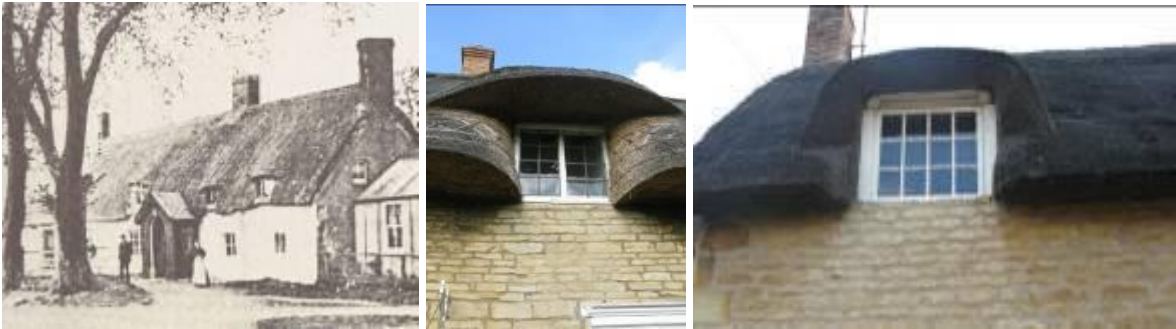
Cottages are of 1 storey and attics with low ceiling heights under longstraw thatch roofs; hooded dormers seem to have been the traditional detail; these have increasingly been replaced by eyebrow dormers. Old photographs show that until the 1950's, thatches had simple straight ridges, unlike the scalloped ridges of today. The dormers were also less pronounced than many of the modern interpretations of historic thatch details, especially where reed has replaced traditional longstraw thatch.

longstraw thatch roofs with hooded and eyebrow dormers

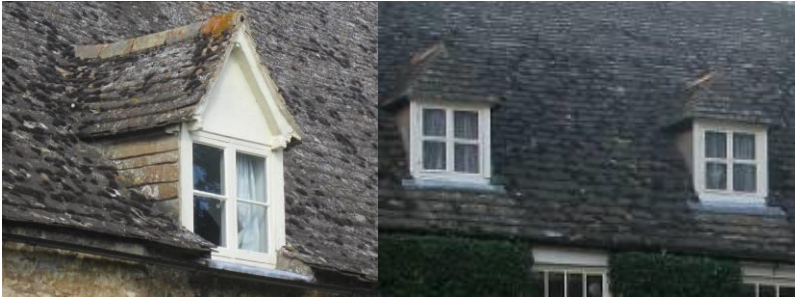
Houses have Collyweston slate roofs incorporating hipped gable dormers or plain gabled dormers

Gabled and hipped gabled dormers

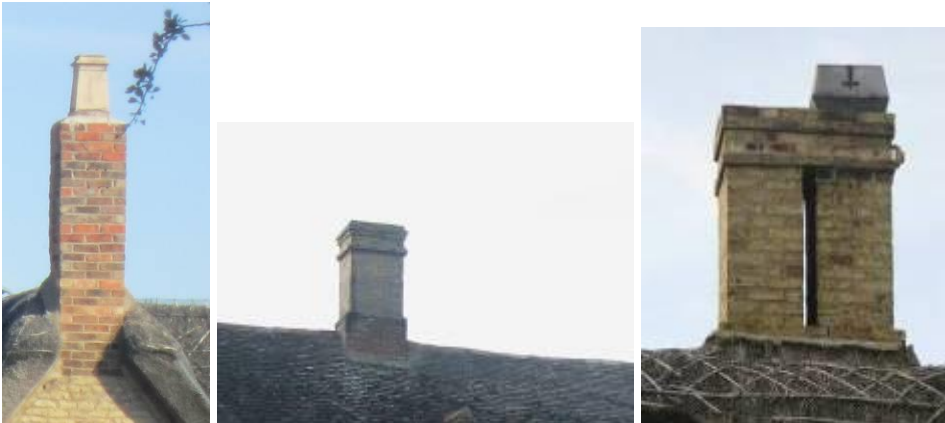
From the 17th century, brick chimneys began to be introduced, invariably centrally placed along the roof ridge. By the 18th century, they were typically built within the end gables. Possibly due to the influence of the Fitzwilliam estate, cut stone was also used.

Brick chimneys inserted in to 17th and 18th century buildings

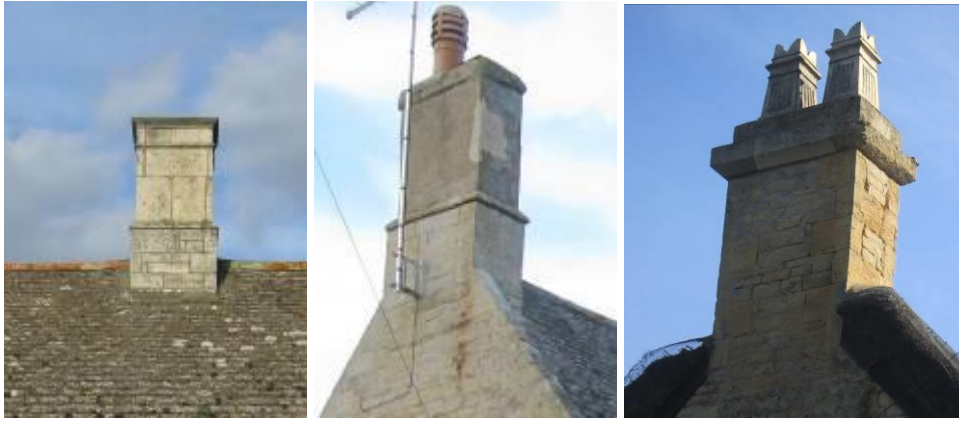
Stone chimneys

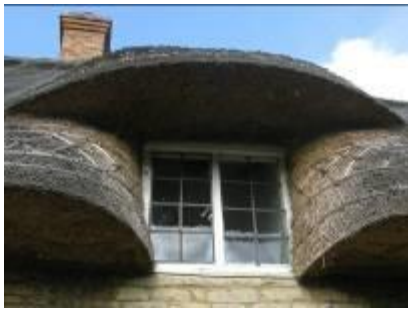
17th century **cottage** windows would have been no more than wooden mullioned frames with shutters, but no glass. In the 18th century Yorkshire type horizontal sliding sash with small blown glass panes were extensively used along with wrought iron frames and leaded lights set in oak frames. Some of the latter still remain to the upper floors of Water End Cottages.

Lights made of wrought frames and leaded lights, Waterend Cottages

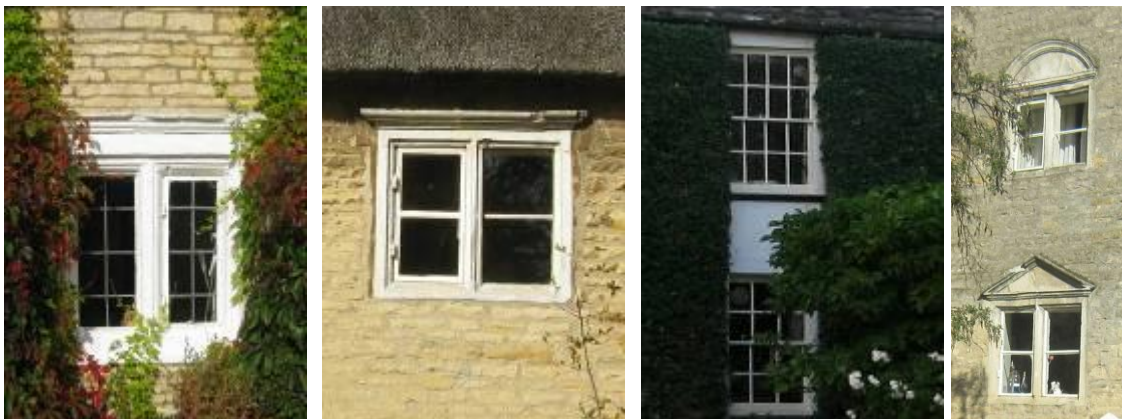
17th century **houses** also incorporated iron frames, but set in stone surrounds. It is likely that most iron lights that survive today are from the 19th century. The windows to Marholm Farm incorporate stone surrounds and mullions with both triangular and segmental pediments above. By the 18th century, sash windows brought more light and technical innovation and rapidly superseded earlier window types.

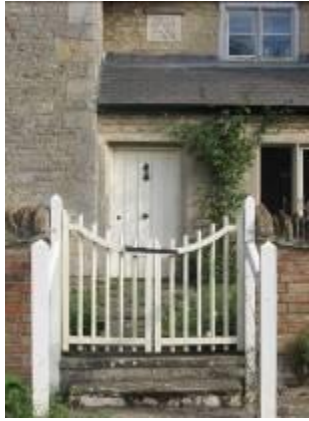
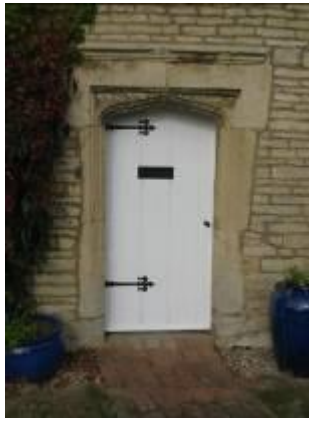
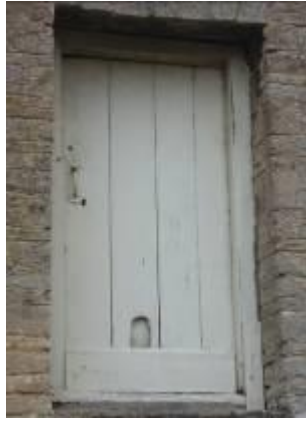
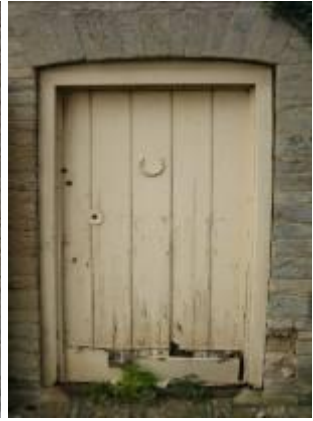
House doors from the 17th century are generally based on 3 or 5 plank forms. It may be that the doors to Water End Cottages and Marholm Farm are replacements, but based on doors that previously existed.

18th century

19th century

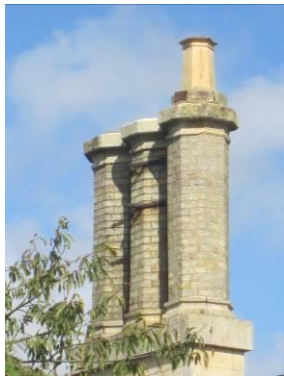
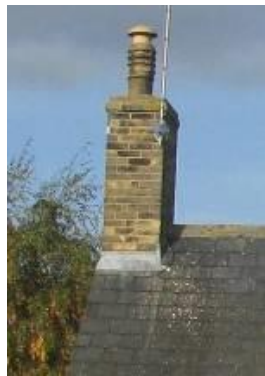
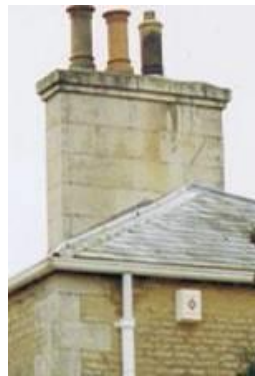
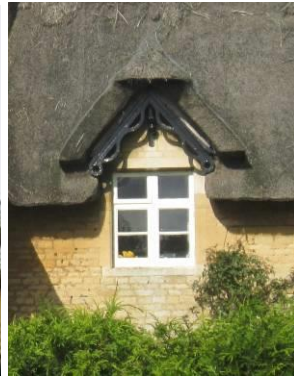
Smaller Victorian houses and cottages typically had roofs in Collyweston, thatch and Welsh slate, some with good quality ashlar stone chimneys, others are in brick with others still having stone bases and brick shafts.

It is normal for Victorian houses to be two storeys, without dormers. However, semi dormers are incorporated into the Foresters house above (right).

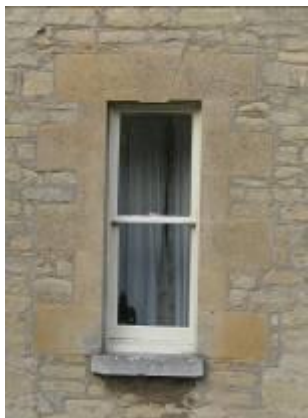
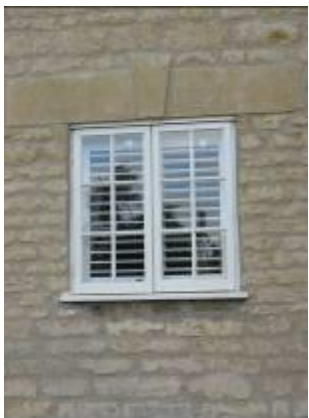
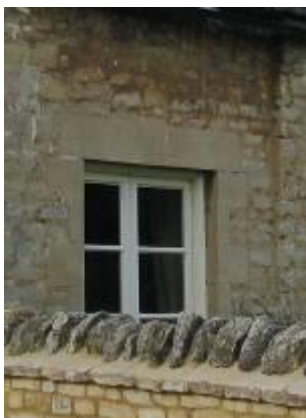
It appears that voussoir lintels (below) have been a local feature and these may have been retrospectively added to some existing windows in later centuries.

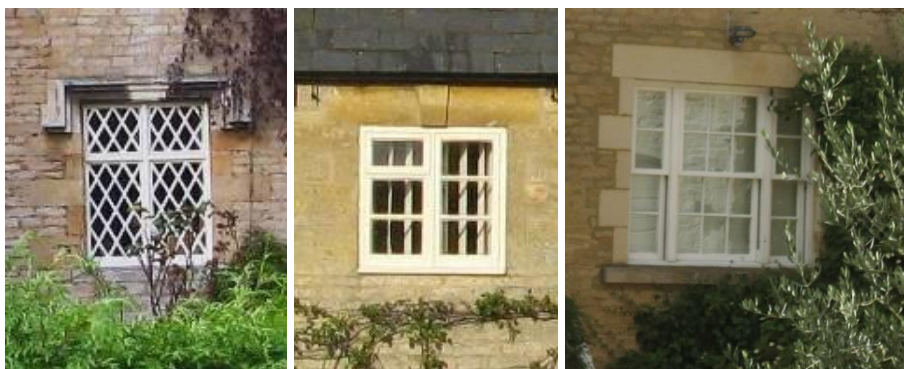
Some 19th century windows and doors remain; others have been adapted or replaced.

- **Cottage window and doors and frames surviving from before 1920 should be repaired and/or taken as patterns for the re-manufacture of replica doors and windows for use in repair and restoration on other similar buildings in the conservation area where modern patterns have replaced traditional fabric.**

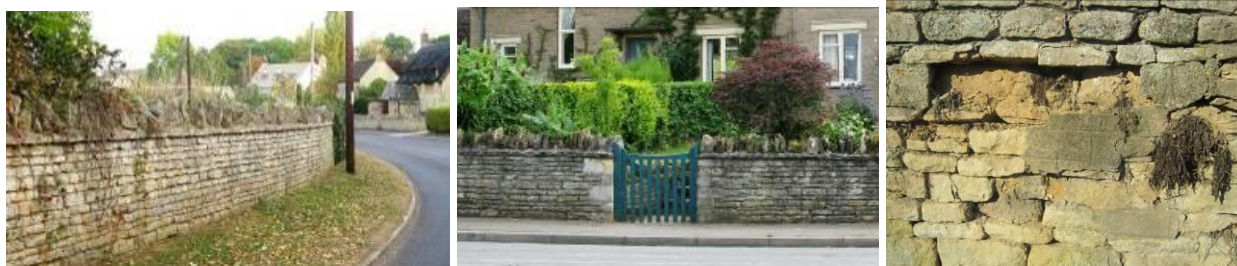
Twentieth century development has resulted in the fragmentation and loss of some walls as gaps are made to accommodate new access. Other walls have fallen into disrepair, been demolished or reduced in height in preference to repair or replaced by fences.

Stone walls within the village

- **All existing stonewalls should be retained, maintained and repaired as necessary and where there are opportunities old walls restored to their original height.**
- **The City Council, in conjunction with the Parish Council, English Heritage and other bodies will consider ways to assist the repair of existing walls and the building of new walls, where appropriate, in the local tradition.**
- **Proposals to install fences behind existing walls should be resisted, the presumption being that the wall will be made structurally sound and if necessary increased in height, all using local materials and methods.**
- **The city council will make available its guidance on the local methods and techniques for the building and repair of traditional stone walls.**

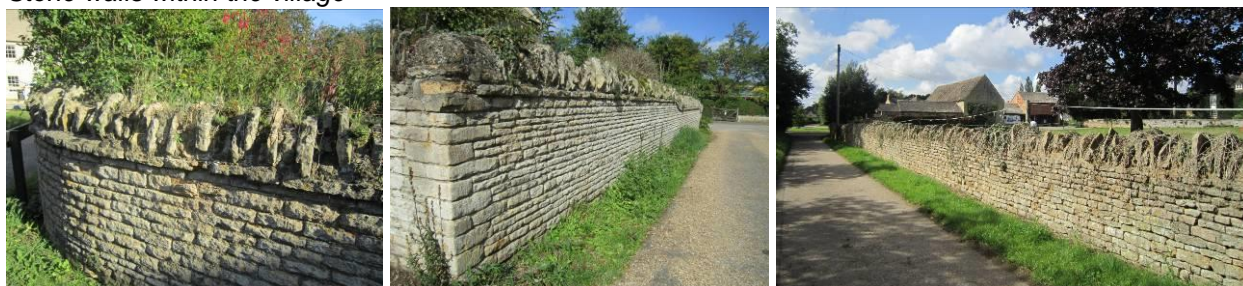
A number of other walls will soon require repair. Further loss of these important historic features would diminish the character and appearance of the conservation area. There may also be opportunities to construct new traditional walls, or restore the height of existing walls. Further puncturing of walls through insertion of new drives should be avoided.

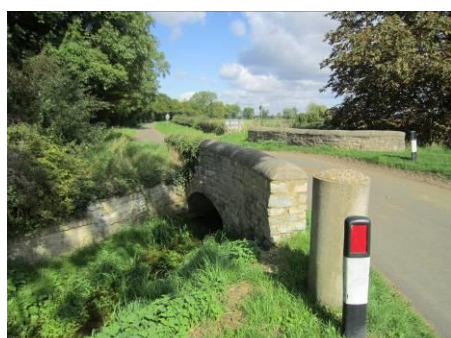
The bridge carrying the Woodcroft Road over the stream appears to have an 18th century arch, with parapets subsequently rebuilt. This appears worthy of consideration for adding to the statutory list.

Bridge from 18th c?

The road bridge to the Woodcroft Road approximately 30m north of Marholm Farm appears to be 18th century, with the parapets subsequently repaired and rebuilt. There are no other unprotected buildings that may fall within the national listing criteria. It is recommended:

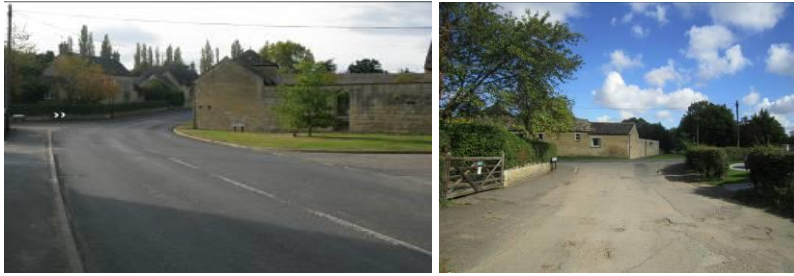
As a result of the re-engineering of village streets, tarmac carriageway and footpaths are more evident. At junctions, in particular, traffic signage, highway markings and other street furniture do not complement the conservation area setting.

Street scenes dominated by highways

Lighting is mainly provided by modern galvanised columns. These and other highway signage and structures detract from the quality of the public realm and the character of the area. Street furniture could be rationalised and better planned. It is recommended:
